MERCRUISER SERVICE BULLETIN

Section: XII (Service
Bulletins)
Number: 20 65-01
Date : 1/5/65

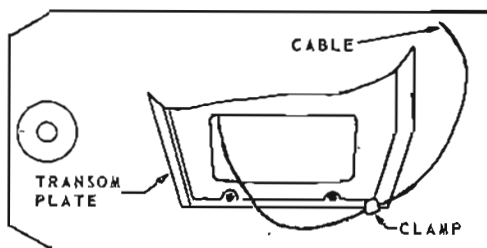
Figure 1. Red Warning Tag

Some MerCruiser IC Stern Drive Units were shipped with an incorrect shift cable warning tag attached to the transom plate assembly. (Figure 1) Later MerCruiser IC shift cables are protected with a spiral protective shield and it is not necessary to clamp the shift cable to the inner transom plate. Disregard the red warning tag. (Figure 1) and follow instructions in MerCruiser IA-IB-IC "Installation Manual". Route shift cable as shown in Figure 2.

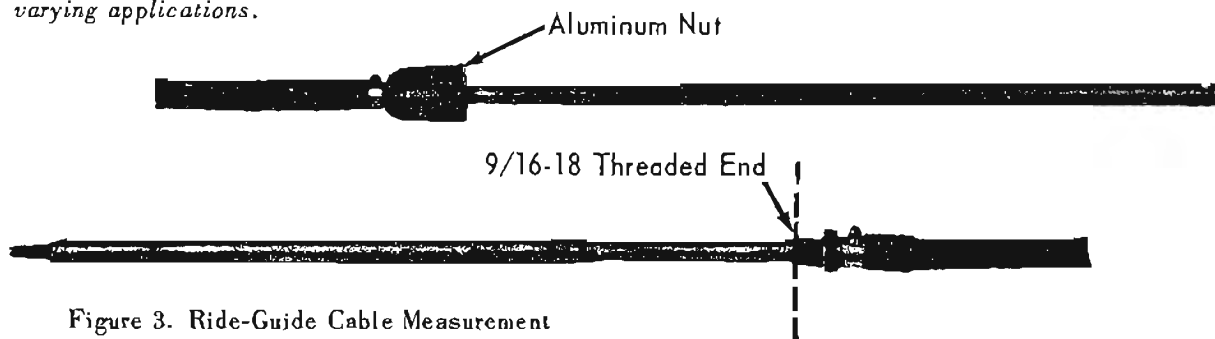
In order to clarify the measurement of Ride-Guide and remote control cables, Ride-Guide cables are measured from the large aluminum nut to the 9/16-18 threaded end (Figure 3), while remote control cables are measured from the end of one cable tube to the end of the other, not to include the inner wire. (Figure 4)
