# MER RUISER

Section: XII (Service

Number: 65-D 3

Date : 2/15/65

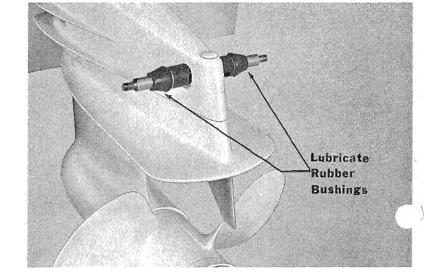
Fig. 1. Lubricating Rubber Bushings

a thin coating of Quicksilver MULTIPURPOSE Lubricant (C-92-35226) on rubber bushings when installing hydraulic tilt cylinders on MerCruiser I and II. (Figure 1) This will result in less resistance and improve action of the tilt.

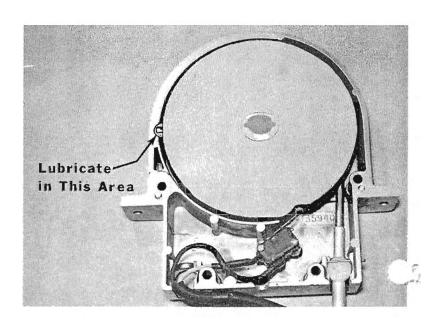
Figure 2. Control Lubrication

Lubricate C-36077A1 & A2 panel controls and C-35651A1 console controls in area where blocking pin roller rides on housing before assembling control housings. (Figure 2) Also lubricate this area when servicing these controls. Use Ouicksilver MULTIPURPOSE Lubricant (C-92-35226).
