MERCUISER SERVICE BULLETIN

Number: 67-1608

Date : 5/10/67

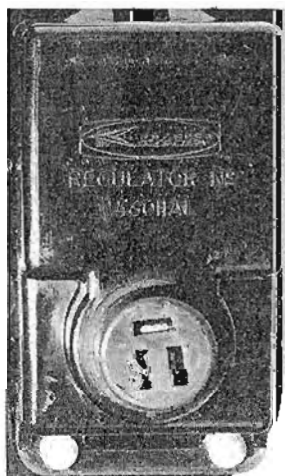
It has been brought to our attention that, occasionally, the external wiring harness is not being plugged into the voltage regulator properly. This condition will show as a full charge on the ammeter at all times above half-throttle and eventually will cause damage to the battery.

◀ Figure 1. Defective Terminal

To remedy this possibility, remove the harness plug from the voltage regulator and be certain that the terminals are making proper contact. If a terminal is found in a condition as shown in Figure 1, straighten the terminal, apply a di-electric type compound, such as DC-4 (C-92-24108-1), and reinstall the plug properly.
