MERCURISER SERVICE BULLETIN

Section: XII (Bulletins)
Number: 68-867-15
Date: 10/3/67

A. HEAVY DUTY GEAR HOUSING PROPELLER COVER - MerCruiser II

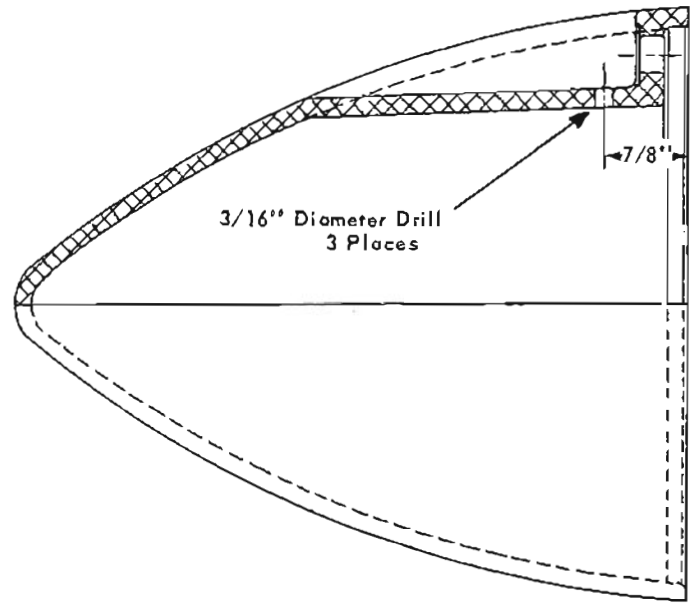
Figure 1. Drilling Locations

It has been brought to our attention that water may be trapped in the propeller cover of MerCruiser II heavy-duty gear housing assemblies. There have been reports that this trapped water can freeze and crack the cover. To remedy, drill out the cover with a 3/16" (4.8mm) dia. drill in 3 places, as shown in Figure 1.
