MERCUISER SERVICE BULLETIN

Number: 69-X-68-16

Date: 10/10/68

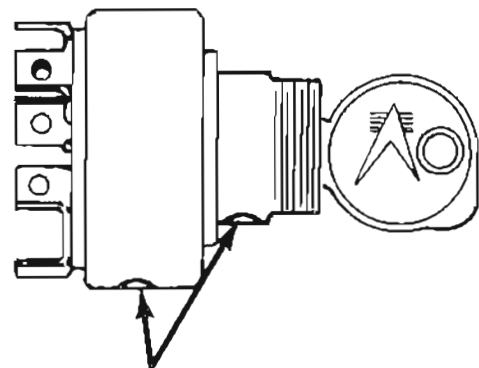
Figure 2. Profile of Key

It has been brought to our attention that key switches are being installed upside-down. A hole is drilled in the bottom of the switch for drainage. (Figure 1)

Holes must face down when switches are installed. Quick identification of proper installation can be made by noting the key position in the switch. The wider portion of the key will be at the bottom. (Figure 2) See chart, above, for new part number which supersedes old part.

HOLES IN BOTTOM

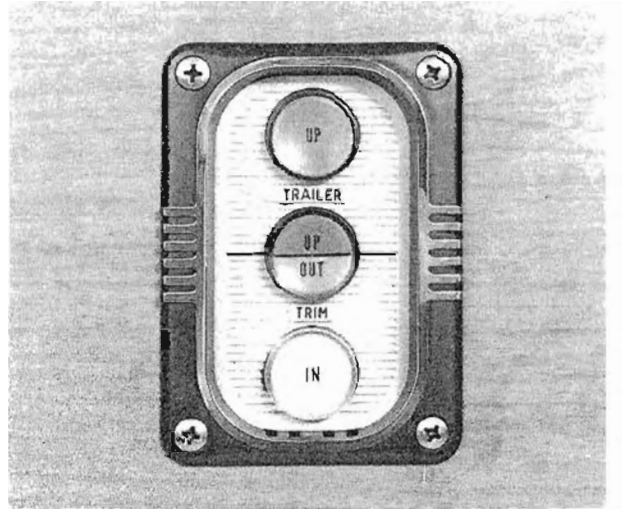
Figure 5. New Power Trim Control Panel

A change has been made in the appearance and operation of the Power Trim control panel. (Figure 5)

The new panel can be identified by the push button color:

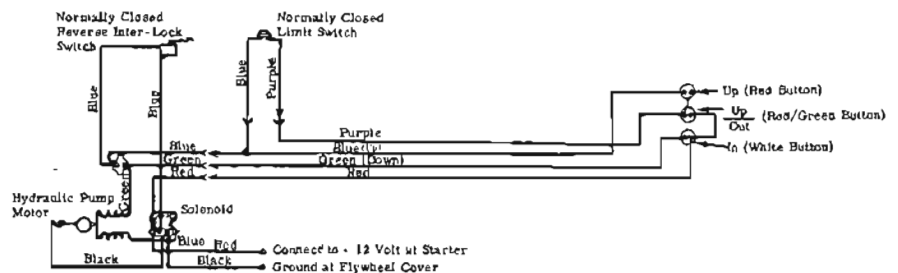
Figure 6. New Power Trim Schematic Wiring Circuit

The electrical circuit for new Power Trim (Figure 6) is not the same as on earlier MerCruiser Power Trim. **DO NOT** rewire control panels according to earlier wiring diagrams.
