# MERCUISER SERVICE BULLETIN

Section: XII (Bulletins)  
Number: 68-15-10  
Date : 5/29/68

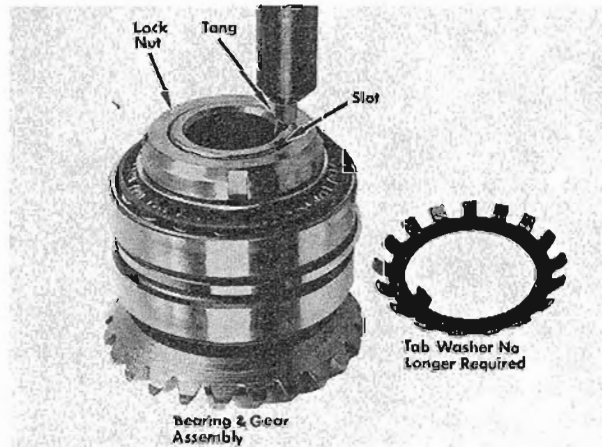
Figure 2 Swaging Tool C-91-53122

The use of drive shaft gear bearing lock nut tab washer C-14-32054 may be discontinued on earlier gear assemblies. The lock nut now is installed with chamfer up and secured with Swaging Tool (C-91-53122). (Figure 2) To swage lock nut, place tool on edge of lock nut, tang in gear slot; then, strike tool with a sharp blow. Lock nuts may be reused and reswaged in repairs, whereas, the tab washer may not be reused.

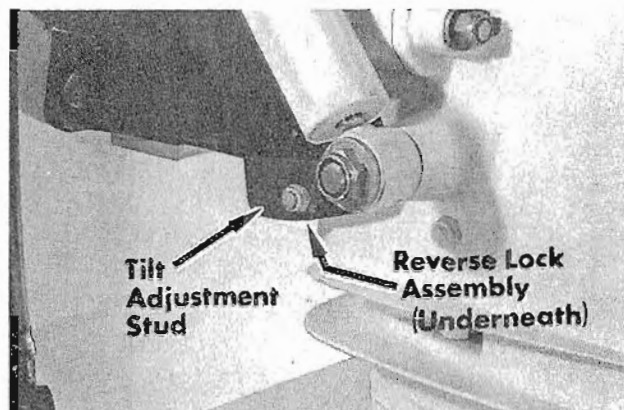
Figure 3. Reverse Hook Location

Reverse hook release mechanism no longer can be installed on service replacement bell housing B-52384A1. To release the stern drive unit, if necessary, press the reverse hook assembly down, away from tilt adjustment stud. (Figure 3)
