MERCUISER SERVICE BULLETIN

Number: 70-9-05

Date: 3/26/70

C. MERCUISER E-Z SHIFT SHAFT (For Drive Unit Section IX)

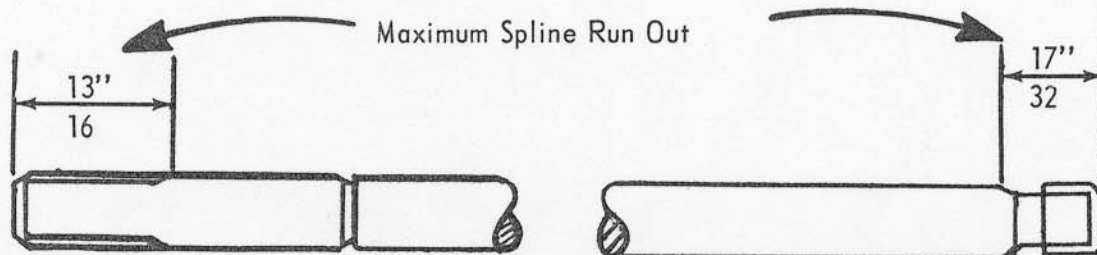
Figure 1. B-37973 Shift Shaft

Some shift shafts (B-37973) have splined ends that are too long. (Figure 1)

Return shafts, which are too long, to your branch or distributor for exchange. The long spline of the defective shift shaft (B-37973) positions the shift shaft with the top splines below the oil seal, thus causing an oil leak.
