MERCROUISER SERVICE BULLETIN

Number: 70-12-08

Overheating of Instrument Panel Harness and Engine Harness (Sec. II)

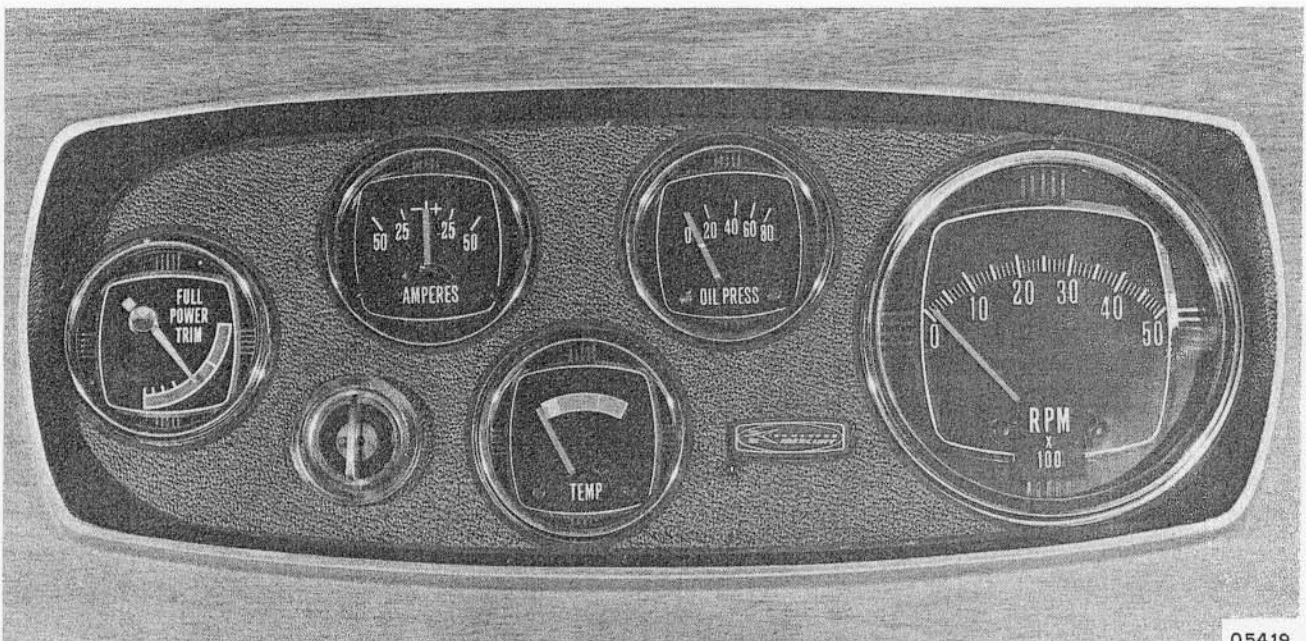
Figure 1. Series B-55194A_ MerCruiser Instrument Panel

Some boats are equipped with B-55194A_ series instrument panels. (Figure 1) If the instrument panel harness and/or engine harness overheats when connecting the battery cables or shows signs of overheating on boats so equipped, the red and/or red/white wires (connected to the ammeter) may be shorted to ground.

The above connections should be inspected (as outlined, following) BEFORE connecting the battery cables on all boats received and those which you have sold. Replace harnesses which show signs of overheating. Be sure that connections at ammeter are correct when installing new harness.

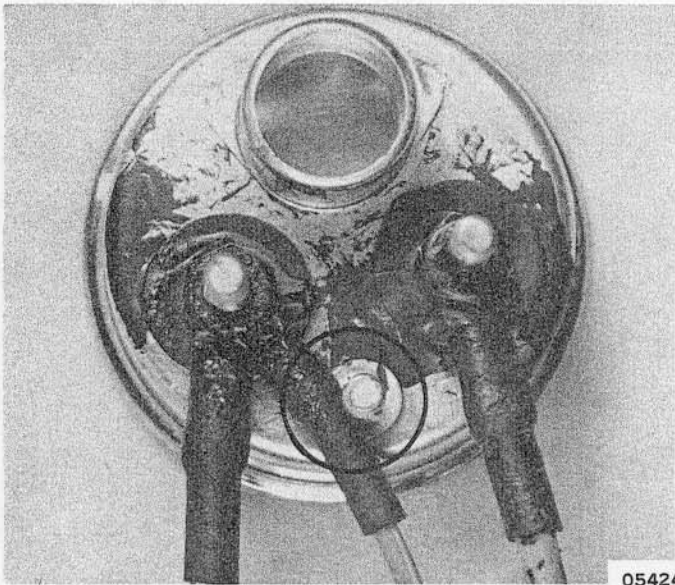
Figure 2. Red/White Wire Shorted to Ground Stud

3. If connections are as shown in Figure 2 or 3, loosen terminal nut and pivot terminal away from ground stud to provide clearance as shown in Figure 5.

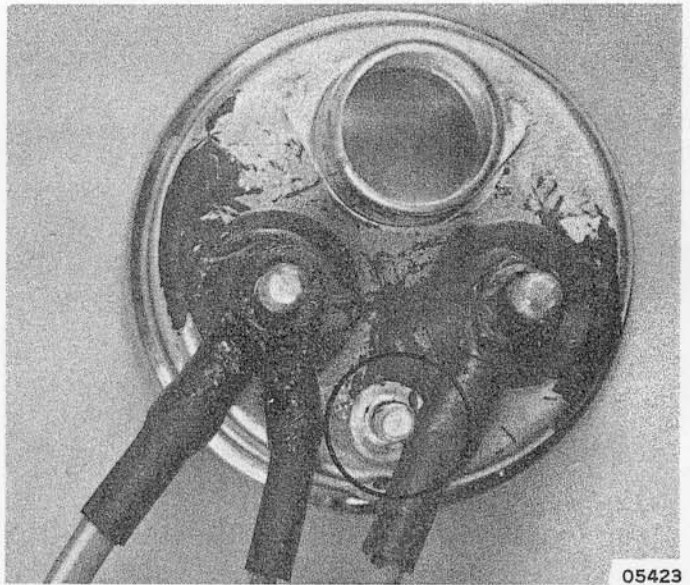
Figure 3. Red Wire Shorted to Ground Stud

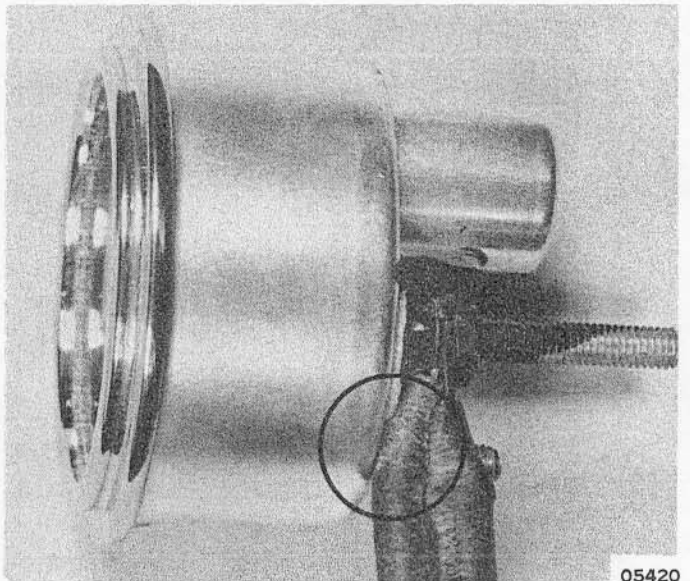
Figure 4. Red/White Wire Shorted to Gauge Case

4. If connections are as shown in Figure 4, bend terminals away from gauge case to provide clearance as shown in Figure 6.

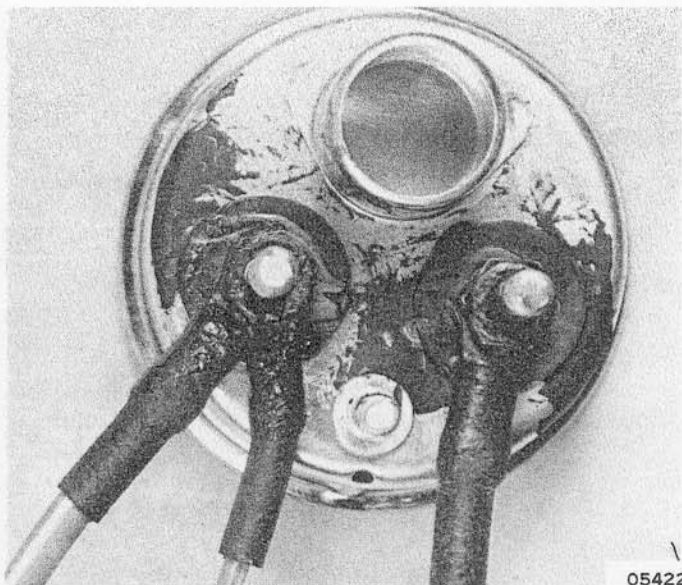
Figure 5. Correct Wire Connections

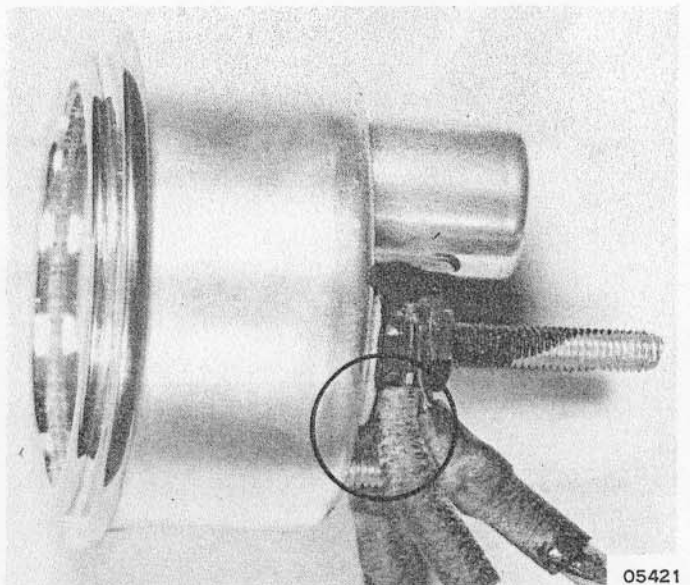
Figure 6. Correct Wire Connections
