MERCUISER SERVICE BULLETIN

Number: 70-16

Date : 8/14/70

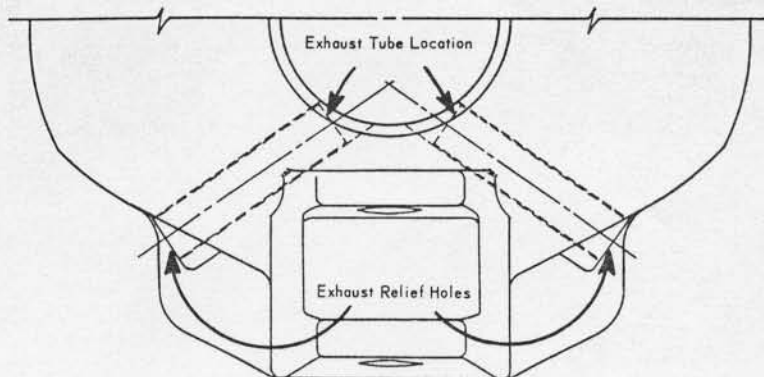
Figure 1. Exhaust Tube Location

Some gimbal housings have been found leaking thru the casting near the exhaust relief holes (located on bottom of housing near the exhaust elbows). To correct this problem, coat the sides of each hole with sealer (C-92-52238-1) and insert one tube (C-32-59563A1) into each exhaust relief hole as shown in Figure 1.
