MERCUISER SERVICE BULLETIN

Section: XII 70-
Number: 21-3 14
Date : 11/17/70

- A. MC 215 Power Steering Hydraulic Hose Routings (Sec. 7B)
- B. MC III Universal Joint Oil Seal Leakage (Section 2E)

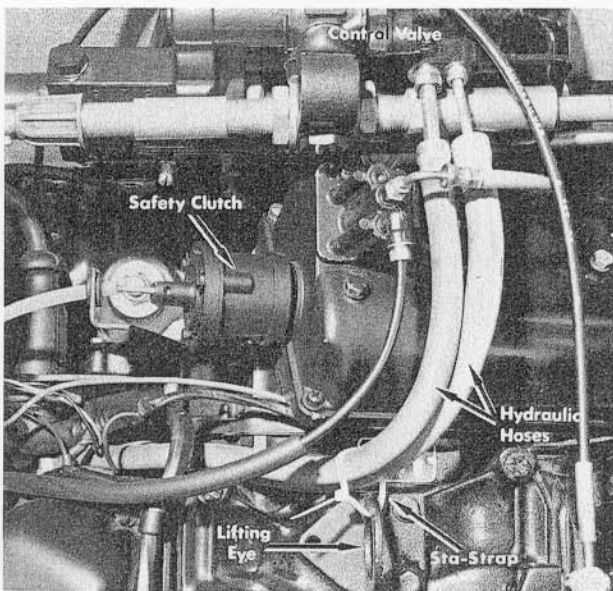
Figure 1

Some Power Steering hydraulic hoses on MerCruiser 215's have been routed around the safety clutch where chafing damages the hoses. Check routing in all boats and, if necessary, reroute the hydraulic hoses from the Power Steering control valve (to oil cooler and engine hydraulic pump) as shown in Figures 1 and 2, below. Clamp hydraulic hoses to engine lifting eye with Sta-Strap (C-47764) (Figure 1) or similar fastening device.
