MERCUISER SERVICE BULLETIN

Number: *NY 70-13*

Date : 9/30/70

- A. MerCruiser I Type Drive Unit Noises (Drive Unit Section)
- B. MC I-thru-165 Gear Case Cover Tool Adaptor (Tool Section)
- C. MerCruiser IA-IB-IC Superseded Drives (Drive Unit Sec.)
- D. MC 120-thru-165 Drive Shaft Bearing Preload (Drive Unit Sec.)
- E. Power Steering and Ride-Guide Cable Lube (Miscellaneous Sec.)

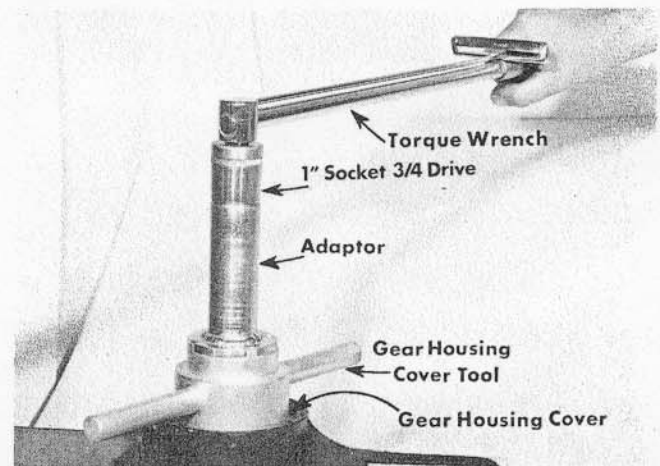
Figure 1. Gear Housing Cover Tool and Adaptor

Adaptor C-91-59553 is placed on Cover Tool C-91-53126 for applying proper torque to gear housing cover nut when tightening cover nut. (Figure 1)

- 150 lbs. ft. (20.75mkg) for bearing carrier WITH lock tab feature
- 200 lbs. ft. (34.58mkg) for bearing carrier WITHOUT lock tab feature
