- A. Trim Tabs Breaking - MerCruiser Drives and Mercury Outboards
- B. MerCruiser Cutout Switch Screw Removal
- C. Gimbal Bearing Replacement - MerCruiser II Models
- D. Checking Gear Housing Drain Holes - MerCruiser 80 and 90
- E. Fuel System Inspection - All Engine Installations

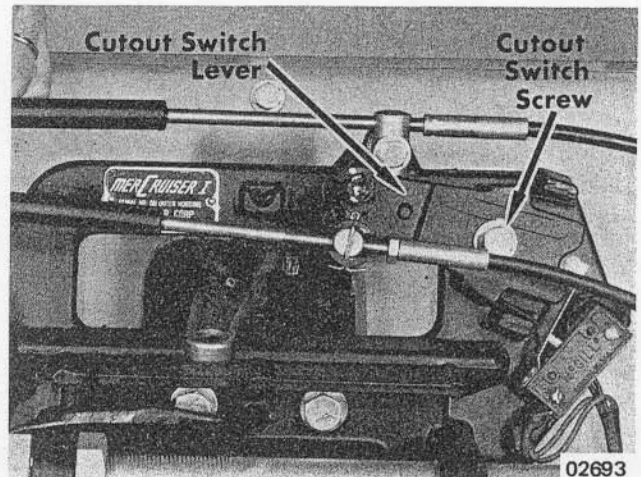
Figure 1. Cutout Switch Screw Location

The cutout switch screw, shown in Figure 1, MUST BE removed after initial shift cable adjustment. Purpose of the switch is to momentarily "cut out" the ignition during shifting to relieve the torque load on the sliding clutch in the gear housing.

Shift cables are improperly adjusted if the cutout switch does not function when shifting while the engine is running with the boat in the water.

Refer to your MerCruiser Service Manual for proper shift cable adjustment.

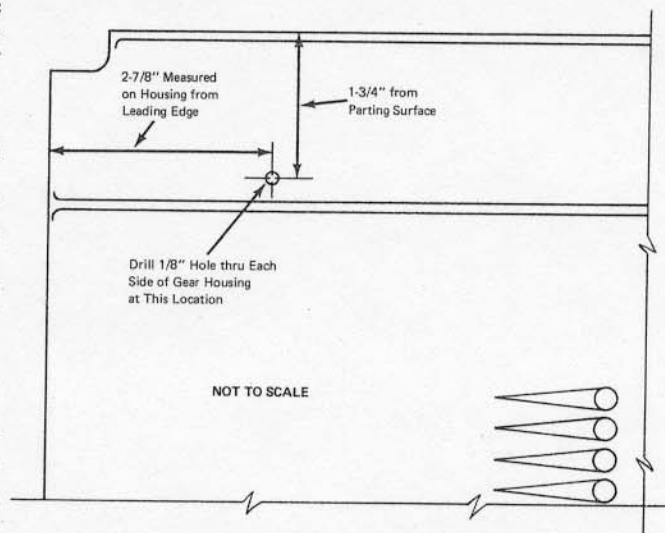
Figure 2. Drain Hole Location

When opportunities arise, check the gear housing drain holes in MerCruiser 80 and 90 models to be certain that the holes are open. The holes must offer free passage so that water will drain from the shift shaft cavities, thus preventing freeze damage and/or mechanical salt and mineral buildup.

If gear housing drain holes are not in the upper shift shaft cavity as shown in Figure 2, drill a 1/8" (3.2mm) diameter hole thru the wall on each side of the housing, as indicated. The drilled hole **MUST BE** perpendicular to the surface being drilled.

**IMPORTANT:** After drilling, protect exposed metal with Zinc Chromate Primer (C-92-31292) and Black (C-92-32291) or White (C-92-29528) Paint.
