- A. Propeller Cavitation Burns
- B. New Battery Servicing
- C. Slow Drive Unit Trimming in Cold Weather
- D. Oversize Pistons and Piston Rings - General Motors Engines
- E. New Service Tool - Rocker Stopper

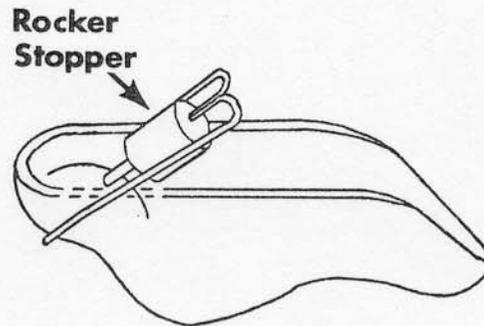
Rocker Stoppers (C-91-66273) eliminate splashing, squirting oil while adjusting the valve lash. A set of 16 "stoppers" will plug the oil holes in ball pivoted rocker arms on all MerCruiser Engines with hollow push rods. (Figure 3)

Figure 3. Rocker Stopper on Rocker Arm
