- A. Incorrect Matching of Quicksilver Rotary Head and Steering Mounts
- B. Locking Sleeve C-71669A1 - Use with MerCruiser 110-thru-470 Power Steering Systems

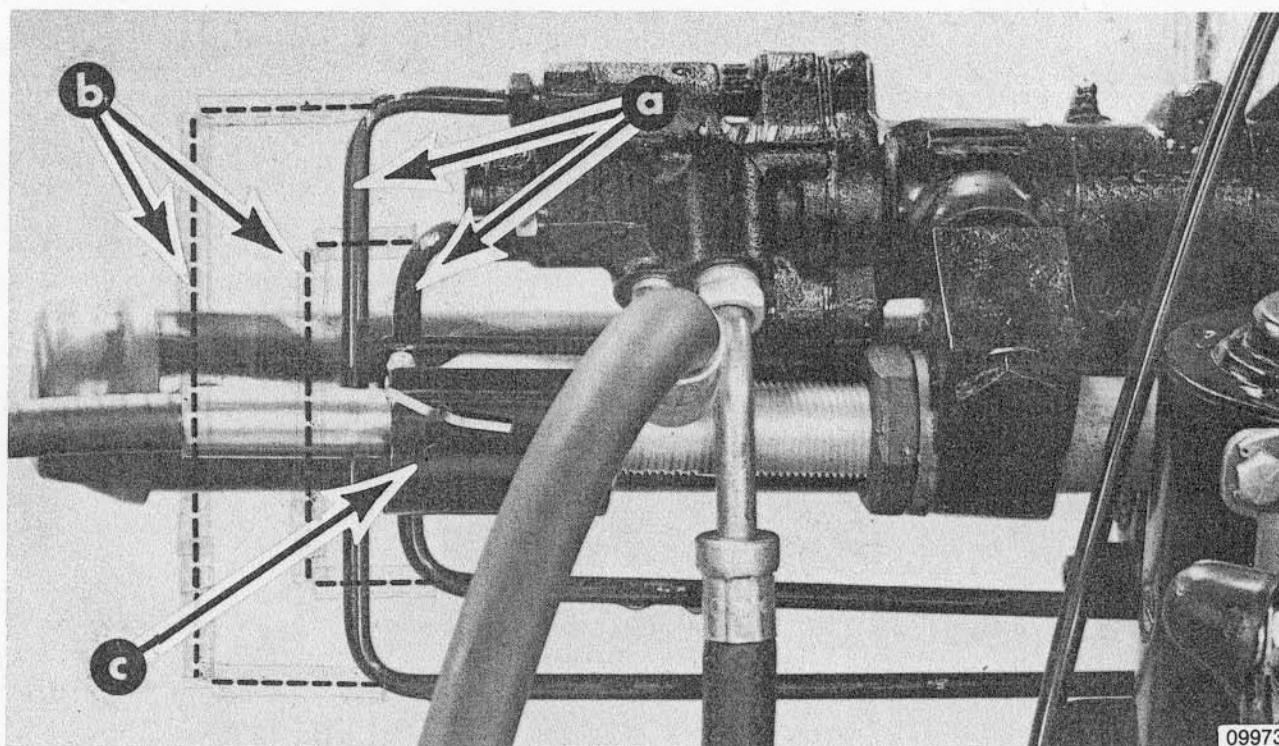
Figure 1. Typical Power Steering Cylinder and Valve Assembly

When installing Locking Sleeve C-71669A1 (Figure 1) on a Ride-Guide cable with MerCruiser Power Steering B-60501A1, B-71333A1 (MCM 110-thru-165) and B-76742A1 and A2 (MCM 470), interference may exist between the locking sleeve ("c" shown in Figure 1) and the short hydraulic tubes ("a"). With the above Power Steering Systems, it is necessary to replace the short hydraulic tubes with longer tubes (B-32-78895 and B-32-78896) before installing the locking sleeve.

a - Short Hydraulic Tubes b - Long Tube Location c - Locking Sleeve
