USE of EXTERNAL TIE-BARS on DUAL MERCUISER INSTALLATIONS

(Attach Bulletin Reference Sticker to Section 2D Index Page of Your Service Manual.)

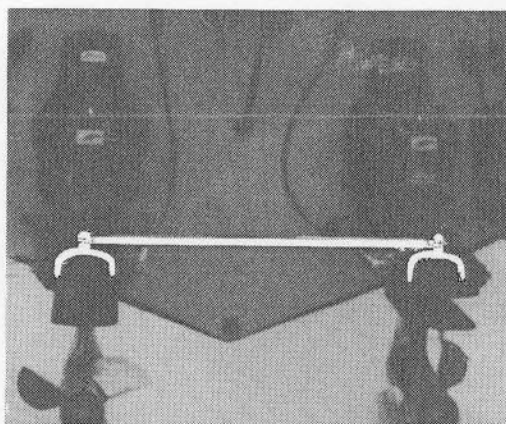
Figure 1. External Tie-Bar Installation

It has been found that, when external tie-bars are used on dual installations (Figure 1), twisting damage to one or both of the upper steering shafts can occur -- if one drive is tilted up ("out") or down ("in") relative to the other. This damage can adversely affect steering. If both upper steering shafts should fail, loss of steering will occur.

We recommend that you advise your customers (owning dual engine boats equipped with external tie-bars) that, if any of the above symptoms exist now or have ever existed, to have an authorized MerCruiser dealer inspect and replace, if necessary, the upper steering shafts as soon as possible. Your customers also should be advised not to tilt one drive unit independently of the other.

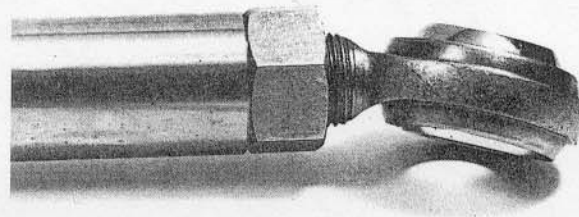
Figure 3. Closeup of Bent End

1. A need for repeated adjustment of the external tie-bar.
2. Excessive steering backlash (sloppiness, looseness) is noticed.
3. A dramatic change of boat steering characteristic, such as an increase of (or excessive) wheel motion to steer the boat, "darting" of the boat, or an increase of force required at the wheel.
4. Observed bending at the ends of the external tie bar (Figures 2 and 3) and/or buckling of steering cable extension at stern drive end and/or Ride-Guide support tube and/or drag link(s).
5. Observed "off-center" angle between either steering arm on inside of the boat and the drive unit outside the boat, when the drive unit is in a straight-ahead position.

Again, if any of the above symptoms of damage occur, one or both of the upper steering shafts could be twisted, and inspection is recommended. To perform an inspection, refer to the MerCruiser Service Manual for repair procedures.
