Number: 78-2

OFFICIAL NOTIFICATION Under the U.S. Federal Boat Safety Act

WIRING HARNESS CHAFING

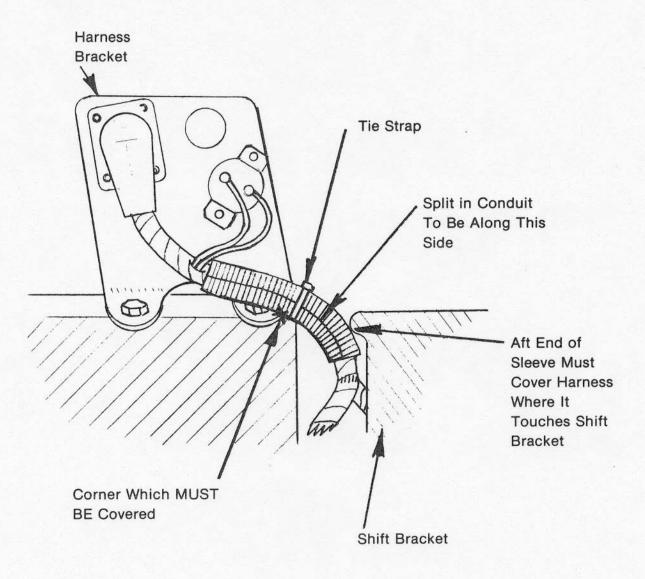
Figure 1. Installation of Insulating Conduit

Mercury Marine has determined that the engine wiring harness on MerCruiser Models 898, 228, 250 and 260 can chafe against the harness connector mounting bracket. If this occurs, the insulation may be worn off the harness and allow a wire to contact the bracket. This can result in a short with damage to the electrical system and cause a potential fire hazard.

To prevent this situation from occurring, the installation of an insulator protector sleeve and tie-strap is necessary. Immediately, contact each customer--with boats equipped with MerCruiser models within the specified engine serial group, below-and have them arrange to check the harness and install an insulator protector sleeve, as illustrated in Figure 1 (over).

Also rework all engines in boats in your inventory. Order one Insulator Protector Sleeve (Part No. B-85-79844-1) and Tie-Strap (Part No. C-61990) each per engine. This is required under the Federal Boat Safety Act.

NOTE: If Harness Is Tied to Leg of Harness Bracket, Remove That Tie.
