## POWER TRIM - TRIM ACTION

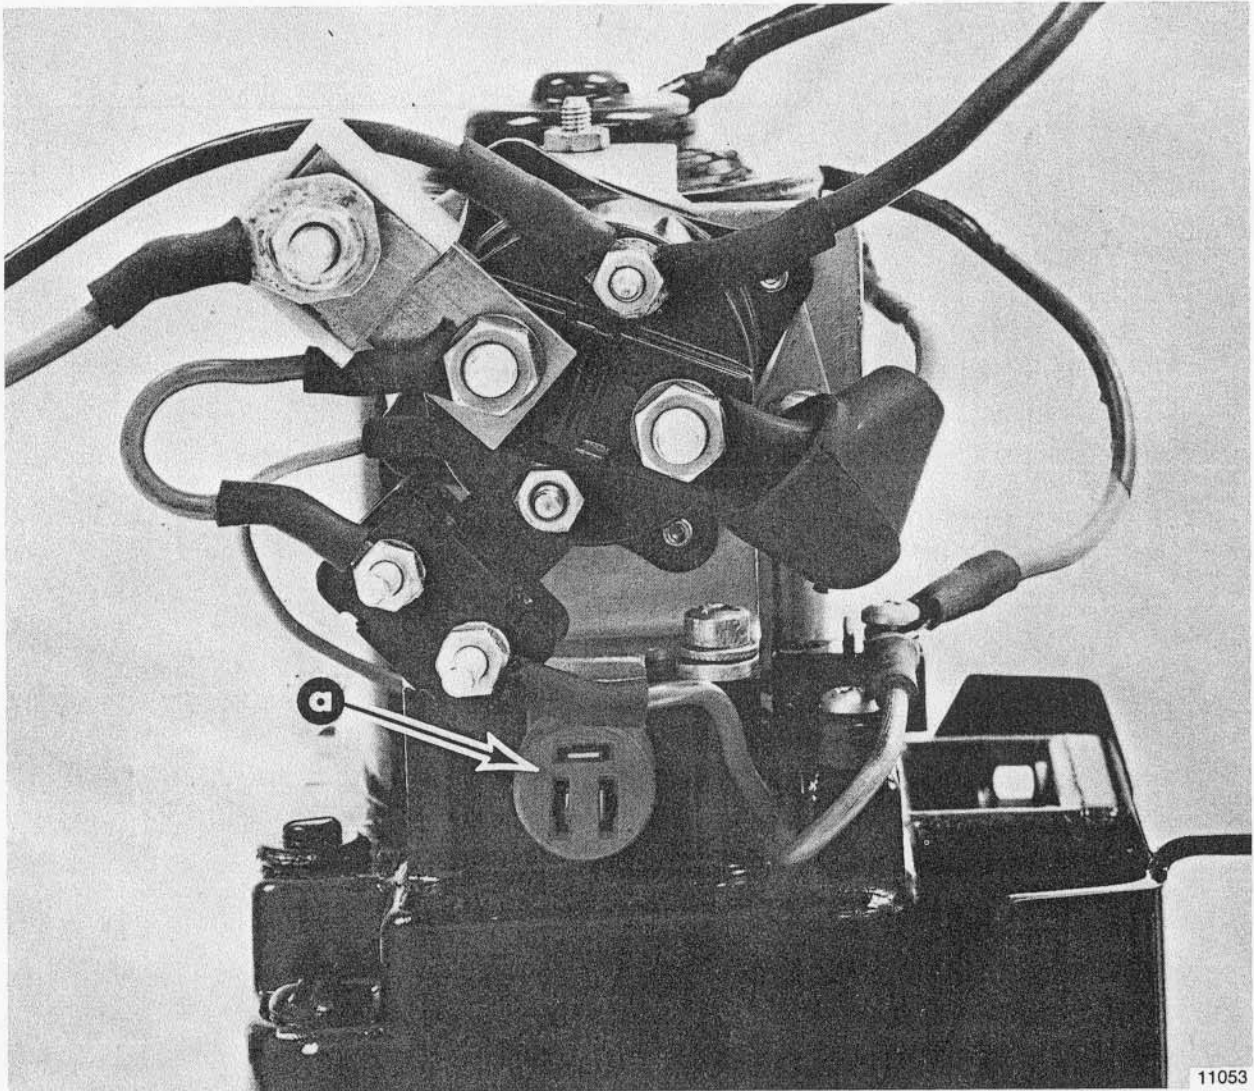
**Figure 1. Harness Connector Identification**

There is a possibility that some Power Trim pump assemblies with Harness Connector B-84-79147 (Figure 1) may have a shorted condition that could allow the Power Trim motor to actuate itself in the "up" direction.

a - Harness Connector

If this symptom exists, check the harness connector for a shorted condition between the harness' three wires. If shorted, replace the connector and submit a properly completed warranty claim (including transom assembly Serial Number) and the connector to your Branch or Distributor for credit.
