service bulletin

A. MerCruiser Shift Shaft Tool

NUMBER: 79-8 DATE: 3/23/79

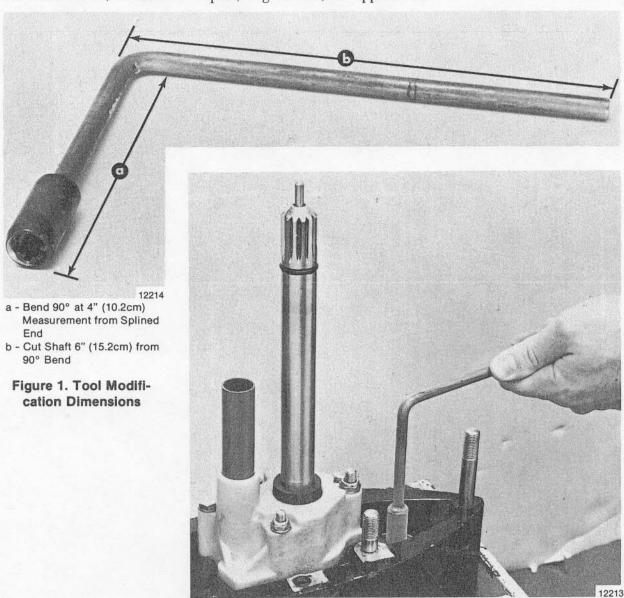
Shift Shaft C-75104A7 now is available to you and can be modified (as shown in Figure 1) to use when checking gear backlash in MerCruiser I gear housings. (Figure 2) Refer to MerCruiser Service Manual, Drive Unit Repair, Page 6A-11, for application.

Figure 2. Tool Installed on Gear Housing Shift Shaft
