No. 86-32

Transmission Foaming/ Venting/Over Heating Borg-Warner In-Line Transmissions With 1.91:1 Reduction Units

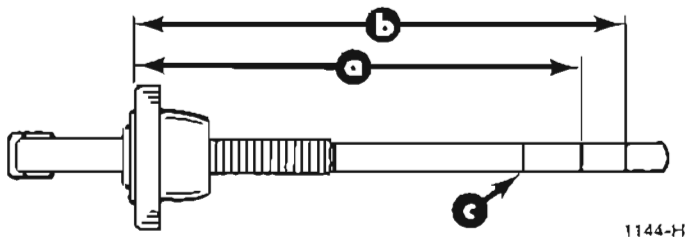
Figure 1. Remarking Transmission Dipstick Measure From Inside of Dipstick Cover

It has come to our attention that under certain operating conditions some boats equipped with MIE engines and 1.91:1 in-line reduction transmissions may experience foaming of the transmission fluid. If foaming of the fluid occurs the transmission may spew fluid out of the vent and/or overheat. If a customer experiences this condition the following steps should be taken to remedy the situation.

- a - 3-13/16" (97mm)
- b - 4-3/16" (106mm)
- c - Original Full Mark (Remove with File)

1. Remark the transmission dipstick.
 - A. Measure down from the inside of the dipstick cover the distance shown and mark two new points on the dipstick. (Figure 1) Using a suitable tool, a hacksaw blade works well, scribe a line across the dipstick at these two points.
 - B. Remove original full mark on dipstick using a file.

- D. Fluid level should be between the two marks on the dipstick. (Figure 1) If not, add or remove fluid as required to adjust fluid between marks. Repeat above procedure to double check fluid level.
