No. 86-20

- A. Over-Travel Shift Conditions on MR and Alpha One Drive Unit
- B. Drive Unit Shift Cable Brass Fitting
- C. Alpha One Over Shift at the Control Handle
- D. Hole Saw and Hole Saw Kit

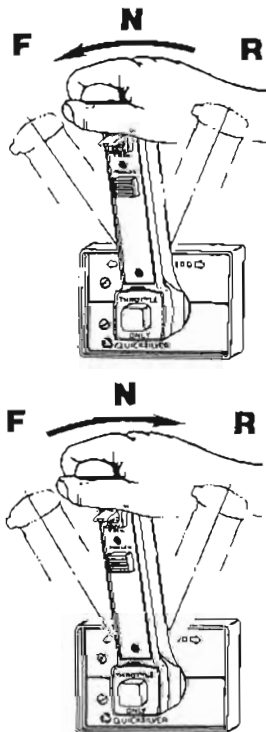
Figure 1.

If the control handle has to be moved past center to get the drive unit out of gear when shifting from forward to neutral or from reverse to neutral (Figure 1), the following should be checked.

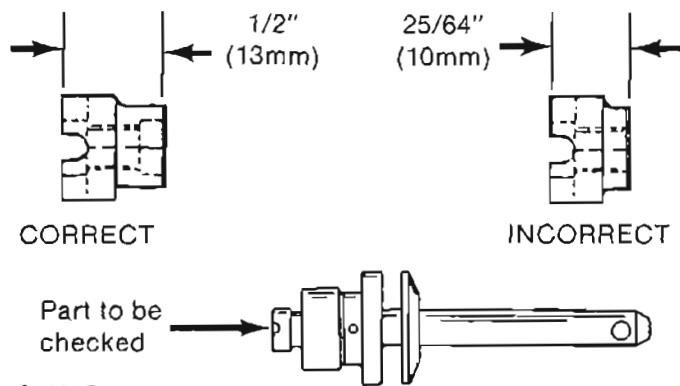
Figure 3. Sleeve

2. If the dimension of the shift cable does not meet to the specification given in Figure 2, check sleeve 23-66068 on shift spool assembly for proper size (Figure 3). If not to dimension shown replace sleeve.

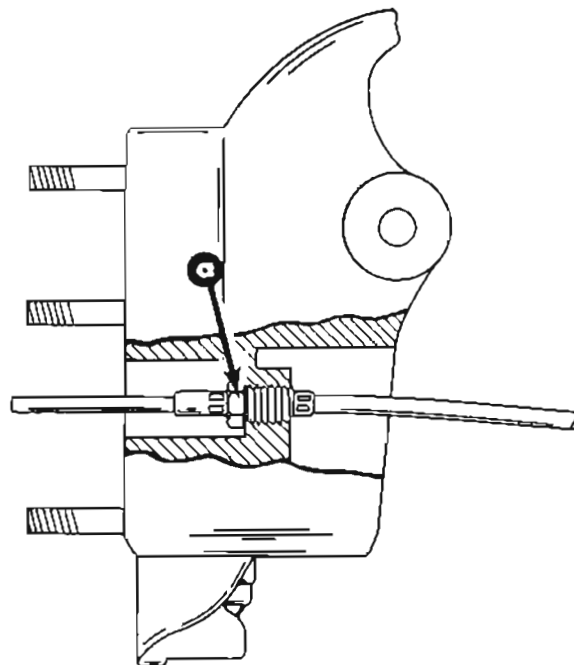
Figure 4. Checking Shift Cable Fitting

If shift cut out switch kills engine when shifting into reverse or if reverse cannot be obtained, check that shift cable brass fitting (a) is tightened properly into bell housing as shown in Figure 4.

a - No More Than 2 Threads of Fitting Should Be Exposed

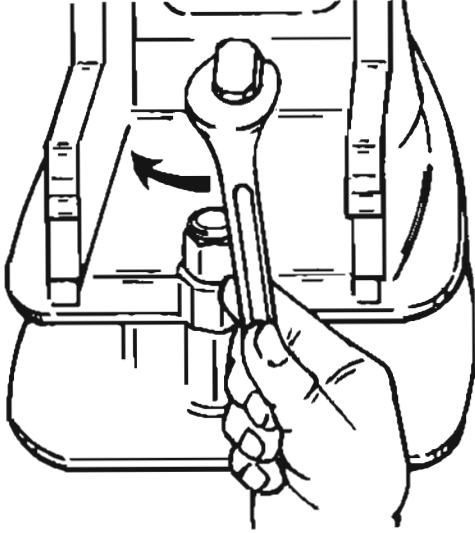
Figure 5.

Using a 1/2" open end wrench on the bronze intermediate shift shaft, (Figure 5) in the drive shaft housing, check the amount of movement from preload on bronze shaft if there is more than 10 degrees movement from straight forward, the castle nut on the spool assembly should be replaced because of wear.

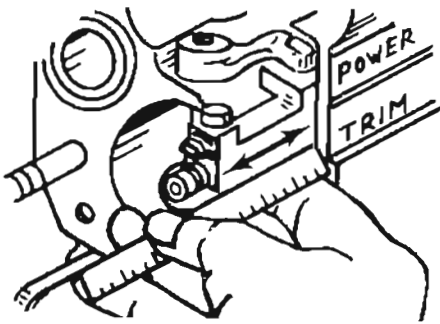
Figure 6.

Check shift slide end movement by measuring from the bell housing gasket surface to the end of the shift slide assembly (Figure 6). This measurement must not exceed 1/16" (2mm) of end movement, the allen set screw will have to be readjusted. The screw must back out no more than 1/4 turn and resafety wired.

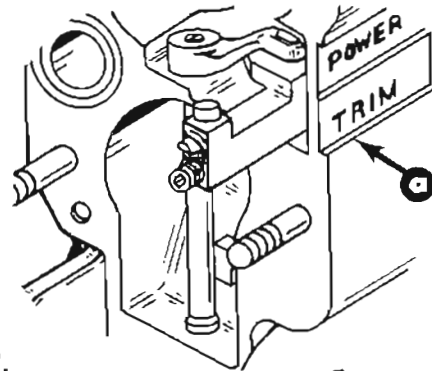
Figure 7.

If engine stalls when accelerating in reverse gear, check the shift slide (a) for contact at the brass nut (b) on the shift cable in the bell housing (Figures 7 and 8). The slide must have side-to-side clearance to move freely, otherwise the shift interrupt switch may be activated.
