## POWER STEERING OPERATION CHECK On V-8 and IN-LINE ENGINES

### CHECK for LUGGING CONDITION

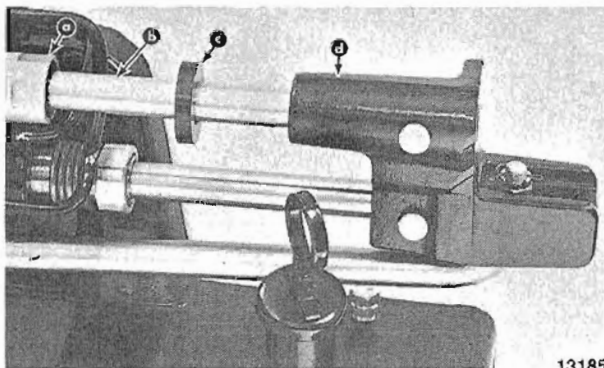
Figure 1. Spacer Installed

1. Start engine and allow it to idle.
2. Turn steering wheel to hard left and observe engine RPM. If pump lugs while in hard left turn, check —
  - a. That steering lever is not contacting cutout in transom. If contact is being made, modify cutout.
  - b. If ("a"), above, is not the cause, then install spacer (C-12-62402) over steering cable so that spacer is between cable guide tube and cable end adaptor. (Figure 1)
  - c. On In-Line Power Steering ONLY, check that Power Steering unit mounting bracket is butted against inner transom plate, as shown in Figure 4. If not, redrill mounting holes and move bracket.

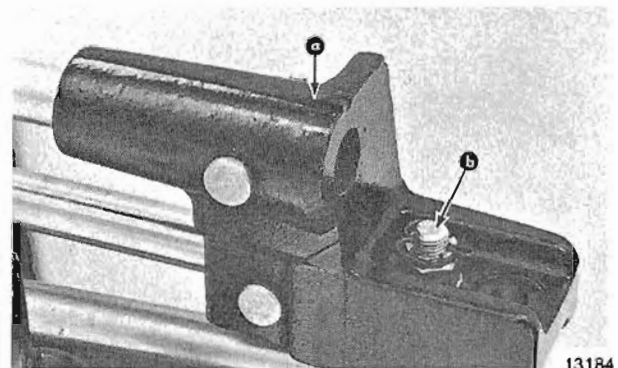
Figure 2. Proper Steering Link Rod Installation

3. Turn steering wheel to hard right and observe engine RPM. If pump lugs while in hard right turn, check —
  - a. That steering lever is not contacting cutout in transom. If contact is being made, modify cutout.
  - b. On V-8 Power Steering ONLY, check that steering link rod is installed in the inner-most hole of the cable end adaptor. (Figure 2)
  - c. If ("a" or "b"), preceding, is not the cause, remove steering cable from Power Steering unit and check steering cable end dimension with cable FULLY EXTENDED. (Figure 3) Dimension from steering cable mounting flange (that butts against guide tube) to center of hole in steering cable end MUST BE  $21\frac{1}{8}'' \pm \frac{1}{4}''$  ( $53.66\text{cm} \pm 6.35\text{mm}$ ). If dimension is incorrect, replace cable.
