- A. Models 120-thru-470 Transom Assemblies with External Return Line Trim Cylinder
- B. Power Trim Pump Vent Screw and Washer

A. MODELS 120-thru-470 TRANSOM ASSEMBLIES with EXTERNAL RETURN LINE TRIM CYLINDER

B. POWER TRIM PUMP VENT SCREW and WASHER

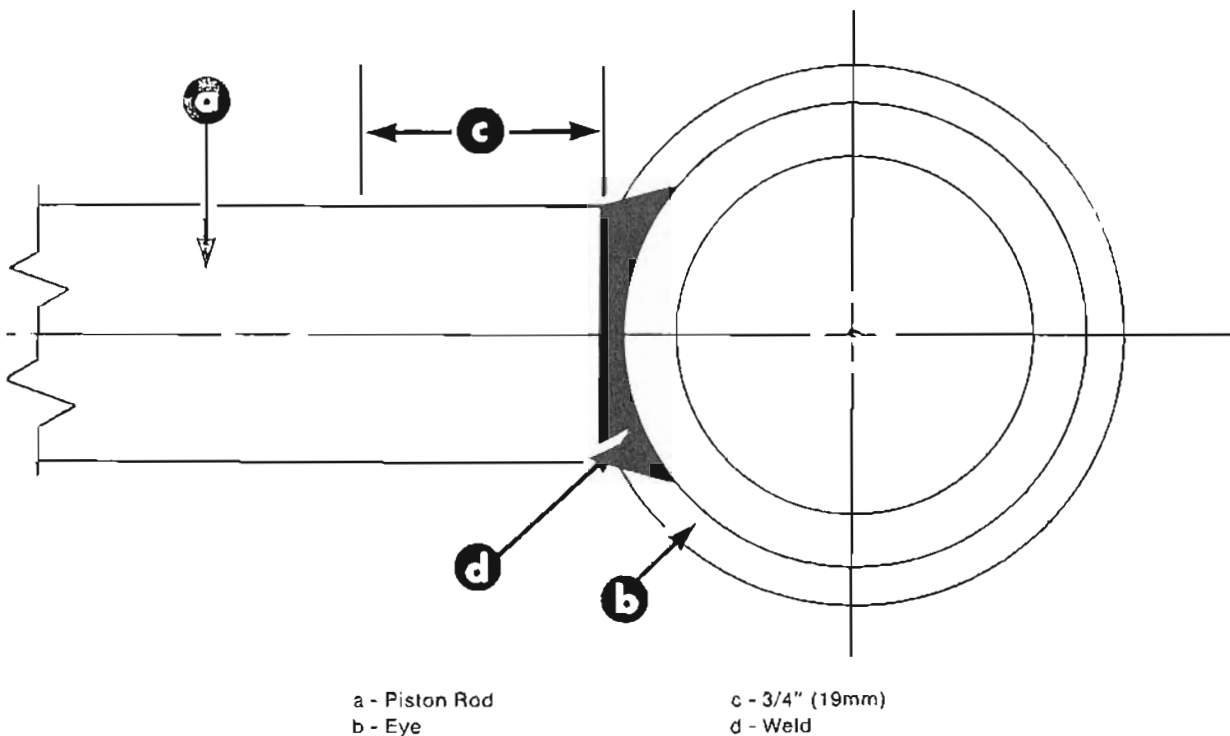
Figure 1. Location of "X" on Piston Rod

Models 120-thru-470 transom assemblies, Serial No. 05643699 thru 05644031, with external return line trim cylinders should have the trim cylinders replaced because of potential internal leakage.

Future transom production with external return line trim cylinders will have an "XO" or "O" stamped on piston rod approximately $\frac{3}{4}$ " (19mm) from the point that the eye is welded to rod. (Figure 1) Cylinders, which are marked with an "XO" or "O", NEED NOT BE replaced.

Since supplies of replacement external return line trim cylinders are limited, please replace all of these cylinders with Part No. B-45706A14 and Hydraulic Hose B-32-86036. Return removed cylinders (with warranty claim) to local Branch or Distributor for credit of replacement cylinders and hoses. Transom serial number must be included on warranty claim. Labor rate is 0.5 hours per transom assembly.

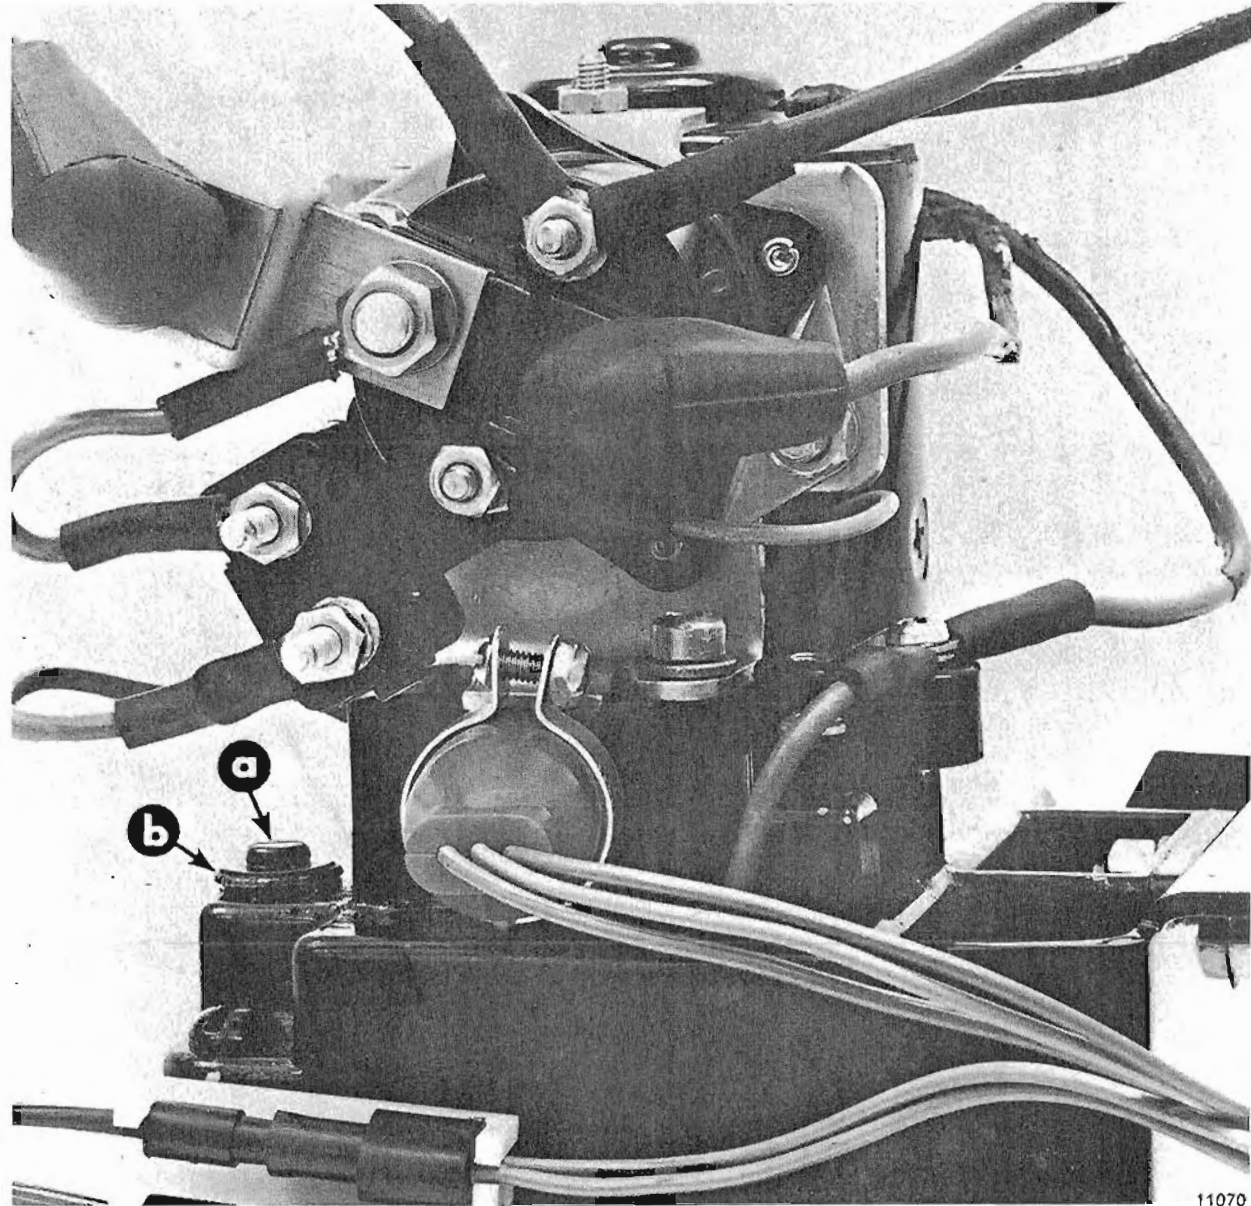
Figure 2. Vent Screw and Washer Location

After installation of Power Trim pump, the vent screw (Figure 2) must be loosened 2 full turns for proper pump operation. However, for a short time a rubber washer was used on the vent screw. This washer will not allow the pump to vent sufficiently. The rubber washer, therefore, **MUST BE REMOVED** on all these trim pumps and the vent screw reinstalled and loosened 2 full turns.

a - "Vent" Screw

b - Washer (Remove)
