service bulletin

STERN DRIVES/INBOARD ENGINES

NUMBER: 80-11 DATE: 8/26/80

D. MCM 470/485 FLAME ARRESTOR DAMAGE

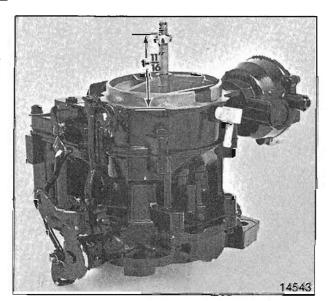
FIGURE 1

A few reports have been received of MCM 470/485 flame arrestor top covers breaking at the "stamped identation" around the retaining stud. This type of damage can be caused by incorrect positioning of the flame arrestor support nut (lower nut) on the center stud. The top of the support nut must be 1-11/16" from the flame arrestor mounting surface on the carburetor (refer to Figure 1). Check this dimension on any carburetor with which flame arrestor breakage has occurred.
