**STERN DRIVES/INBOARD ENGINES**

# service bulletin

NUMBER: 81-21

**Subject:** PUSH ROD/ROCKER ARM FAILURES ON  
MCM 370 TRS ENGINE -  
SERIAL NUMBER 5669330 to 5669660

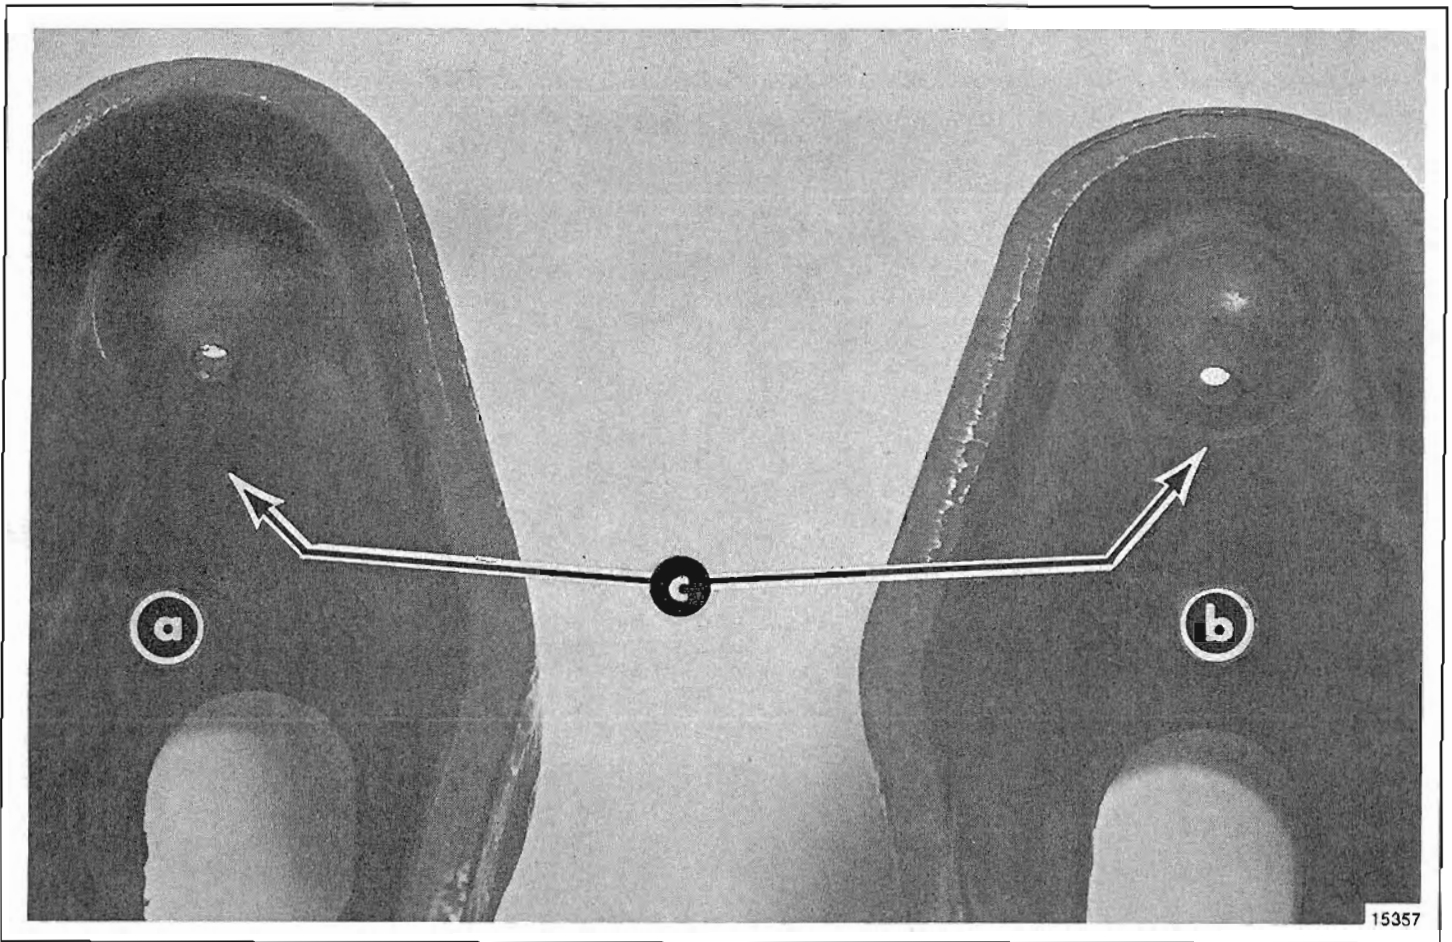
Figure 1. Top View of Rocker Arm

Notice difference in push rod seats ("c" in Figures 1 and 2). The normal seat ("a") DOES NOT have a "creased" area on forward portion of seat while the abnormal seat ("b") does. Also notice how the metal is "stretched" upward around the push rod seat in rocker arm "b".

a - Normal Formed Push Rod Seat

b - Abnormal Formed Push Rod Seat

c - Difference in Push Rod Seats

When repairing a push rod/rocker arm failure, INSPECT ALL ROCKER ARMS for this condition. Factory stock has been inspected, but it is a good idea to inspect the new replacement rocker arms as well as remaining rocker arms on engine(s). Rocker arms can be inspected easily without removing them from the engine. USE ONLY rocker arms that look like "a" in Figures 1 and 2.

If only the rocker arm and push rod have been damaged, REPLACE THE BALL UNIT ALSO. Use Engine Oil Supplement (C-92-78372-12) between the ball unit, rocker arm and push rod. If the camshaft has to be replaced because of damage, replace all hydraulic valve lifters. Pour Engine Oil Supplement over camshaft lobes before installing hydraulic valve lifters to help seat new lifters to camshaft lobes.

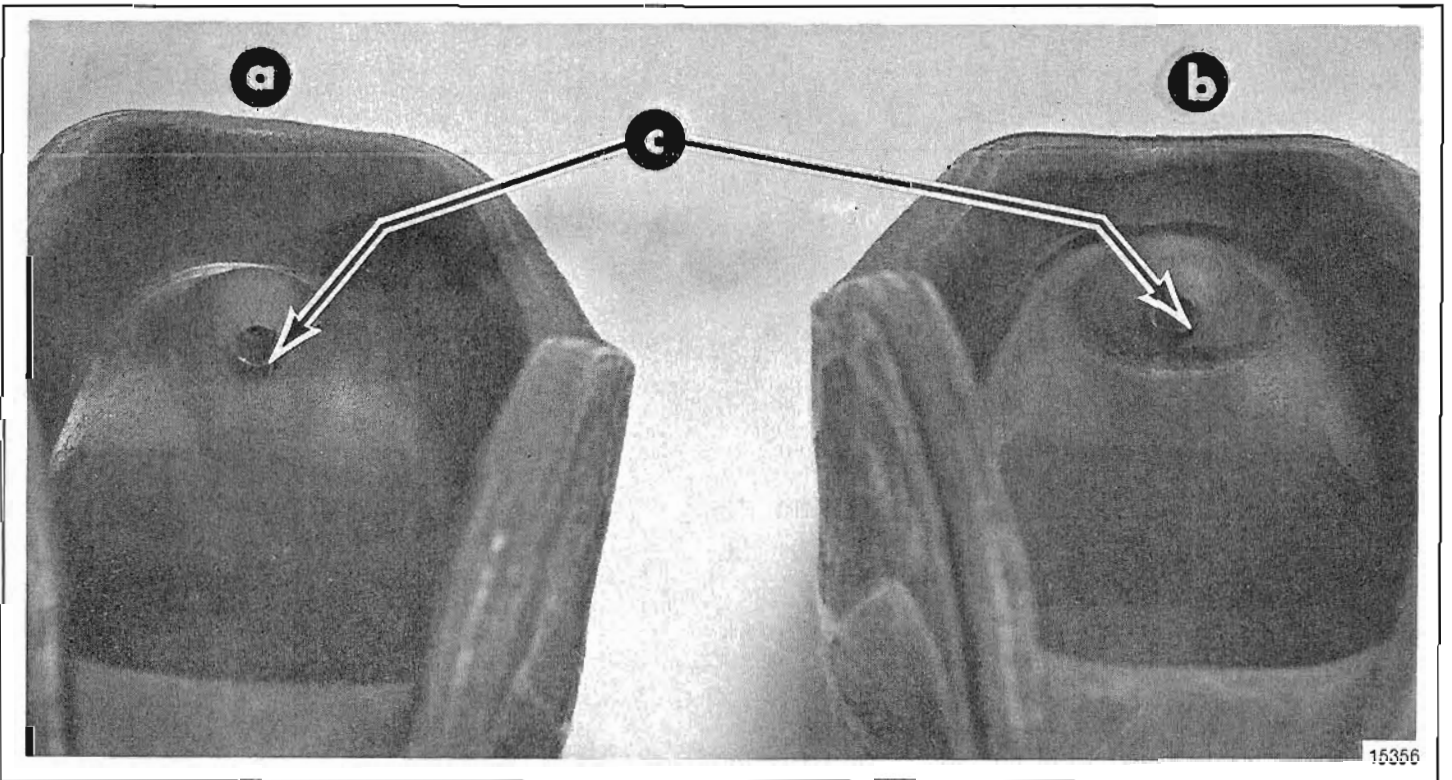
Figure 2. Front, Top View of Rocker Arm

a - Normal Formed Push Rod Seat

b - Abnormal Formed Push Rod Seat

c - Difference in Push Rod Seats
