- A. Checking Stern Drive Unit Seawater Pickup Pump Output - MerCruiser I Stern Drives
- B. Insufficient Water Flow From MC-I Drive Unit Seawater Pickup Pump Troubleshooting Chart
- C. MC-I Drive Shaft Housing Water Passage Improperly Drilled

A. CHECKING STERN DRIVE UNIT SEAWATER PICKUP PUMP OUTPUT - MERCUISER I STERN DRIVES

C. MC-I DRIVE SHAFT HOUSING WATER PASSAGE IMPROPERLY DRILLED

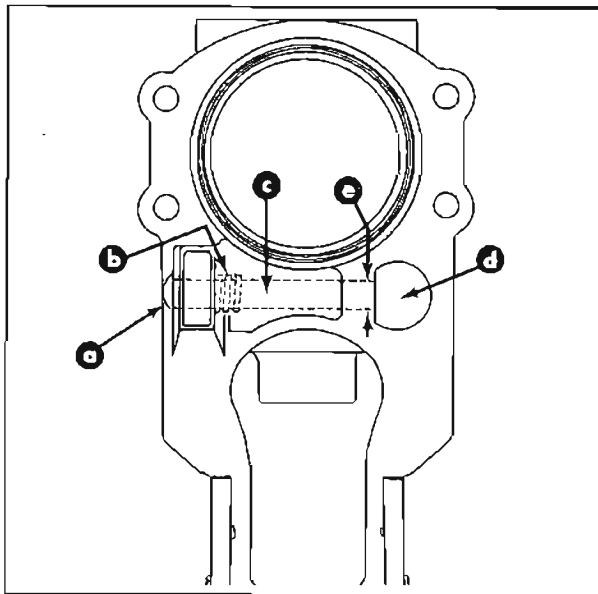
Figure 2. Drive Shaft Housing Cross-Drilled Water Passage

If troubleshooting an otherwise unexplainable overheating condition, problem may be due to an improperly cross-drilled water passage in drive shaft housing. (Figure 2) A few cases have been reported where the drill was not run far enough into the water passage during the machining operation at the factory. Only the tip of the drill penetrated thru the casting at the end of the water passage, leaving a ¼" to ⅜" (6.4mm to 9.5mm) diameter hole [instead of a .580" (14.7mm) diameter hole] at end of passage. This restricted water flow sufficiently to cause engine to overheat.

To check cross-drilled water passage, remove stern drive unit and inspect passage thru water cavity on port (left) side of drive shaft housing (Figure 2), using a flashlight. Water passage should be approximately ½" (12.7mm) in diameter. If not, proceed as follows:

1. Remove decal from starboard (right) side of drive shaft housing and remove welch plug (under decal). (Figure 3)
2. Apply heat to water passage pipe plug (Figure 3) and remove plug with a large blade screwdriver.
3. Drill out material at end of water passage, using a 9/16" (14mm) diameter drill bit.
4. Clean threads in drive shaft housing with a ⅜" x 18 NPTF tap. Clean old sealer from pipe plug with a wire brush.
5. Apply Perfect Seal (92-34227) to threads of pipe plug and thread into drive shaft housing. PIPE PLUG MUST BE INSTALLED FLUSH OR SLIGHTLY INDENTED INTO INNER SURFACE OF DRIVE SHAFT HOUSING TO PREVENT INTERFERENCE WITH SHIFTING SLIDE ASSEMBLY.
6. Apply Loctite "A" (92-32609) to outer diameter of NEW welch plug (19-32562). Place plug in drive shaft housing and flatten, using a hammer and suitable driver.
7. Install a new decal.
8. Reinstall stern drive unit.
