- A. Manual Release Valve "O" Rings being Damaged on "Oildyne" Power Trim Pumps
- B. New Air-Bleeding Procedure for Power Trim Systems with "Oildyne" Pump
- C. 20 Amp Fuse on "Oildyne" Power Trim Pumps
- D. Individual Relief Valves for "Oildyne" Power Trim Pumps
- E. Malfunctioning Down Pressure Relief Valve on "Oildyne" Power Trim Pumps
- F. Troubleshooting "Oildyne" Power Trim Pumps

NUMBER: 83-34

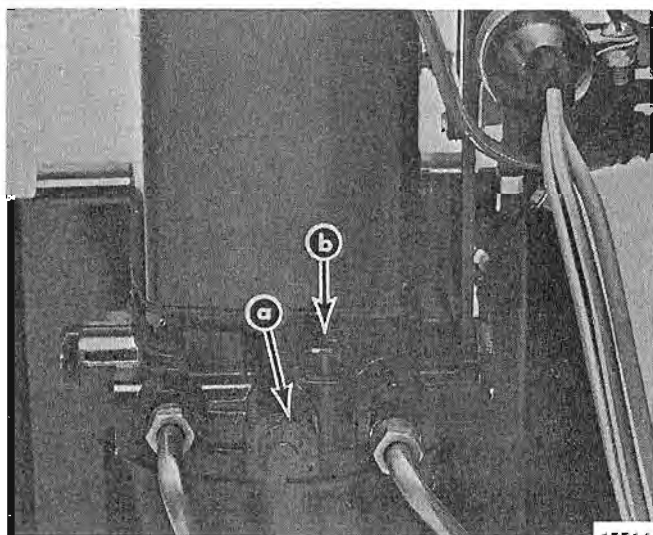
Figure 1. Oildyne Power Trim Pump

If you encounter a MerCruiser Stern Drive with an "Oildyne" Power Trim pump that has one of the problems listed below, the trouble may be due to damaged "O" rings on the "Manual Release Valve". (Figures 1 and 2)

- Drive unit leaks down from raised position.
- Drive unit cannot be trimmed "Out" or raised.
- Drive unit cannot be trimmed "In" or lowered.

a - Manual Release Valve  
b - Fill/Vent Screw

- Operation of the Power Trim pump with the "Manual Release Valve" partially open. **Valve Must Be Completely Closed (Turned Clockwise Until Bottomed-Out) When Trimming "IN" or "OUT"**. Tighten valve finger-tight only -- DO NOT USE A PLIERS.

- Opening "Manual Release Valve" quickly with stern drive unit in the fully raised position. **Valve Must Be Opened SLOWLY to Gradually Relieve Pressure On System.**
- Continuous use of "Manual Release Valve". **Valve Is Designed for Emergency (Limited) Use Only.**

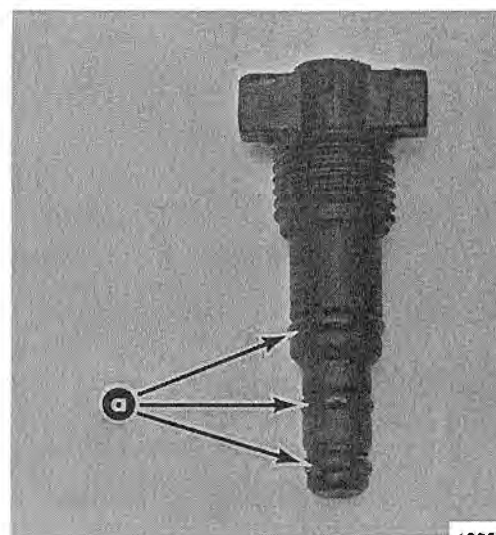
Figure 2. Manual Release Valve

Damage to the "O" rings may result from the following:

a - "O" Rings (3)

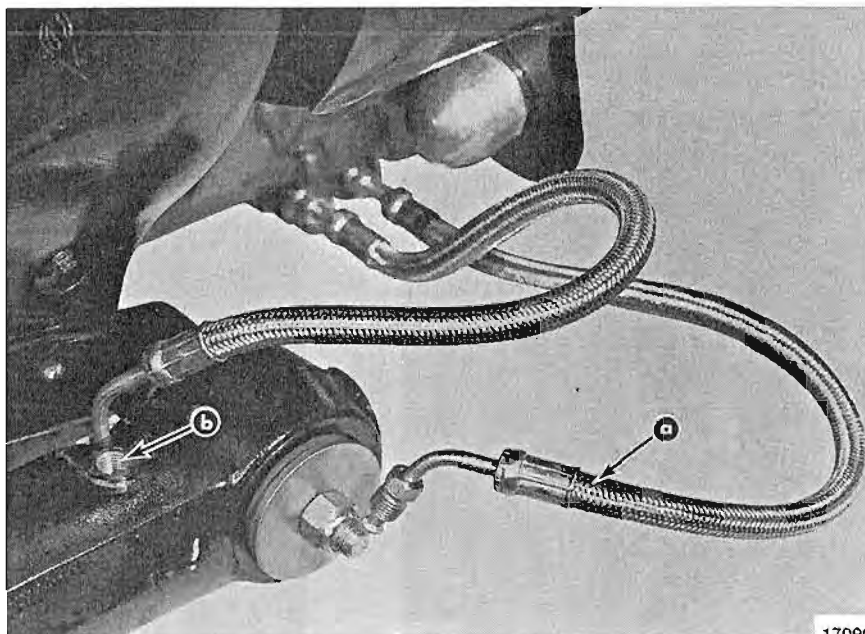
**Figure 3. Bleeding "Up" Trim Circuit**

a - "Up" Trim Hose  
b - Front Connection On Trim Cylinder

2. Make sure that "Manual Release Valve" (Figure 1) is completely closed (bottomed-out).
3. Disconnect "Up" hose from front connection on rebuilt trim cylinder. (Figure 3) If both cylinders were rebuilt, disconnect hose from both cylinders.
4. Direct end of trim hose(s) into a container; then, run trim pump in the "Out" ("Up") direction until a solid, air-free stream of oil is expelled from hose(s). Reconnect hose(s) and tighten securely.
5. Refill trim pump to proper level.
6. Disconnect "Down" trim hose (on side with rebuilt trim cylinder) from rear connection on gimbal housing hydraulic connector. (Figure 4) If both cylinders were rebuilt, disconnect hose from aft connection on both sides of connector.
7. Plug connector(s) in hydraulic connector, using plug (22-38609) or a suitable device. (Figure 4)

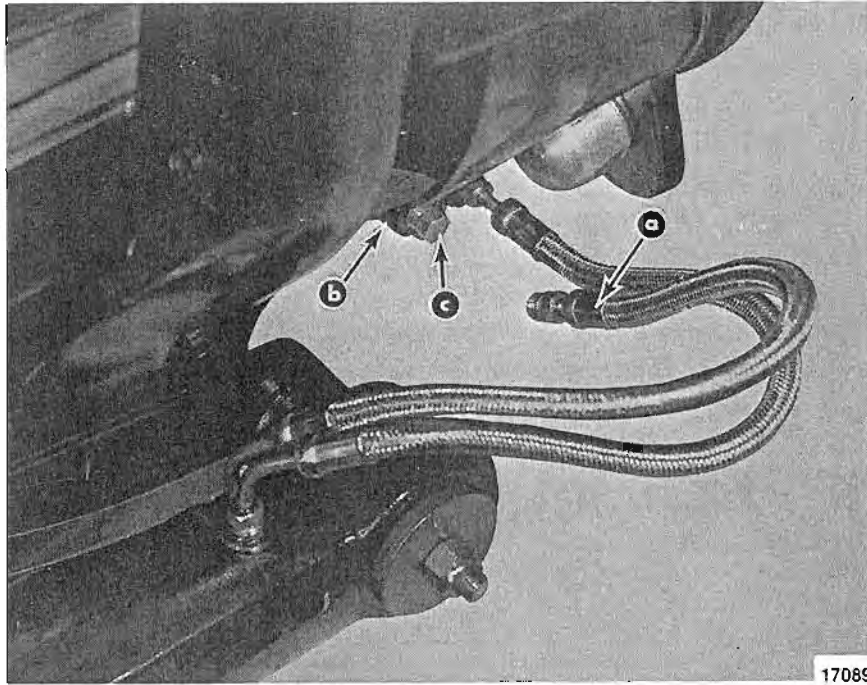
**Figure 4. Bleeding "Down" Trim Circuit**

- a - "Down" Trim Hose
- b - Hydraulic Connector
- c - Plug (22-38609)

8. Direct end of trim hose(s) into a container. Run trim pump in the "Out" ("Up") direction until trim cylinders are fully extended.
9. Remove plug(s) from gimbal housing hydraulic connector and momentarily run trim pump in the "In" ("Down") direction until a solid stream of oil is expelled from connector. Reconnect trim hose(s) and tighten securely.
10. Lower drive unit to the fully "In" ("Down") position and refill trim pump to proper level. Run trim system "In" and "Out" several times and recheck oil level.

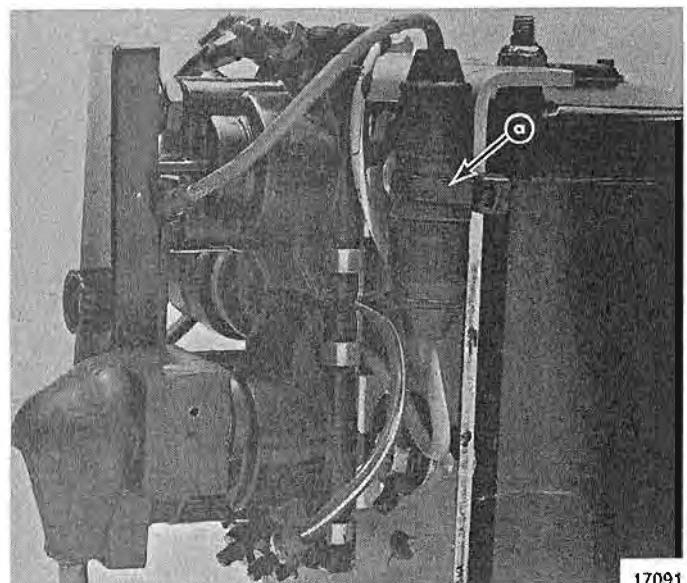
**Figure 5. 20 Amp Fuse On "Oildyne" Pump**

Newer production "Oildyne" trim pumps are equipped with a 20 amp fuse instead of a circuit breaker (Figure 5). The part number for the replacement fuse is 88-79091. This fuse protects the trim control and wiring harness.

- a - Fuse

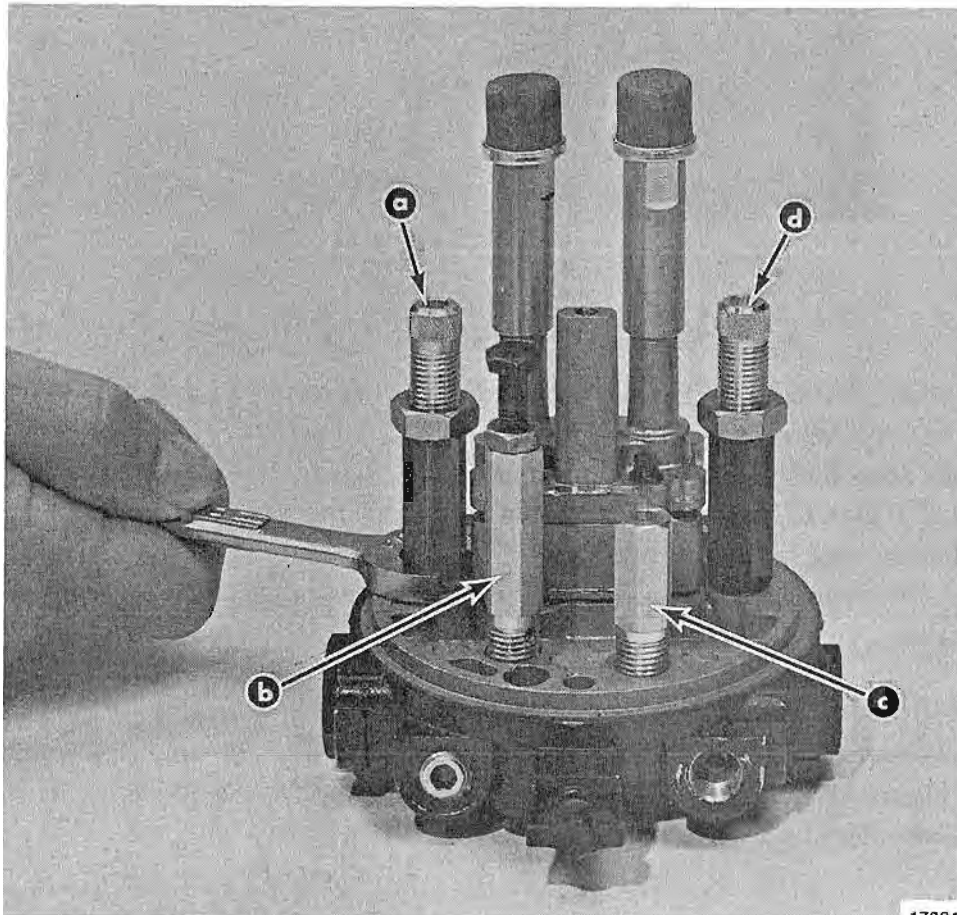
**Figure 6. "Oildyne" Power Trim Pump Relief Valve**

*NOTE: Early production "Oildyne" pumps were equipped with a trail-out valve. This valve was eliminated on later pumps. If this valve should fail on one of the early production pumps, the valve can be removed and replaced with plug (19-11005).*

- a - Down Pressure Relief Valve
- b - Trail-Out Valve (Used on Early Production Pumps Only)
- c - Thermal Relief Valve
- d - Up Pressure Relief Valve

If you encounter a MerCruiser Stern Drive (with an "Oildyne" trim pump) where the pump motor runs, but the drive unit will not lower from the raised position, the problem may be due to a malfunctioning down pressure relief valve. (Figure 6) To correct this problem, install a new down pressure relief valve (95355A1). This valve is of a new design for improved reliability.

Individual relief valves for the "Oildyne" Power Trim pump are now available under the part numbers listed below. (Figure 6) Installation instructions are included with each valve.

- 95355A1 - Down Pressure Relief Valve
- 95351A1 - Up Pressure Relief Valve
- 95353A1 - Thermal Relief Valve
- 19-11005 - Replacement Plug - Trail-Out Valve
