NUMBER: 83-17

- A. Oil Leaks on MCM 120R/140R Engines
- B. Transmission Fluid Venting Out of Tube - Borg-Warner Transmissions

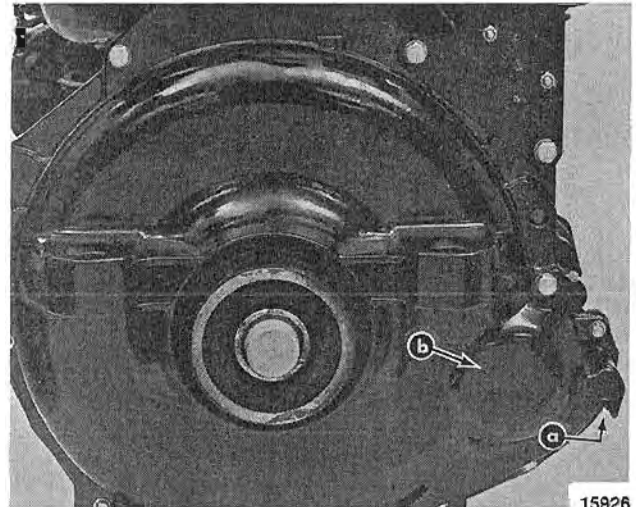
Figure 1. Flywheel Housing

We have received complaints about oil in the sealed flywheel housing on new MCM 120R/140R engines. When the engine is started, during the predelivery check, oil sprays out of the "water pump out vent". This vent is located on the starter motor side of the flywheel housing.

a - Water Pump Out Vent
b - Starter Motor

This could be "normal" with the new, sealed flywheel housing under certain conditions. If the boat is shipped at an angle (bow high) from the O.E.M., oil may leak from the rear main crankshaft seal (Part No. 26-58203). This seal is not a static oil seal. The crankshaft has to be turning before the seal is "oil tight". This leaking oil, on 1982 and older engines, ran into the flywheel housing and then into the bilge of the boat. In the past, oil in the bilge was thought to have come from the power trim system during its installation, when in fact, it came from the rear main crankshaft seal. It is suggested that the engine be run until the oil stops spraying out of the vent hole. At that time, the oil can be wiped up. Do not confuse this type of oil leak with the following leaks.

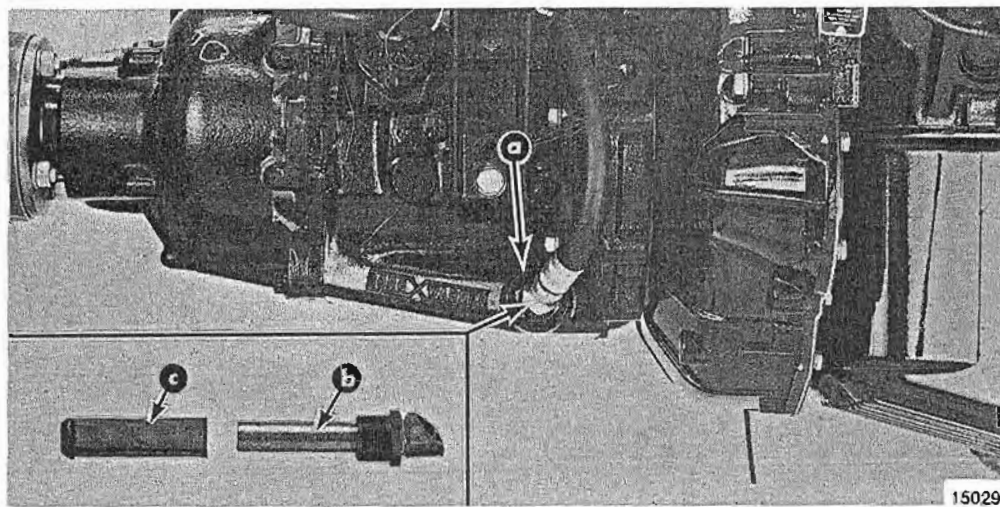
Figure 2. Removing Charge Tube

Under certain operating conditions such as, but not limited to; constant high RPM operation or high engine angle (while underway), can cause the transmission to vent fluid out of the vent tube. To help correct this condition, determine the model and gear ratio of the transmission that is having the venting problem. Refer to chart below and perform modifications as shown below.

a - Remove Cooler Return Hose Bushing from Transmission c - Reinstall Strainer and Bushing and Refill Transmission
 b - Unscrew Charge Tube from Bushing and Discard Tube
