- A. New MerCathode System for MerCruiser 120-thru-260 R & MR Models
- B. Improved Corrosion Resistance On New Trim Cylinders
- C. Stern Drive Continuity Test
- D. Stainless Steel Propellers Corroding
- E. Anti-Fouling Paint Usage On MerCruiser Stern Drives
- F. Inactive Sacrificial Zinc Anodes
- G. MerCathode Monitor Operation and Testing
- H. Corrosion Protection Testing and Troubleshooting
- I. MerCathode System and Monitor Wiring Diagrams

A. NEW MERCATHODE SYSTEM FOR MERCUISER 120-thru-260 R & MR MODELS

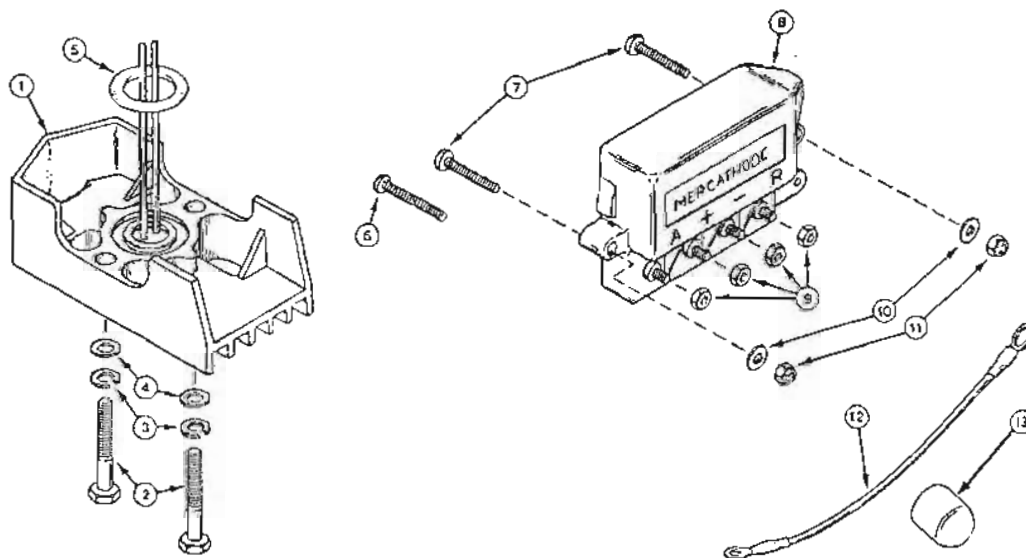
Figure 1. MerCruiser 120-thru-260 R & MR MerCathode System

The new system features an electrode assembly with an integrated reference electrode and anode. The electrode assembly attaches directly to the bottom of the gimbal housing, thus eliminating the need to drill holes thru the transom as was required with the old system. A new controller attaches directly to the engine, providing a quick, convenient installation.

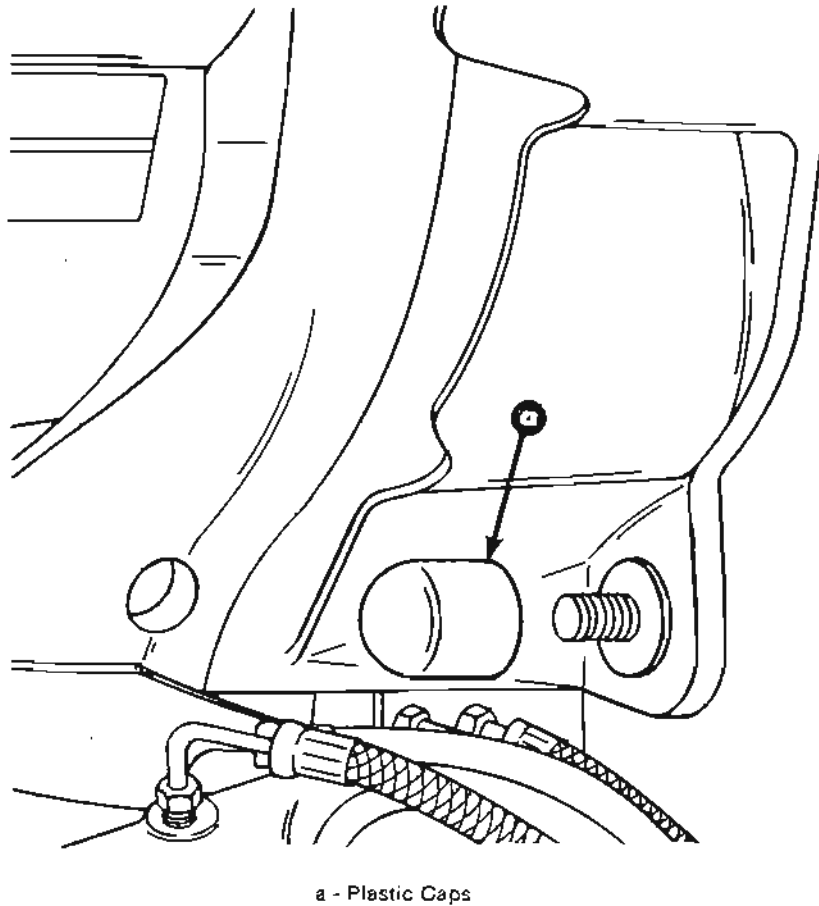
Figure 2. Gimbal Housing Plastic Caps

- **DO NOT** paint electrode assembly as this will render the system inoperative.
- Do not replace plastic caps (Figure 2) with zinc anode heads, as this will affect the operation of the MerCathode System.

8. *MerCathode reference electrode or anode painted.	8. Remove paint.
9. *Zinc anode heads used instead of plastic caps (MerCruiser 120-thru-260 R & MR MerCathode System Only)	9. Reinstall plastic caps. (Refer to Subject A, preceding.)

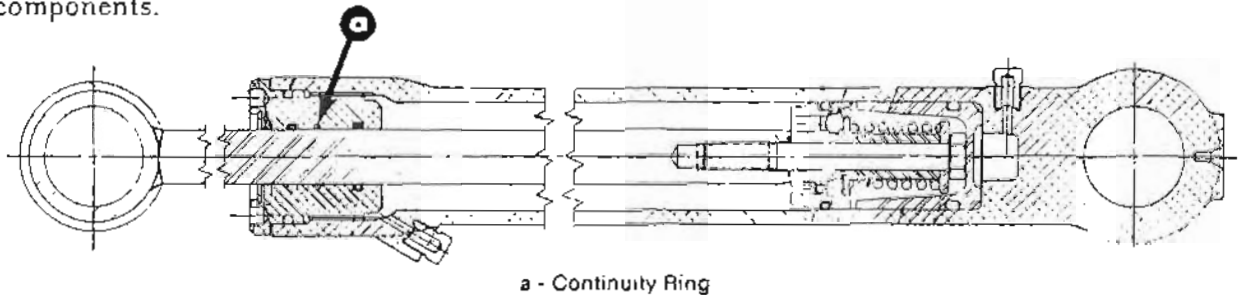
Figure 3. 1½" I.D., External Return Line Trim Cylinder

The MerCruiser 120-thru-260 R & MR models and later TR and TRS models are equipped with 1½" (38mm) ID external return line trim cylinders. These cylinders are equipped with an internal continuity ring (Figure 3) to maintain continuity between the piston rod and outer tube. To further improve the corrosion resistance of these cylinders, a new procedure is being used when manufacturing the end cap and outer tube to ensure good continuity between these components.

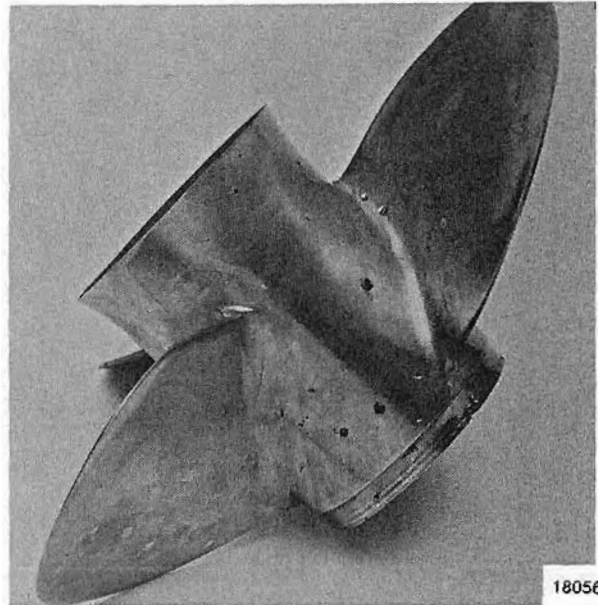
Figure 7. Propeller Corrosion from Loss of Continuity

Good continuity must be maintained between a stainless steel propeller and propeller shaft or corrosion damage to propeller will result. The corrosion damage will appear in the form of deep pits or holes in the metal. (Figure 7) Loss of continuity to the propeller also will contribute to surface rust forming on the metal.

To help ensure good continuity, propeller should be removed periodically and all mating surfaces on propeller, propeller attaching parts and propeller shaft should be cleaned. A liberal coat of Quicksilver Special Lubricant 101, 2-4-C Multi-Lube or Perfect Seal should be applied to propeller shaft before reinstalling propeller. Be sure to retorque propeller nut to 55 lbs. ft. (75 N.m).

Stainless Steel Propeller Corroding	Loss of continuity between propeller and prop shaft	Clean mating surfaces on propeller, propeller shaft and attaching parts. If applicable, install continuity washer (refer to Subject D, preceding). Torque propeller nut to 55 lbs. ft. (75 N.m).
Paint blistering - metal under blistered paint is not pitted.	Surface was not properly prepared before paint was applied.	Sand surface down to bare metal, prime and repaint with Quicksilver Phantom Black Spray Paint.

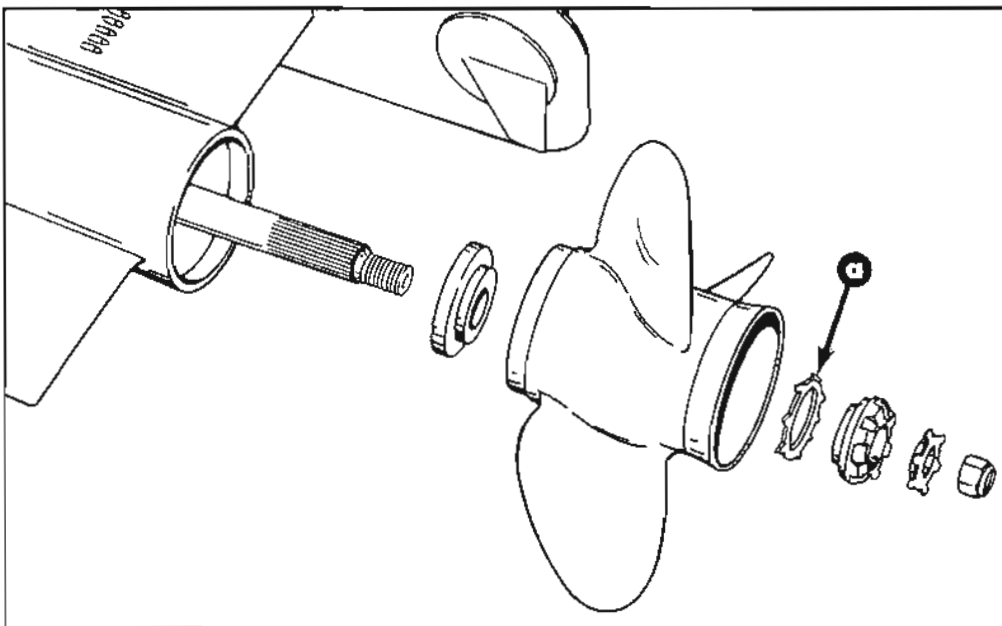
Figure 8. Continuity Washer Installation

a - Continuity Washer 13-42351

On MC-I, Black Max and TRS Cleaver Propellers (with square rubber drive hub), a continuity washer (13-42351) can be installed between the spline washer and the propeller to help ensure continuity. (Figure 8) In the future, this washer will be included as standard equipment with these propellers. MerCruiser 120MR-thru-260MR models also will be equipped with this washer.

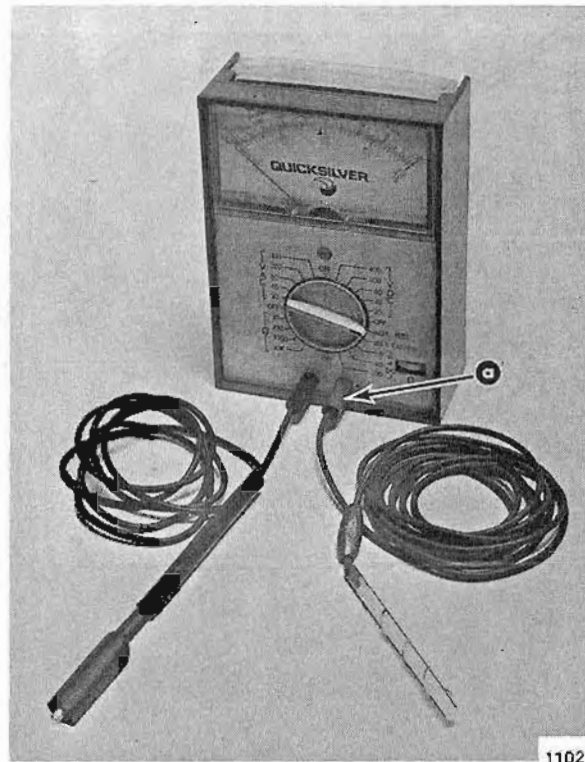
Figure 10. Quicksilver VOA Meter 91-62562A1 and
MerCathode Reference Electrode Tester 76675A1

The MerCathode Reference Electrode Tester 76675A1 is equipped with a special jack (containing a resistor) to provide the proper scale reading when used with Quicksilver VOA Meter 91-62562A1. Previously, we stated that this plug could be removed to allow tester to be used with

other analog type meters. Further testing has revealed that this could result in inaccurate readings and; therefore, we no longer recommend the removal of this plug and the use of other analog meters. Resistor jack can be left in place when using digital meters.
