## service bulletin

**NUMBER: 84-10**

A. Mando Alternator Regulator

C. MCM 165 Engine Oil Pan Attachment Changes

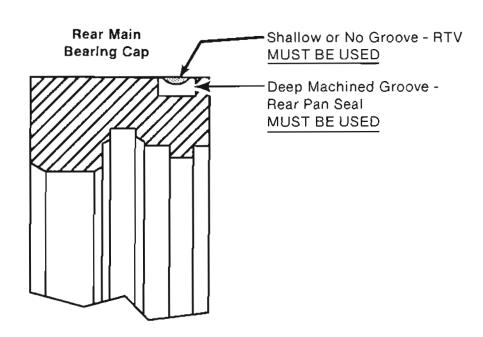
In 1979, G.M. started using RTV sealer in place of the rear oil pan seal on the MCM 165 engine. At that time, the rear main bearing cap oil seal groove was eliminated and only a shallow cut was made to control the thickness of the RTV.

In 1980, G.M. started using RTV instead of the front oil pan seal and oil pan side rail gaskets. At this time, the number of oil pan attaching bolts was reduced from 12 per side (24 total) to 8 per side (16 total). This was accomplished by eliminating 4 bolt locations on each side. The location of the remaining holes will match with the original oil pan attaching holes.

24 Holes - Gasket or RTV Sealer <u>CAN BE USED</u> on Front and Side Rails

16 Holes - RTV MUST BE USED on Front and Side Raifs

The 1980 style oil pan and/or cylinder block are used to service past models. Any and all combinations are acceptable by using the following guidelines.
