- A. C-Ring Kit to Eliminate Universal Joint Knocking
- B. Universal Joint Knocking in Extreme Turns While Trimmed Out
- C. Universal Joint Knocking/Vibration Troubleshooting

A. C-RING KIT TO ELIMINATE UNIVERSAL JOINT KNOCKING

C. UNIVERSAL JOINT KNOCKING/VIBRATION TROUBLESHOOTING

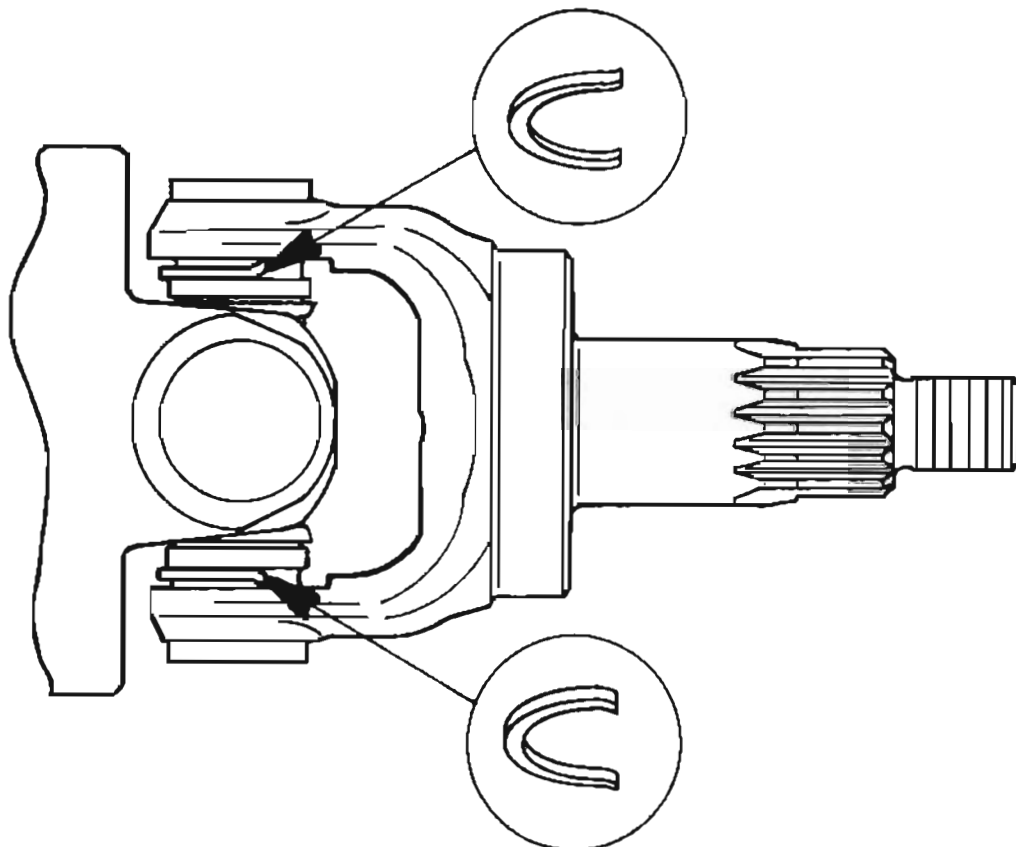
Figure 1. C-Ring Installation

If you encounter a MerCruiser I, TR or TRS stern drive with a universal joint knocking or vibrating problem when turning or trimming, the problem may be caused by excessive side-to-side play in the universal joint cross and bearing assemblies. This condition can be corrected by replacing the standard cross and bearing assembly C-rings with C-ring Kit 53-12067A1. Kit contains 8 C-rings which is enough for 1 drive unit. C-rings are curved at the ends and must be installed with the curve toward the yoke or center socket. (Figure 1) Be sure C-rings are seated in grooves.

IMPORTANT: New C-rings can be used with original cross and bearing assemblies only. C-rings cannot be used with service replacement Spicer cross and bearing assembly 41431 as grooves in bearing caps are too narrow.

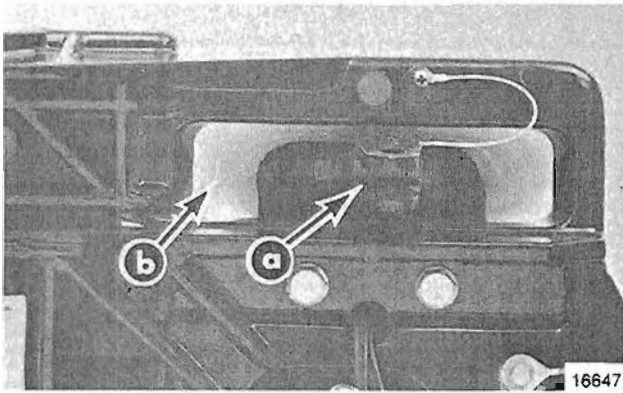
Figure 2. Steering Lever Cutout (Typical)

POSSIBLE CAUSE	REMEDY
1. Steering lever contacting transom cutout opening in turns. (Figure 2)	1. Modify transom cutout.
2. Engine flywheel housing contacting inner transom plate or exhaust pipe. (Figure 3)	2. Determine cause for interference (loose engine mounts, transom too thin, etc.) and correct as necessary.

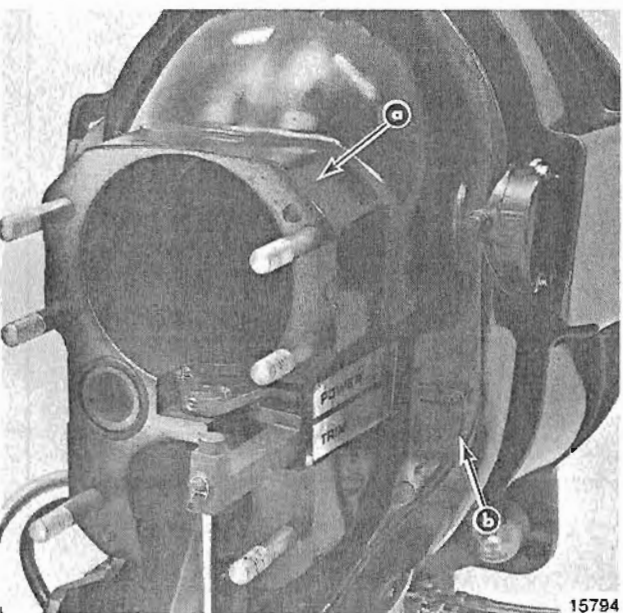
Figure 4. Stern Drive Bell Housing

3. Bell housing contacting gimbal ring. (Figure 4) This would cause knocking in the fully trimmed in position only.	3. Check for soft trim cylinder bushings. (Figure 5)

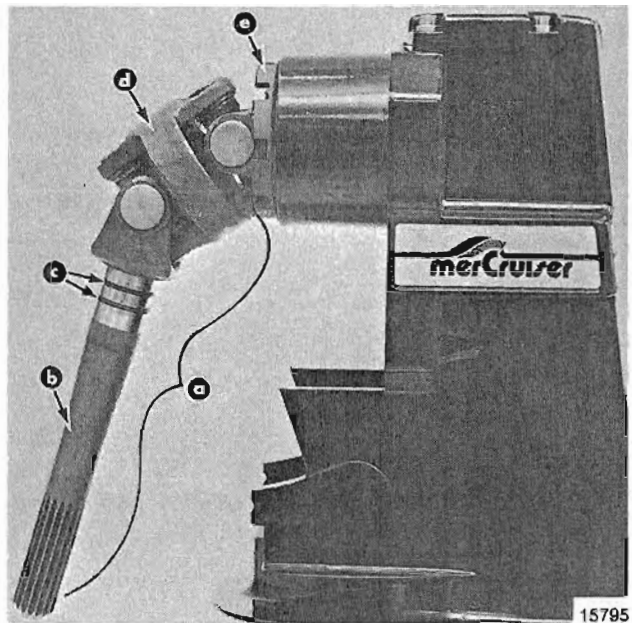
Figure 6. Universal Joint Assembly

7. Excessive side-to-side play in U-joint cross and bearing assemblies.	7. Install C-ring Kit 53-12067A1 (refer to subject A, preceding).
8. U-joint bearing caps contacting center socket or drive shaft housing bearing retainer. (Figure 6)	8. Make sure that proper cross and bearing assemblies are being used. If interference is slight, grind off area on center socket or retainer where bearing caps are hitting. If interference is severe, replace center socket.

10. O-rings missing or flattened out on U-joint shaft (Figure 6) -- causing shaft to rattle against ID of gimbal bearing.	10. Install new O-rings.
11. Worn U-joint shaft splines and/or engine coupler splines.	11. Remove U-joint coupling end yoke (Figure 6) and insert into gimbal bearing and engine coupling. Rotate shaft back-and-forth. If play is excessive, replace U-joint coupling end yoke and/or engine coupler, as necessary.

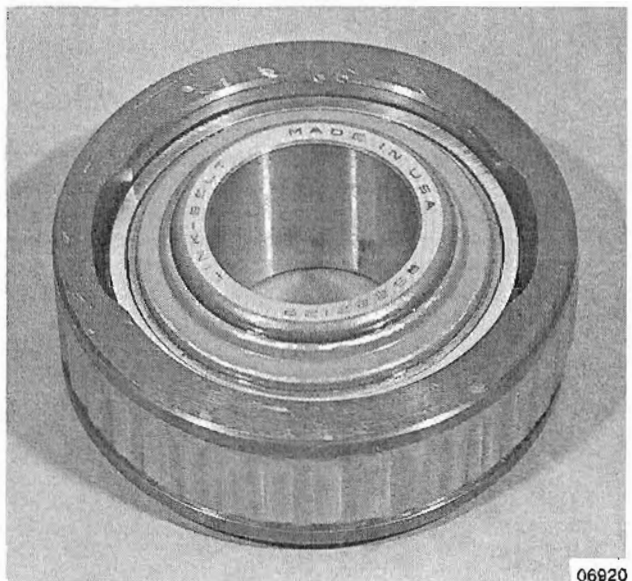
Figure 7. Cartridge Type Gimbal Bearing

POSSIBLE CAUSE	REMEDY
<p>13. Gimbal bearing rough.</p> <p>14. Loose gimbal bearing.</p> <p>15. Gimbal bearing not fully seated in gimbal housing -- MC-I units with cartridge type bearing only. Yoke moves back and forth in turns and may hammer against bearing if not fully seated.</p> <p>16. Excessive clearance between gimbal ring and gimbal housing. (Figure 10) This could cause misalignment between bell housing and gimbal housing and also may allow gimbal ring to vibrate up-and-down in turns.</p> <p>17. Stringer height uneven or transom assembly installed cocked on boat transom. This will affect engine alignment, but is usually not detectable with alignment tool.</p> <p>18. Weak boat transom or boat bottom that flexes under power and causes engine misalignment -- this condition will usually cause engine coupler to fail.</p> <p>19. Rear engine mount attaching hardware improperly installed or missing. (Figure 11 or 12)</p> <p>20. Improperly installed or failed rear engine mounts. This will affect engine alignment, but usually is not detectable with alignment tool.</p> <p>21. Engine mounting holes drilled off-center in inner transom plate engine supports or engine flywheel housing.</p> <p>22. Boat transom too thin [1-3/4" (44mm) minimum on MC-I models]. On older MC-I models this could cause U-joint shaft to bottom out in engine coupler in turns.</p> <p>23. Boat transom thickness uneven [1/8" (3 mm) variance maximum]. This could affect engine to transom assembly alignment and is usually not detectable with alignment tool.</p> <p>24. Misalignment between bell housing, gimbal housing and engine coupler.</p>	<p>13. Replace gimbal bearing. IMPORTANT: On MC-I models with cartridge type bearing, (Figure 7) bearing and carrier MUST BE replaced as an assembly as they are a matched set. Failure to do this may result in a loose bearing fit in carrier.</p> <p>14. Reinstall bearing using a new tolerance ring if carrier is loose in gimbal housing. If bearing is loose in carrier, bearing assembly must be replaced.</p> <p>15. Drive bearing assembly into place. IMPORTANT: On gimbal housings with snap ring groove, bearing must be pressed in past groove (snap ring is not used). (Figure 8) On newer units without snap ring groove, bearing must be pressed in past lead-in chamfer in bearing bore. (Figure 9)</p> <p>16. Check and adjust clearance as outlined in appropriate service manual.</p> <p>17. Measure distance between engine flywheel housing and inner transom plate on both sides. (Figure 11) If distances are uneven, problem may be due to uneven stringer height or a cocked transom assembly. Adjust stringer height or relocate transom cut-out as required.</p> <p>18. This condition can sometimes be detected by having someone jump up-and-down on the drive unit while watching the inner transom plate. If movement can be observed, transom is weak and must be repaired.</p> <p>19. Reinstall hardware correctly.</p> <p>20. Check for uneven mount height or loose or soft mounts. Check to make sure that there is clearance between flywheel housing and fiber washer. (Figure 11) If no clearance exists mounts have probably sagged. Install mounts correctly or replace as necessary.</p> <p>21. Check to make sure that holes are equally spaced fore and aft and are equal distance from centerline.</p> <p>22. Add thickness to transom.</p> <p>23. Repair boat as necessary.</p> <p>24. Contact your regional service center and arrange to have a technical service representative check the unit using a special gauge.</p>

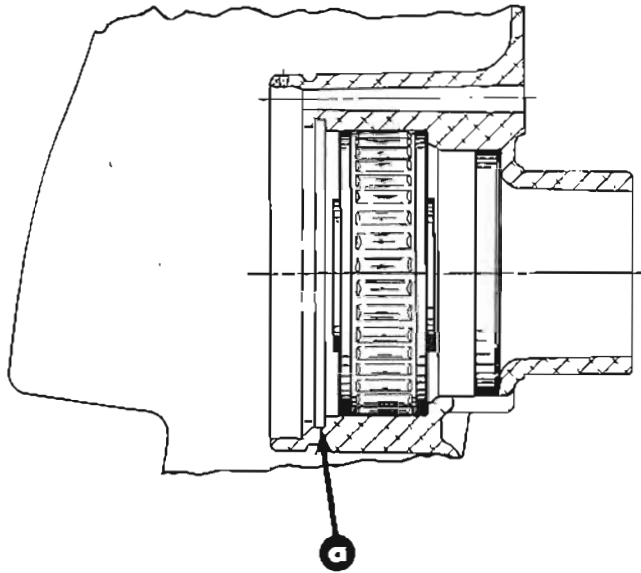
Figure 8. Gimbal Bearing Installation On Units With Snap Ring Groove

a - Bearing Cartridge Must Be Pressed In Past Groove

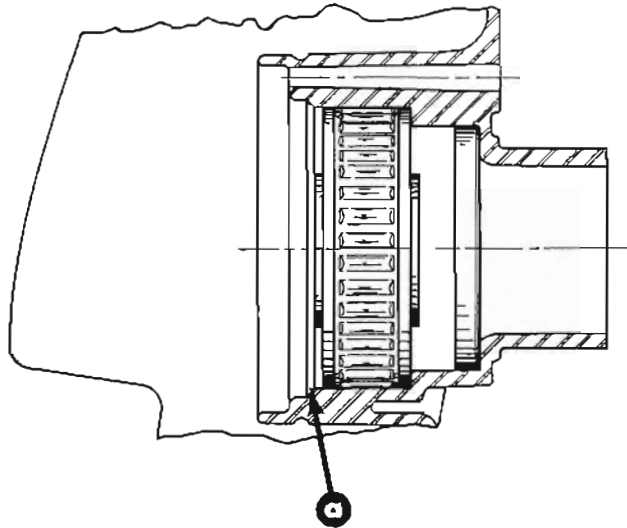
Figure 9. Gimbal Bearing Installation On Units Without Snap Ring Groove

a - Bearing Cartridge Must Be Pressed In Past Lead-In Chamfer
