- A. Checking Shift Cable Adjustments on MerCruiser 120-thru-260R & MR Models
- B. Difficult Shift Cable Adjustment

## A. CHECKING SHIFT CABLE ADJUSTMENTS ON MERCUISER 120-thru-260R & MR MODELS

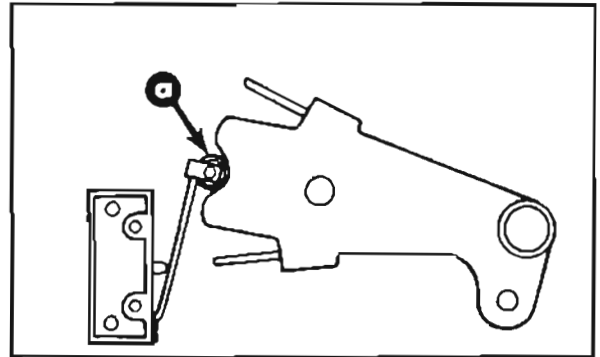
**Figure 1. Checking Shift Cutout Switch**

1. Shift operation can be checked with boat in the water or with stern drive connected to a garden hose.
2. Shift into forward and reverse gear making sure that clutch engages before engine begins to accelerate.
3. Shift into forward gear and stop engine. Fully advance throttle. Check that shift cutout switch roller is centered in notch of shift lever. (Figure 1) Repeat same procedure for reverse gear.
4. If proper shift operation is not observed, adjust shift cables, as outlined in "MerCruiser I-Drive Shift Cable Installation and Adjustment Procedure" (SIS-873), which was sent out with the previous service bulletin mailing.

a - Shift Cutout Switch Roller Centered In Lever Notch

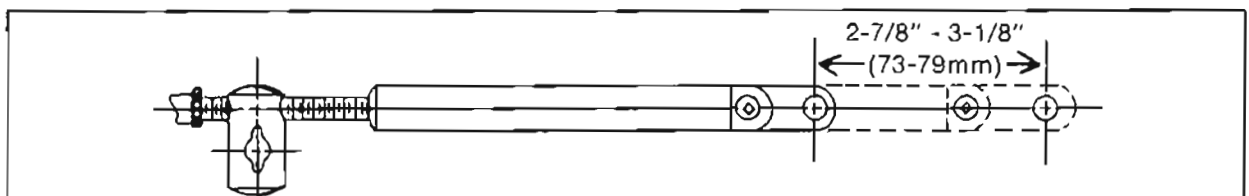
**Figure 2. Remote Control Shift Cable Travel**

Remote control must provide the shift cable travel shown in Figure 2 to properly shift the drive unit. Pull out on cable end guide when checking dimension in forward gear and push in on end guide when checking dimension in reverse gear.

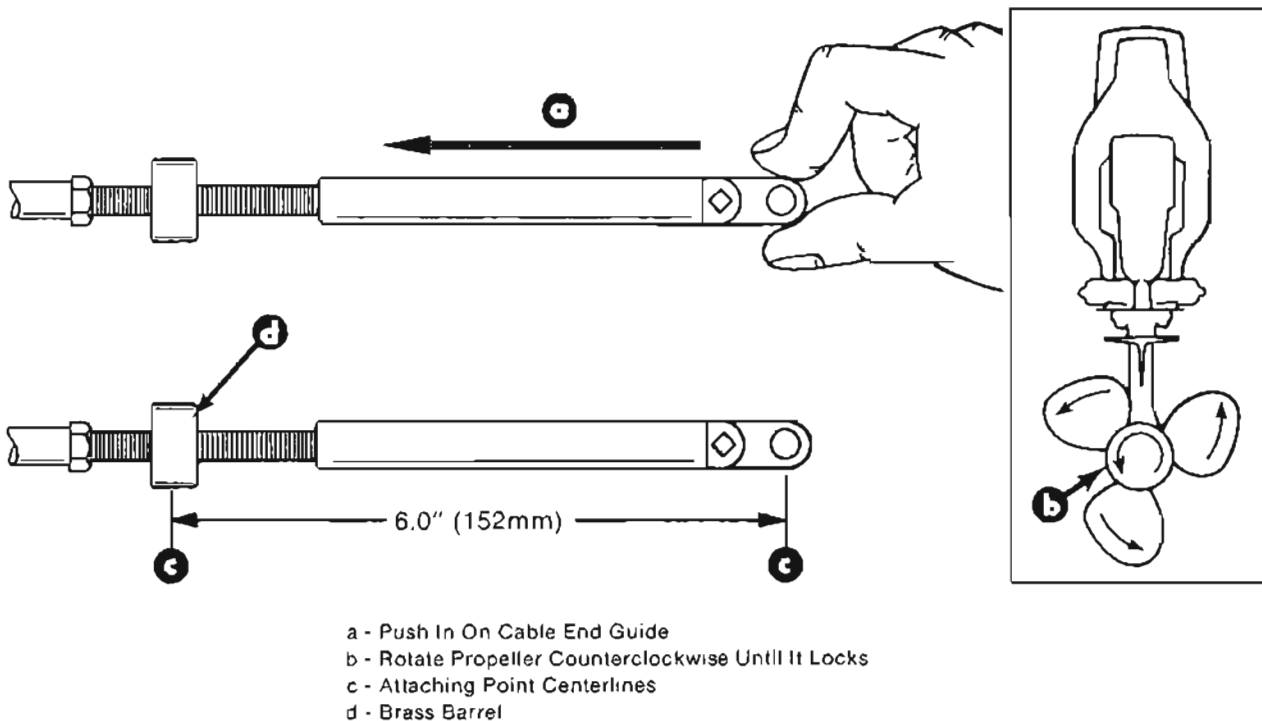
Figure 3. Checking Cable End Dimension

Check cable end dimension as shown in Figure 3.

- If dimension is less than specified, check items 5 and 7, following.
- If dimension is more than specified, check item 6, following.
- If the above is not the cause, remove shift cable end guide, check inner core wire dimension and readjust cable as outlined in SIS-873.

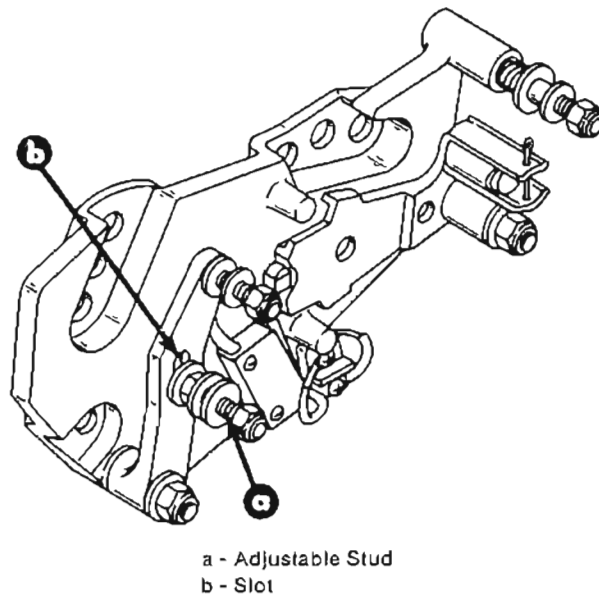
Figure 4. Shift Lever Adjustable Stud

If shift cutout switch kills engine when shifting into reverse, check shift lever adjustable stud to make sure that it is all-the-way to bottom of slot. (Figure 4)

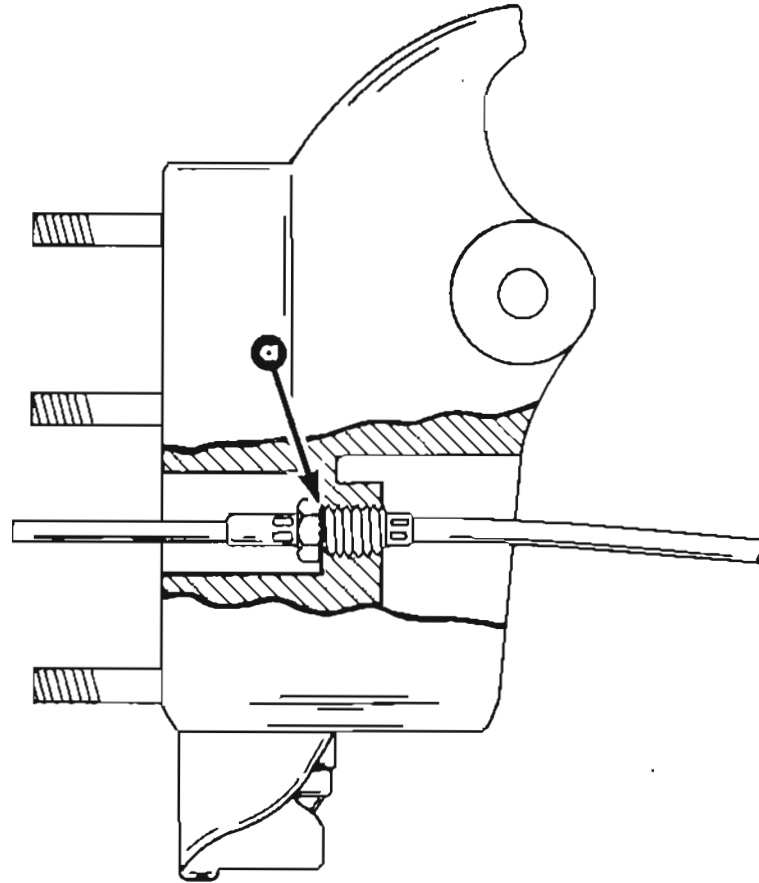
**Figure 5. Checking Shift Cable Fitting**

If shift cutout switch kills engine when shifting into reverse, check to make sure that shift cable brass fitting is tightened properly. (Figure 5) No more than 2 threads on brass fitting should be exposed.

a - No More Than 2 Threads of Fitting Should Be Exposed

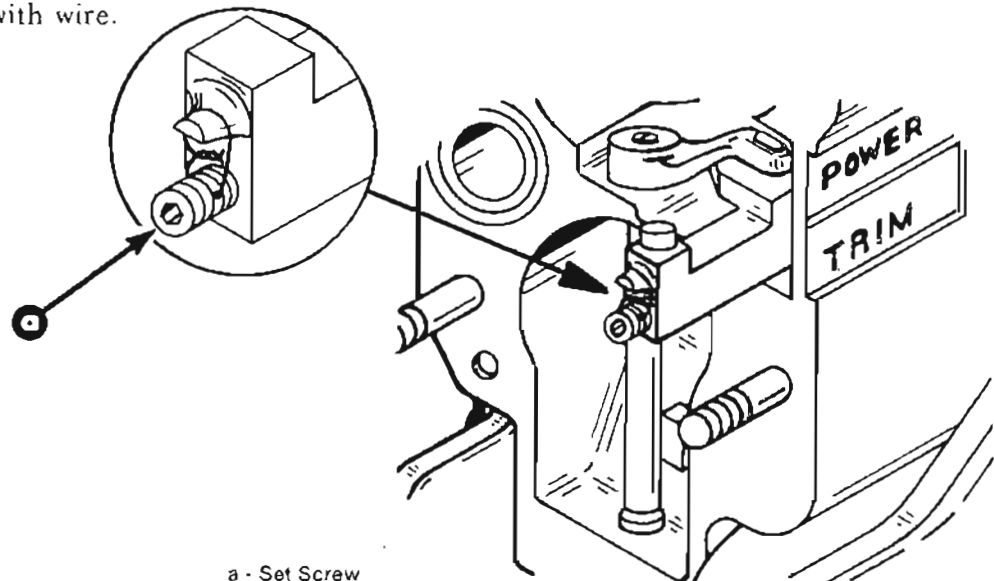
**Figure 6. Shifting Slide Assembly Set Screw**

If difficulty is experienced in getting good clutch engagement in forward or reverse, check shifting slide assembly set screw to make sure that it has been tightened correctly. (Figure 6) Screw should be turned in until it bottoms out, and then backed out  $\frac{1}{4}$ -turn before it is secured with wire.

a - Set Screw

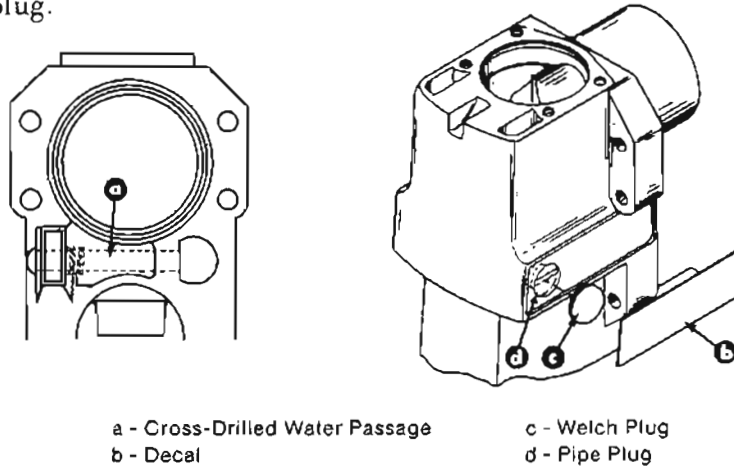
**Figure 7. Drive Shaft Housing Cross-Drilled Water Passage**

If good forward clutch engagement is not obtained, or if shift cutout switch kills the engine when shifting into forward or reverse, check cross-drilled water passage pipe plug in drive shaft housing to make sure that it is not interfering with shifting slide assembly. (Figure 7) This can be done by shining a flashlight into shifting slide assembly cavity. Plug must be flush to slightly recessed in inner casting surface. If necessary, remove decal and weld plug and tighten pipe plug.

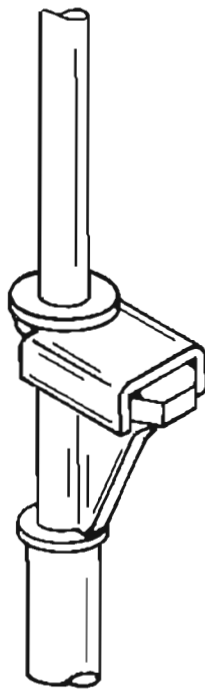
**Figure 8. Upper and Intermediate Shift Shafts**

If clutch does not engage fully in forward or reverse or does not shift out of gear properly, check to make sure that intermediate shift shaft is engaging properly with upper shift shaft. (Figure 8) If not, problem may be due to a missing shift shaft bushing washer. (Figure 9)
