NUMBER: 84-21

- A. MerCarb Acceleration "Bog" - MCM 120R/140R/470R/898R
- B. MerCarb Right Turn Lean Out - MCM 120R/140R
- C. MerCarb with No Adjustment on Idle Mixture Screw -
MCM 120R/140R/470R/170MR/898R/200MR

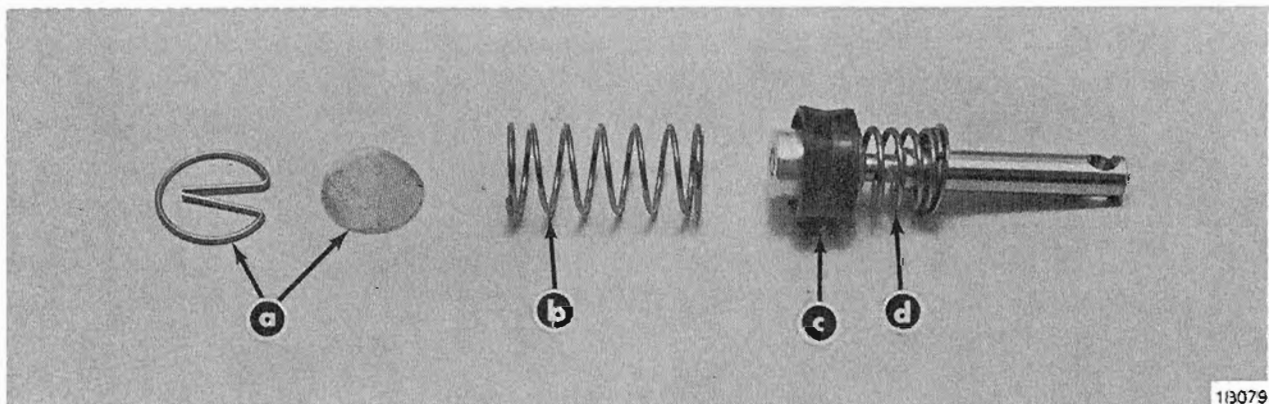
Figure 1. 3302-9046 Pump Kit

You may receive complaints that the above model engines "bog" on acceleration. We have found the problem to be the neoprene seal on the accelerator pump in the carburetor. The original seal will expand when subjected to gasoline containing alcohol. Many automotive regular leaded, non-leaded or premium gasolines sold today, contain alcohol, although it is not advertised as gasohol.

a - Screen and Clip
b - Return Spring

c - Double Lip Seal with New Material
d - Silver Colored Duration Spring

1. Replace accelerator pump with kit P/N 3302-9046. (Figure 1)

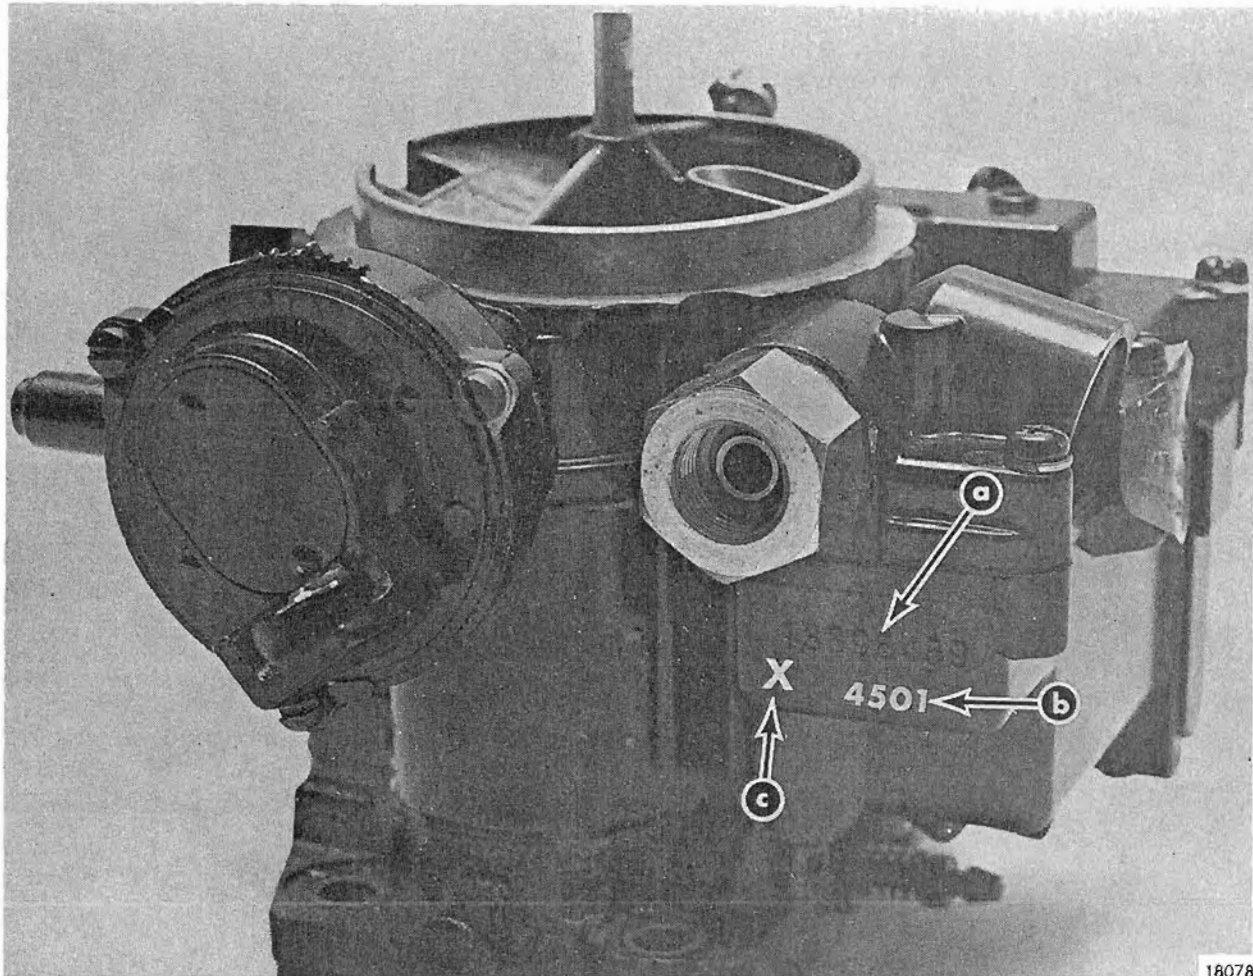
Figure 2. Carburetor Identification

IMPORTANT: Carburetors with a date code of 4501 and above have the new kit already installed. (Figure 2)

- a - Part Number
- b - Date Code
- c - Mark with "X"

2. As a temporary fix, stronger duration springs (only) were sent to dealers. On carburetors that had only the duration spring changed, a new 3302-9046 Pump Kit should be installed.
3. The screen (in the bottom of the accelerator pump hole) should be left in. If screen is dented downward, toward check ball, replace screen.
4. Check pump rod adjustment as outlined on page 20 of the MerCarb Service Manual SIS-864.
5. After installing new kit, make an X at location shown in Figure 2.
6. Start engine and check timing.

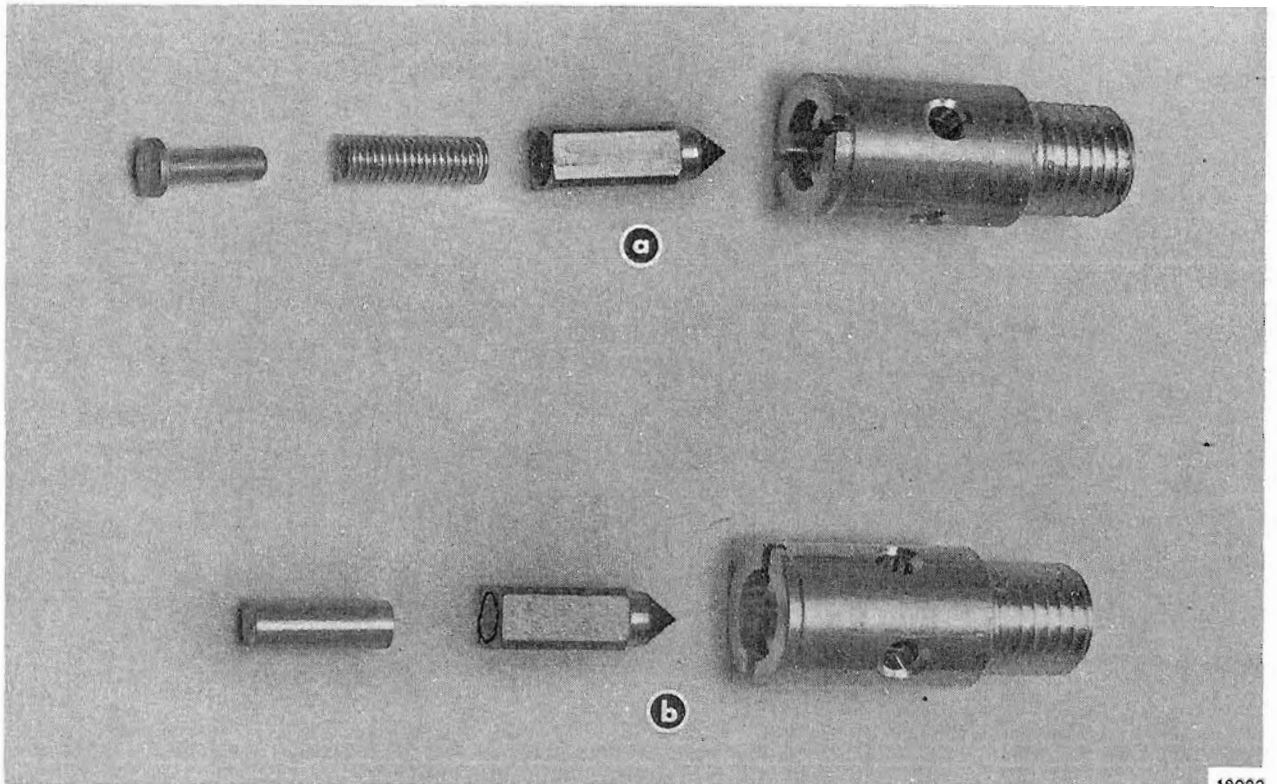
Figure 3. Difference Between Inlet Seat Kits

You may have a complaint about a right hand turn lean out. A good example would be, while pulling a water skier, the skier falls. The driver puts the boat in a hard right turn and accelerates to go back to the fallen skier. If the engine hesitates during this time, proceed as follows:

a - Original Spring Loaded Needle
b - New Two Piece Solid Needle

1. Replace original inlet seat kit with 3302-9407 Inlet Seat Kit. The original kit has a spring loaded needle while the new kit has a solid, two piece needle. (Figure 3)

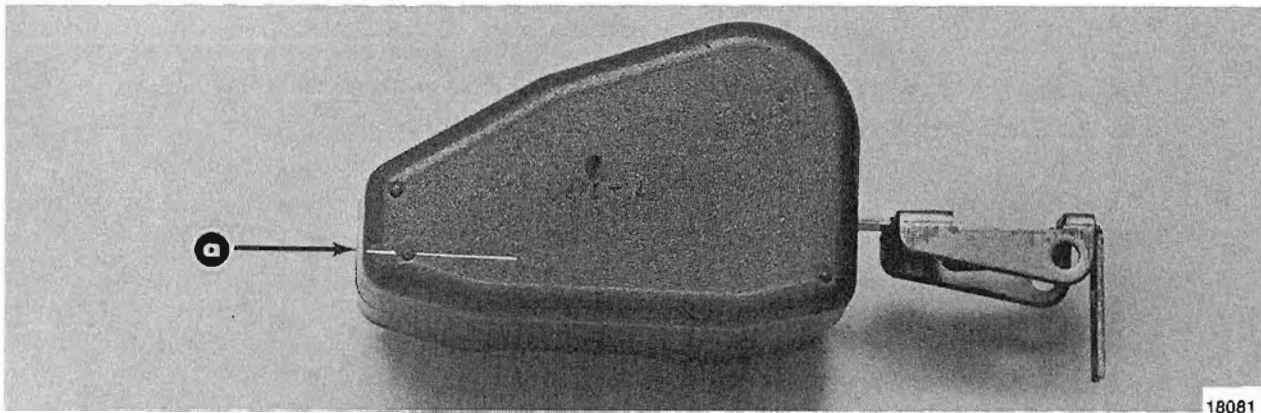
Figure 4. Float Assembly

a - Measure from This Point to Air Horn Casting Surface

2. Reset float level to 5/16" (7.5mm) as shown in Figures 4 and 5. This float level is higher than original level.
3. DO NOT make mark on carburetor after this change has been made to it.
