NUMBER: 84-23

## LEAKING EXHAUST PIPE ON MCM 120MR and 140MR

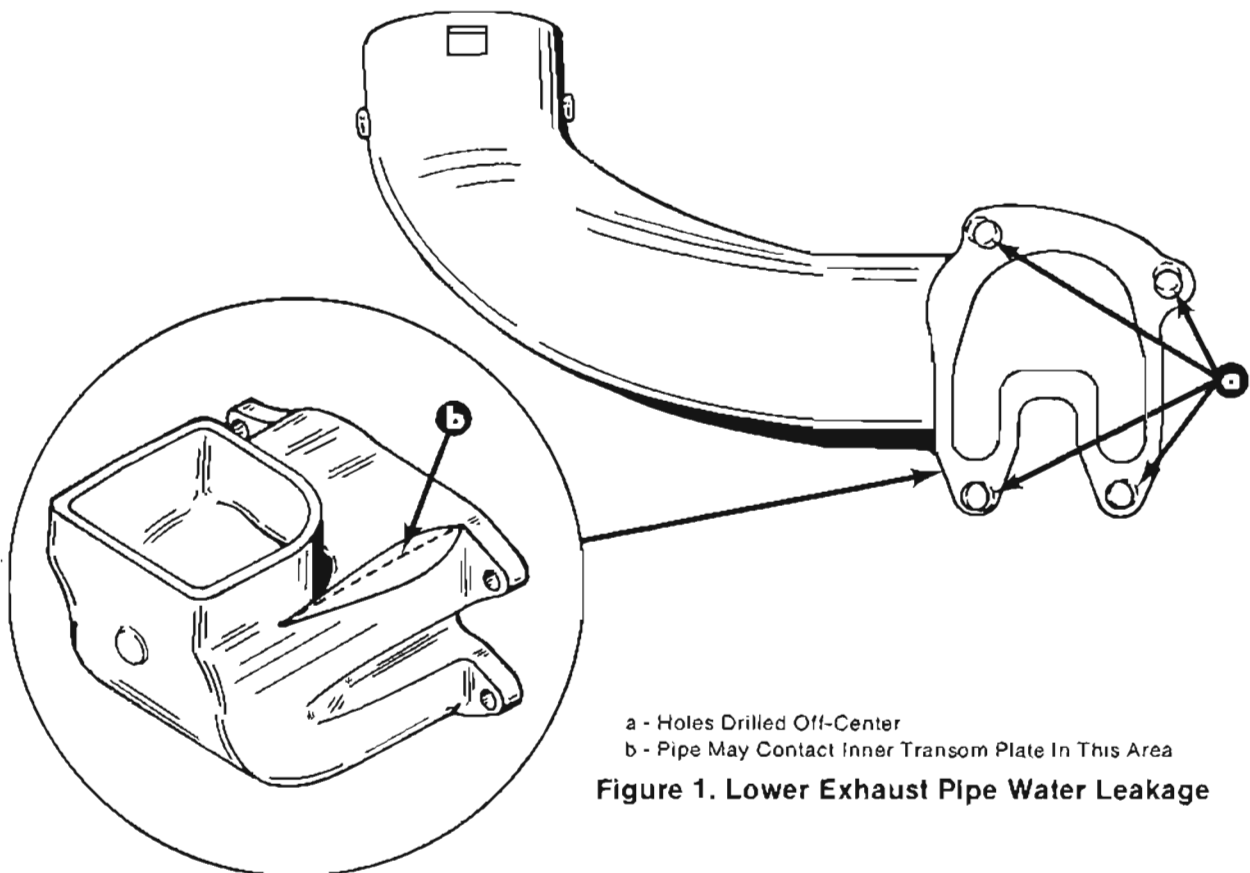
**Figure 1. Lower Exhaust Pipe Water Leakage**

MerCruiser 120MR and 140MR power packages with engine serial number 6865151 to 6876739 may be subject to a water leak at the lower exhaust pipe. The problem could be caused by one or both of the following conditions: (Figure 1)

1. Mounting holes in exhaust pipe may be drilled off-center. This could cock the exhaust pipe and prevent it from sealing properly against the seal on the gimbal housing.
2. Exhaust pipe may be contacting inner transom plate, preventing it from butting squarely against gimbal housing mounting surface.

a - Holes Drilled Off-Center  
b - Pipe May Contact Inner Transom Plate In This Area

If you encounter a power package with either of the above conditions, install new, lower exhaust pipe, 42421A5. Labor allowance is 3.5 hours.
