- A. Rochester Quadrajets Carburetor Flooding
- B. Modifying 1347-9142A2 Rochester Carburetor for Use on MCM 488 and Early MCM 190 with 10° Wedge
- C. Torx® Screwdrivers Used on Rochester Quadrajets Carburetors
- D. Serial Numbers

A. ROCHESTER QUADRAJET CARBURETOR FLOODING

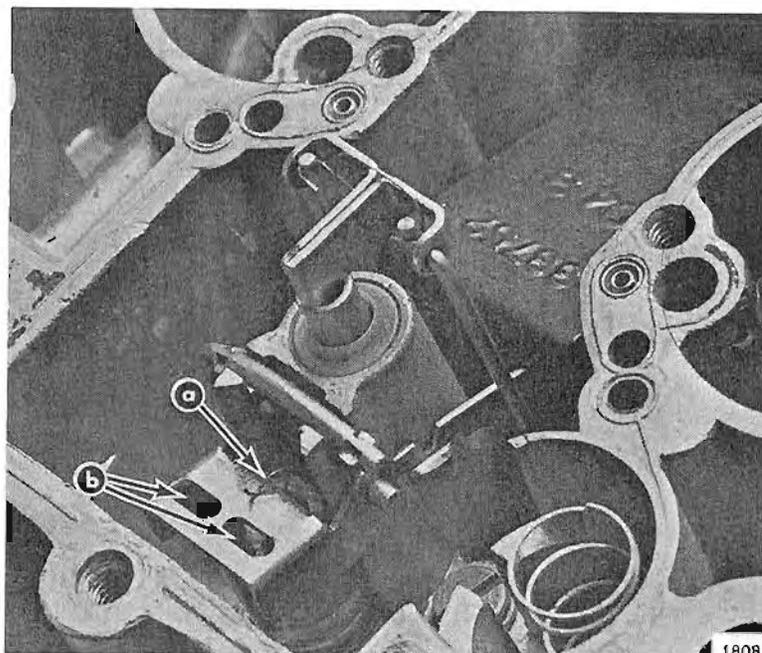
Figure 1. Pull Clip Installation

1. Dirt or metal chips in the inlet seat area.
 - a. Whenever repairs are done to a carburetor, remove fuel filter and blow out fuel inlet passage from inlet seat side. Clean fuel filter and reinstall. The rest of the fuel inlet system should be checked and cleaned as necessary.
2. Inlet needle seat damaged during installation.
 - a. Use a wide bladed screwdriver when installing inlet seat. Inspect seat for damage after installation.
3. Inlet needle pull clip hooked onto float arm at incorrect location.
 - a. Install inlet needle pull clip onto float arm as shown in Figure 1.

IMPORTANT: DO NOT install pull clip in either hole because needle will not seat properly.

a - Hook over end of float arm
b - DO NOT hook in these holes

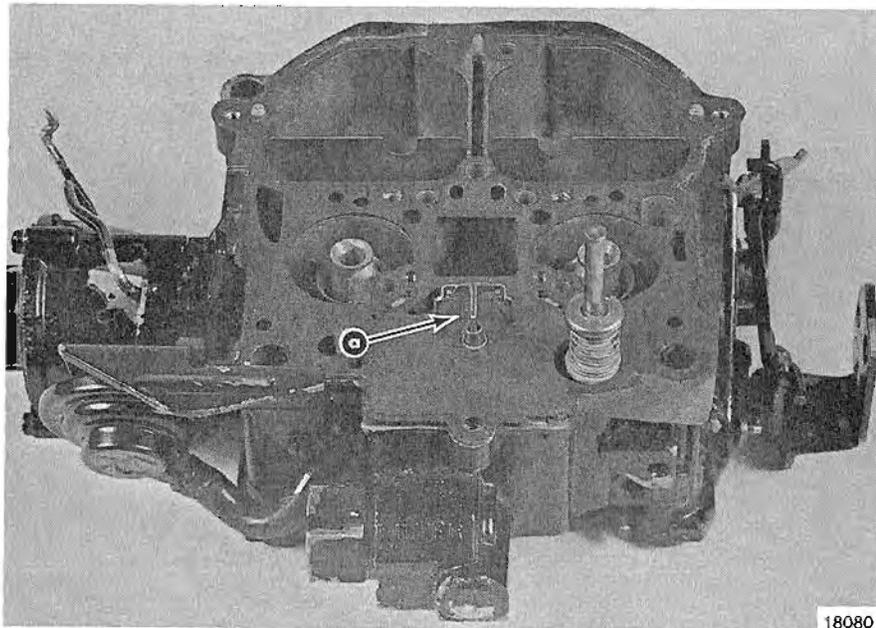
Figure 2. Correct Gasket Installation

IMPORTANT: Make sure gasket is installed **ON CARBURETOR BODY** before installing air horn, as shown in Figure 2. If gasket tab is on top of Power Piston and Metering Rods, a lean condition at mid throttle will occur.

a - Tab **MUST BE UNDER** Power Piston and Metering Rods

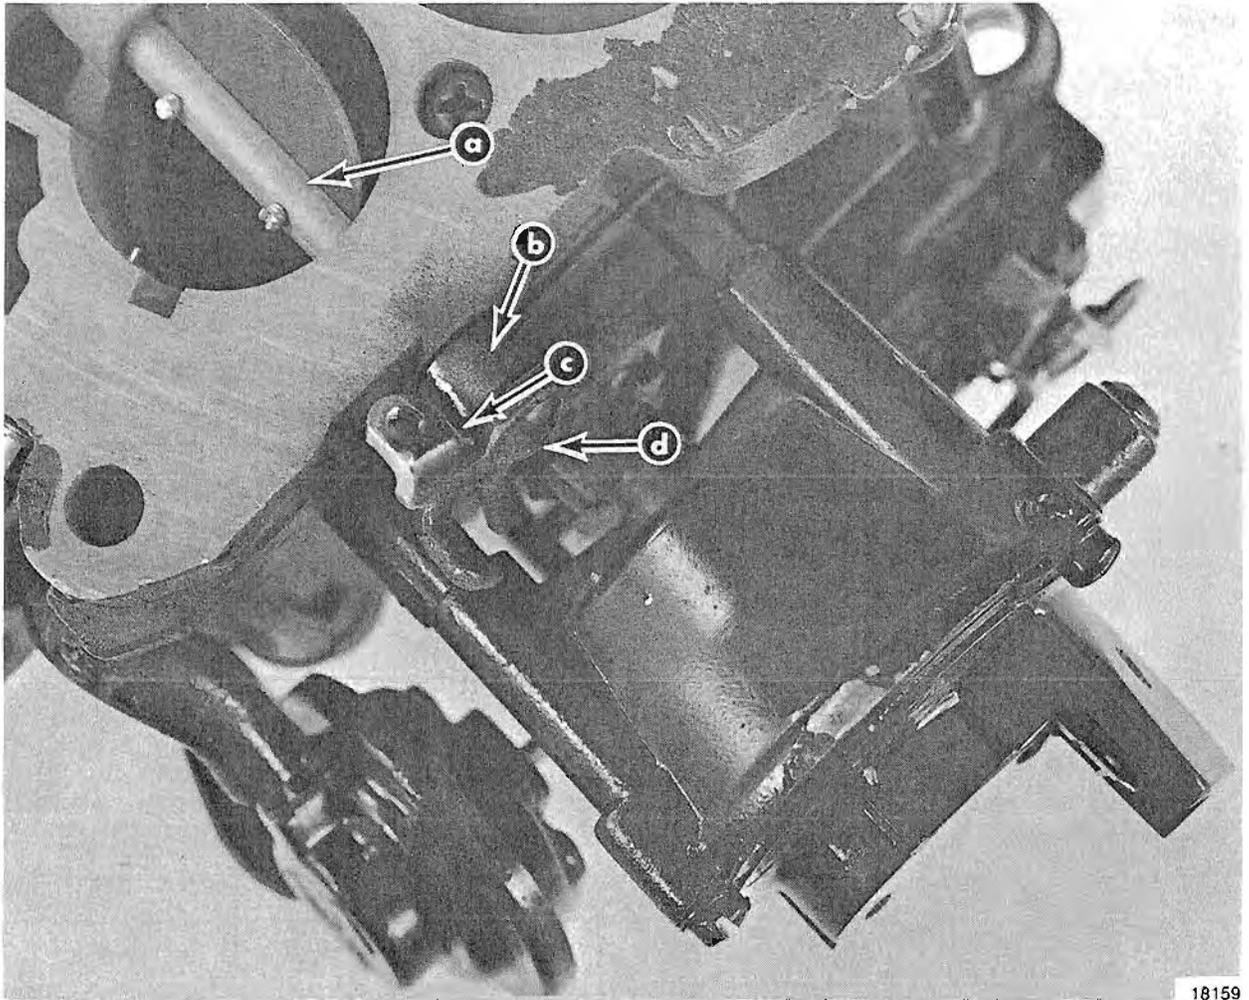
Figure 3. Modifying 1347-9142A2 Carburetor

The original MCM 488 carburetor (1347-8460A3), has been superseded by the MCM 190 carburetor (1347-9142A2). Before installing the 1347-9142A2 carburetor on a MCM 488 or early MCM 190 with 10° wedge, remove and discard the choke pull-off lever, spacer and screw as shown in Figure 3. These parts must be removed because they will hit the 10° wedge when installing the carburetor.

IMPORTANT: DO NOT remove these parts when installing the 1347-9142A2 carburetor on MCM 190 engines **WITHOUT** the 10° wedge (carburetor setting flat on intake manifold).

- a - Throttle Shaft
 - b - Spacer
 - c - Lever
 - d - Screw
- Remove and Discard
