service bulletin

NUMBER: 85-17

Subject: A. TIMING CHANGE - ALL MCM 300 TEMPEST MODELS

B. INCREASED CUP ON QUICKSILVER CLEAVER PROPELLERS

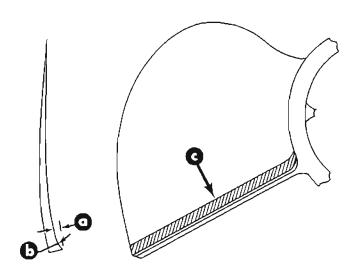
Figure 1. Blade Cross Section

Future production MerCruiser I and TRS Cleaver propellers (part numbers listed below) will be manufactured with additional cup in the trailing edge of the blades. (Figure 1)

a - Cup Offset

New - .100" \pm .010" at Tip; .060" \pm .010" at Hub with a Straight Transition Between These Points Old - .060" \pm .010" from Tip to Hub

b - 1" Radius

c - Cupped Area

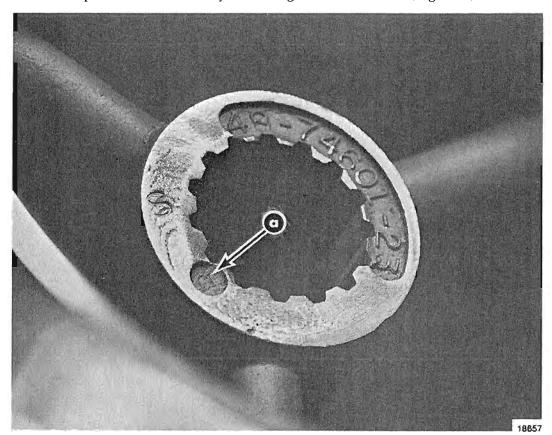
Figure 2. Propeller Identification

Modification will occur as a running change without a change to the part number. Propellers with increased cup can be identified by observing the series letter. (Figure 2)

a - Series Letter Solid Hub Cleaver - New "R"; Old "P" Rubber Hub Cleaver - New "E"; Old "D"
