## service bulletin

**NUMBER: 85-29**

## C. MODIFICATION TO BEARING PRELOAD TOOL USED TO SERVICE THE MERCRUISER MR GEAR HOUSINGS

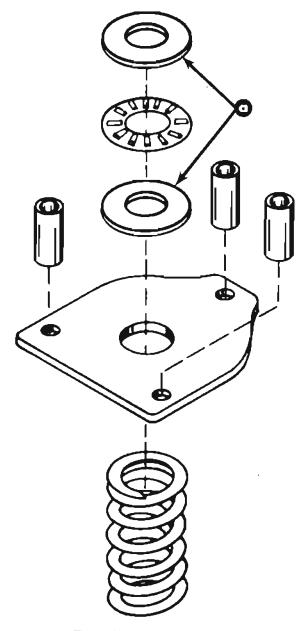
a - Thrust Washers P/N 12-13382A1 Figure 1.

The service department has received some complaints that the locking collar and plate contained in the (91-44307A1) bearing preload tool are galling on the surfaces where the thrust bearing contacts them. If the surfaces become galled, the gear backlash reading could be inaccurate.

To eliminate galling, order P/N 12-13382A1. It contains two thrust washers which should be installed as shown in Figure 1.

All new orders for P/N 91-44307A1 will be shipped with the thrust washers in the bearing preload tool kit.
