No. 88-5

Overrich Acceleration “Bog” on MerCarb Equipped Models MCM 120/140/2.5L/3.0L

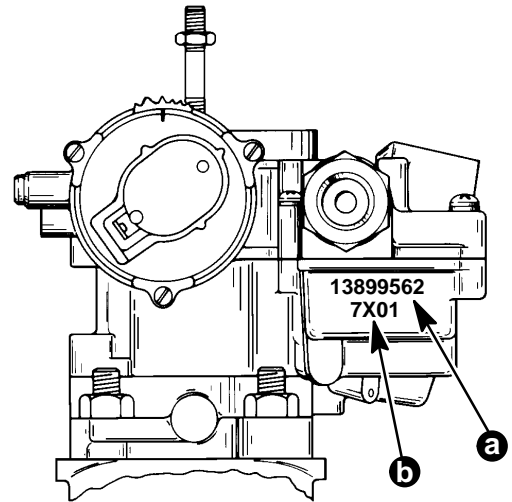
Carburetor Part Number Location Figure 1.

There is a new Venturi Cluster P/N 3302-9810 available to correct the “overrich bog” condition that may be encountered on these model engines equipped with Mercarbs which have the increased capacity (4cc) accelerator pump.

Models equipped with the new cluster have day code 7X01 (Figure 1). Models and starting serial numbers with 7X01 Mercarb are 2.5L, OB923578 and 3.0L, OB923342.

This new Venturi Cluster can only be used on Mercarbs, P/N 1389-9562, equipped with the increased capacity accelerator pump P/N 3322-9655.

Accelerator pumps that are modified in any way from original to correct this “boggling” condition, must be converted back to original specification and parts before the new cluster venturi is installed. Also, if a 1/4” ball was used under the accelerator pump to restrict the pumps movement, discard that ball after installing the new venturi.

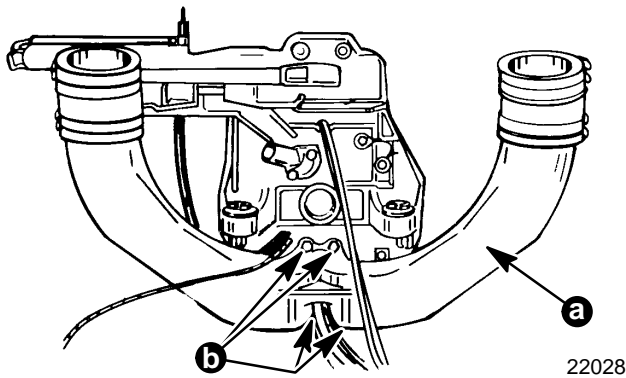
Figure 2.

All MerCruiser V-6 and V-8 Alpha One Magnum models are now being equipped with the new Plus Power exhaust system for improved performance. The exhaust pipe on these models is now secured to the gimbal housing with 4 screws, instead of 3 (Figure 2). Early exhaust pipe installation used only 3 screws. (S/B 86-27) The additional screw has been added at the 11:00 o'clock position on new models being manufactured (Figure 2).

The torque specification for these screws is still the same as in the past -- 20–25 lbs. ft.

- a - Exhaust Pipe Assembly
- b - Torque Bolts to 20–25 lb. ft. (27–34 N.m)

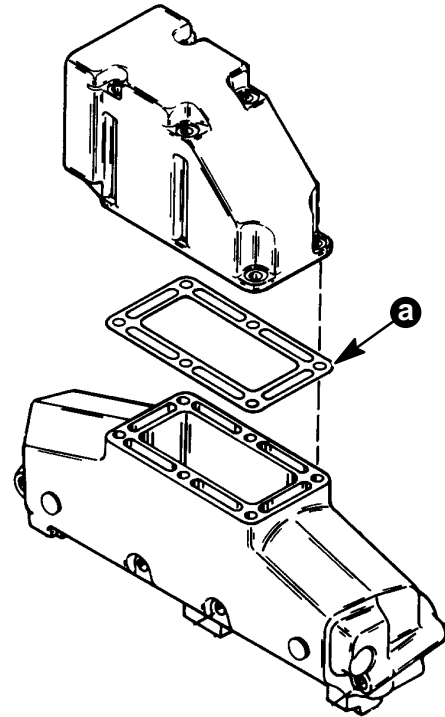
Figure 3.

MCM HP 420 Exhaust Elbow Water Leak

When replacing a leaking HP 420 exhaust elbow to manifold gasket P/N 27-13847 (Figure 3) coat both sides of gasket with Perfect Seal P/N 92-34227. This will prevent the water leak (weeping) from reoccurring between exhaust elbow and manifold.
