No. 88-16

Possible Water Leak Caused by TR/TRS Transom Cutout

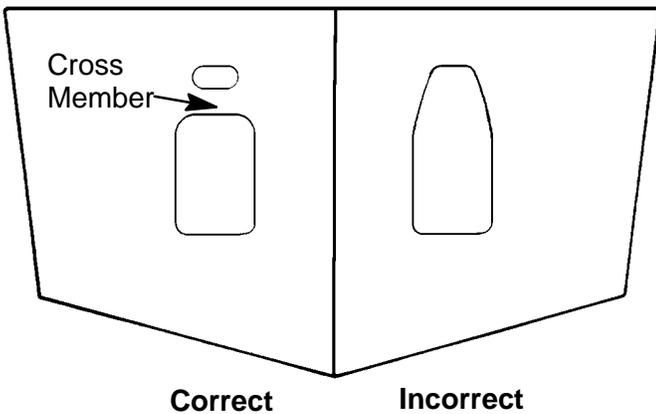
Figure 1.

It has been brought to our attention that some boat manufacturers have been incorrectly cutting the transom cutout for the TR/TRS model stern drives.

The current style gimbal housing (shown in Figure 2) is now cast with a hole for access to the "U" bolt nuts at the top of the gimbal ring. Keep this in mind when replacing the gimbal housing. The cross member between the upper and lower cutout opening (shown in Figure 1 following) is required to support the cork gasket to prevent water from leaking into the boat.

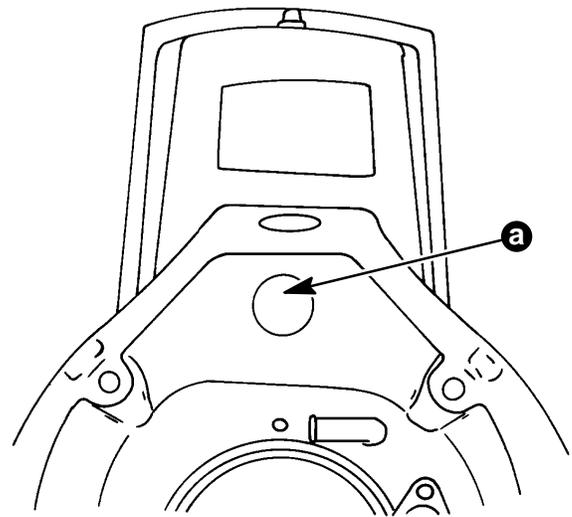
19555

a - Water Leakage Problem
Current Style
