No. 89-31

Alpha One - Bravo One and Bravo Two Trim Sender Indexing Marks Misaligned

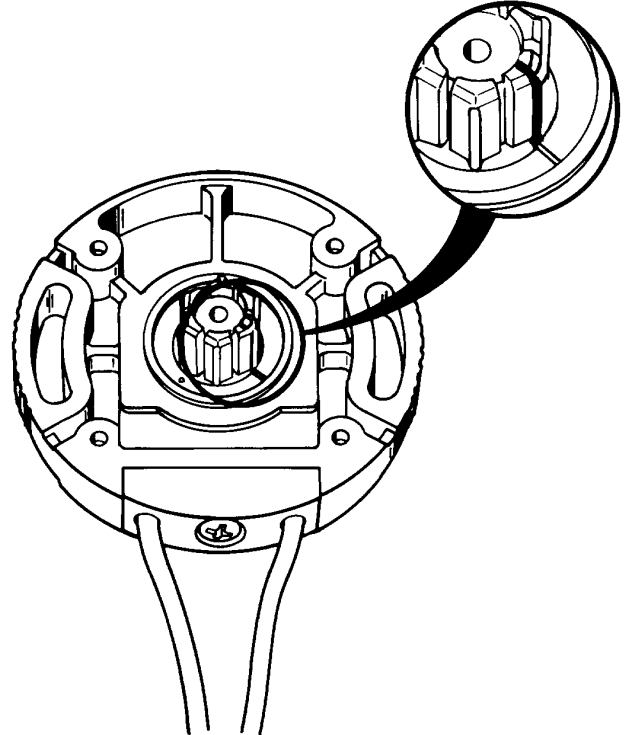
50842

It has been brought to our attention that the indexing marks on the Alpha One and Bravo One and Bravo Two trim position sender may not be aligned properly. Please remove and align indexing marks as shown in the following diagram. When indexing marks are misaligned the trim gauge needle will jump to the top end of the gauge scale when trimming. Units affected are from serial number 0C833540 thru 0C888889.

IMPORTANT: Sender adjustment must be done with stern drive at full down "IN" position. DO NOT adjust sender with stern drive at maximum trim position because sender may be damaged or give incorrect gauge readings.
