No. 89-23

Attachment of Gear Lube Monitor Hose Fitting to Gimbal Housing Connector on the Bravo Transom Assembly

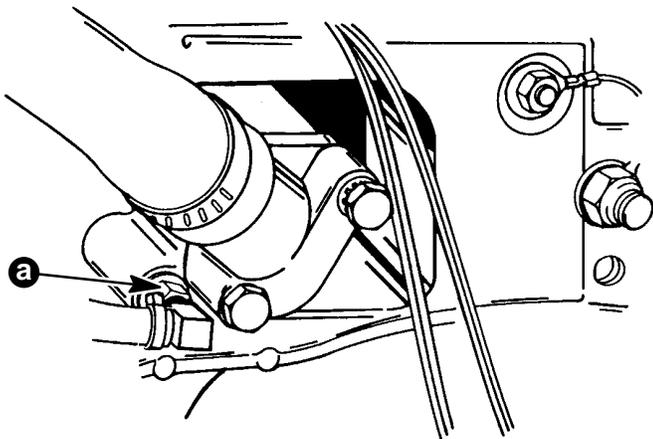
Figure 1.

It has been brought to our attention that the gear lube monitor hose fitting (a) shown in Figure 1, has been mistakenly attached by a few boat manufacturers to the transom assembly stud (b) rather than on connector (c) in the gimbal housing. This will cause premature failure of the drive unit because the oil will be forced out through the connector into the bilge area of the boat, draining the drive unit oil low enough to cause bearing failure usually at the drive gear on the universal joint.

We suggest that the dealer inspect for this condition before delivery of the boat.
