No. 91-9

A. OIL LEAKING FROM WATER PICKUP HOLES IN GEAR HOUSING ON ALPHA ONE GENERATION II DRIVE

MCM 3.0L/3.0LX/4.3L/4.3LX/5.0L/5.0LX/5.7L Alpha/350 Magnum

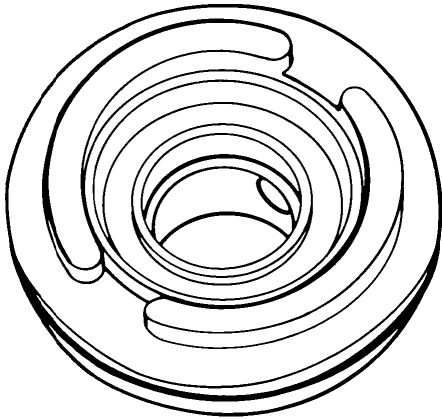
A. Old Style

The oil seal carrier is being changed from the brown color (aluminum) material back to a black glass filled nylon material. This new seal carrier will supercede the aluminum version. The new seal carrier can be identified by looking at the base where the old plastic carrier had only two support feet the new one will have four support feet.

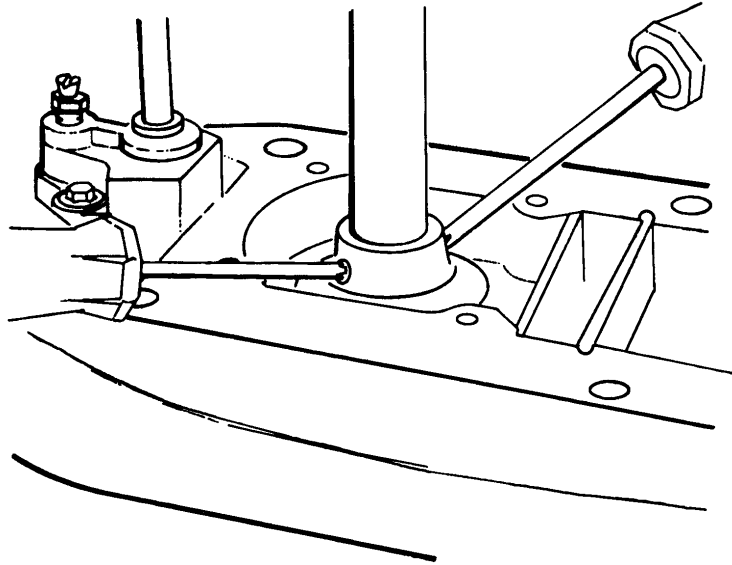
70489

If oil is detected leaking from the water pickup holes in the gear housing, the oil seal carrier under the water pump face plate may be cracked. This would cause oil to leak from the water pickup holes in the gear housing and could lead to gear failure.

Remove cracked carrier from gear housing using a couple of screw drivers to lift it up and out of the housing bore.
