Revised June 1999. Information underlined is new.

MerCarb 2 bbl Carburetor

8 Point Carburetor Check List

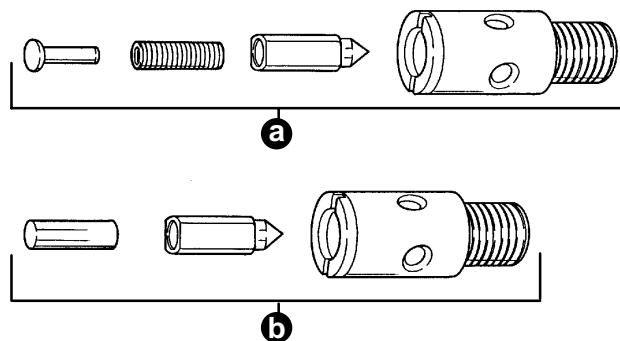
72290

If all these items have been checked, then check the type of needle and seat installed in the carburetor. Most older MerCarbs used a solid two-piece needle. If the carburetor has a solid two-piece needle and seat in it, install the spring loaded needle and seat kit. Reset float level to correct specifications.

- a - Spring Loaded Needle and Seat.
b - Solid Two-Piece Needle and Seat.

Installing a spring loaded needle and seat kit on a 4-cylinder engine can cause a lean out condition in extremely hard turns.

GM 153, 181 cid: Right turn.

Mercury Marine, 224 cid: Left turn.

Because of this potential lean out condition in extremely hard turns, you should make the boat owner aware of this condition before installing the spring loaded needle and seat kit. The spring loaded needle and seat kit is the preferred one to use if you have a flooding problem at idle RPM.

3302-9407 Solid Two Piece Needle and Seat Kit.

3302-9029 Spring Loaded Needle and Seat Kit.

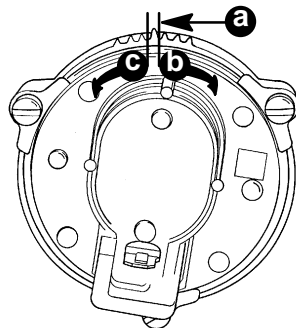
72403

When servicing an engine, the choke should be reset to specifications as listed below. Add these choke specifications to all your older service manuals. The old setting were too rich for most engines. Production carburetors on new engines are set at these settings. If needed, the choke can be set slightly richer or leaner to customize it for the operating conditions that the engine will be run in.

- a - Timing Mark in Cover is Shown In Line With Center Index Mark.
- b - Clockwise = Leaner.
- c - Counterclockwise = Richer.

3.0L: 1 Index Mark Clockwise.

V6, V8: 2 Index Marks Clockwise.

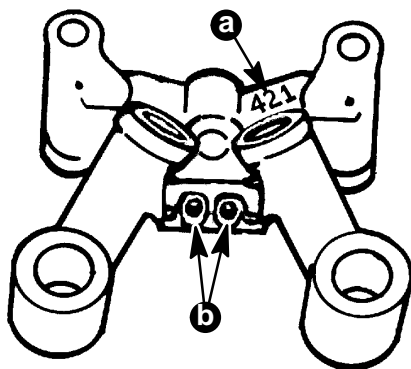
72779

The venturi clusters are matched to the carburetor. Sometimes the replacement clusters get packaged wrong. Clusters have an identifying number on them. Refer to the service manual for the engine that you are working on for the correct cluster number.

a - Identification Number

b - Accelerator Pump Discharge Holes

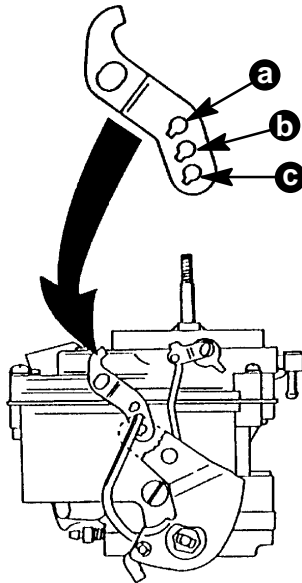
73131

The replacement accelerator pump lever has three holes in it. This lever will allow you to change the amount of fuel delivered to the engine by the accelerator pump. Most bogging problems can be corrected by changing the rod's location, providing the bogging problem is being caused by the carburetor. Always test run the boat in the water to see if bog has been corrected.

- a - Full Accelerator Pump Stroke.
- b - 0.5 cc Less Fuel Per Stroke (Leaner).
- c - 1.0 cc Less Fuel Per Stroke (Leanest).

When installing this lever on an older carburetor, put the rod in the center hole. This will give 0.5 cc less fuel to the engine on acceleration, than the single hole lever did. Remove any metal ball that someone may have put in the accelerator pump well to limit pump travel. Also, make sure that the duration spring on the accelerator pump is stock and has not had several coils cut off. Verify that the venturi cluster is the correct one as called for in service manual. Production started using carburetors with the 3 hole lever in June 1992.

3302-823725 Lever (With 3 Holes)
