No. 92-10

OFFICIAL NOTIFICATION UNDER THE U.S. FEDERAL BOAT SAFETY ACT

A. REQUIRED DISTRIBUTOR CAP GASKET INSTALLATION

MCM 4.3L/4.3LX Stern Drive Engines

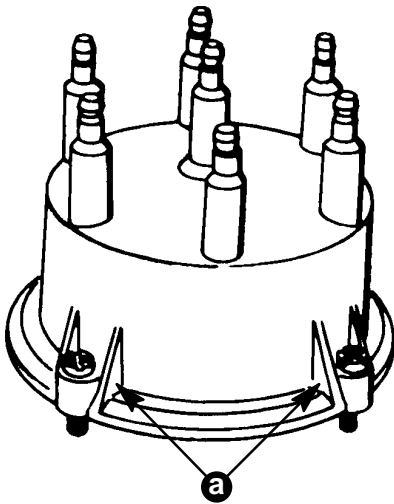
Figure 1

The distributor cap with reinforcement ribs by the hold-down screws (Figure 1), may not seal tight enough to comply with SAE J1171 "External Ignition Protection of Marine Electrical Devices" regulations. There may be a gap between the cap and the distributor housing. This gap may reduce the explosion arresting ability of the distributor assembly creating the potential for fire or explosion if gasoline or a gasoline vapor source is present.

2. Remove cap to see if gasket has been installed in cap.
 - a. If there isn't a gasket, go to Step 3.
 - b. If there is a gasket, go to Step 4.
3. Install gasket P/N 27-98242--1 in cap.
4. Reinstall cap and tighten hold down screws securely.
5. Close engine hatch.

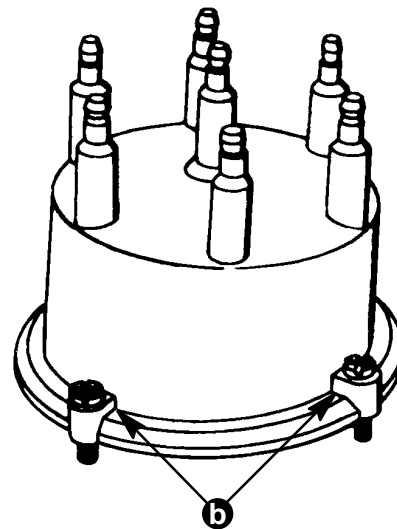
Figure 2

1. Open engine hatch and look at distributor cap.
 - a. If the cap has reinforcement ribs (a) as shown in Figure 1, go to Step 2.
 - b. If cap does not have reinforcement ribs (b) as shown in Figure 2, go to Step 5. This cap complies with SAE J1171 and is not affected by this recall.
