No. 93-30

A. INCORRECT ANEROID ADJUSTMENT

MCM D7.3L and MIE D7.3L Diesels

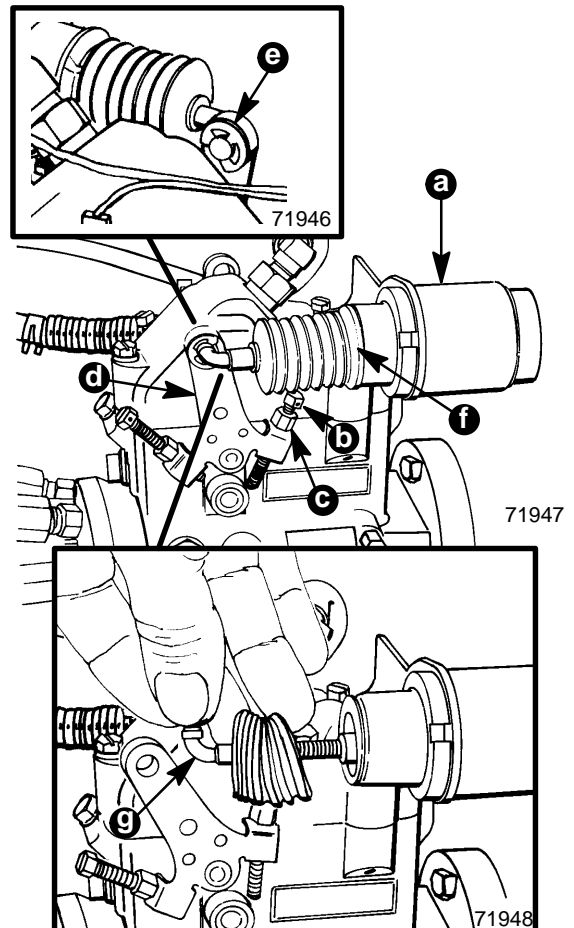
Aneroid adjustment set incorrectly (too lean) from the factory.

1. Remove e-clip from aneroid rod.
2. Remove aneroid rod from lever.
3. Remove convoluted seal from end of aneroid.
4. Remove rod from hole in lever.
5. Remove and discard wire from adjustment screw.
6. Loosen the jam nut and turn the screw in (clockwise) 1/4 turn. Tighten the jam nut.
7. Screw the rod in or out until rod will enter the hole with out pushing or pulling the lever (no load).
8. Install e-clip and convoluted seal.
9. Do not use wire to secure the adjusting screw. It is not necessary, and serves as an indication that the job was completed.
