No. 93-16

A. EXHAUST BELLOWS FALLING OFF

All Alpha Generation II / Bravo One / Bravo Two

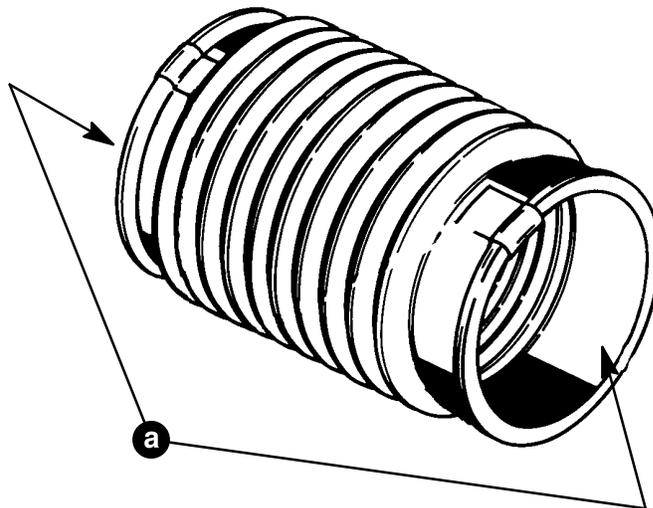
22079

a - Mounting Surface (Apply Bellows Adhesive)

1. Remove the stern drive unit
2. Clean old adhesive from bellows mounting flanges on the gimbal housing and bell housing using either Quicksilver spray paint leveler or lacquer thinner.
3. Clean old adhesive from mounting surfaces of exhaust bellows.
4. Apply bellows adhesive 92-86166 to mounting surfaces on inside of bellows. Allow adhesive to dry until no longer tacky (approximatley 10 minutes).

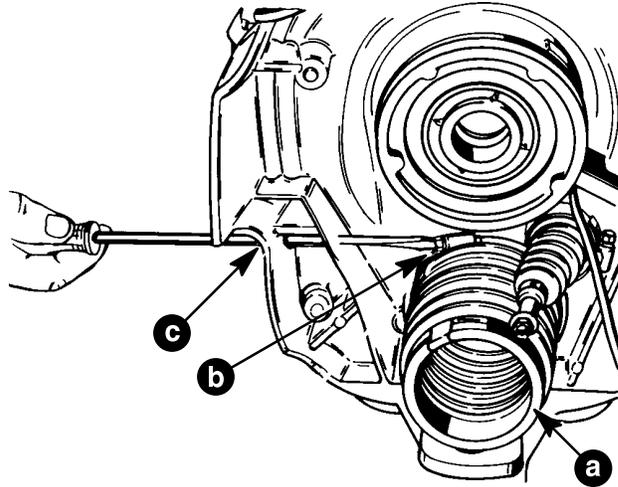
22081

- a - Exhaust Bellows
- b - Hose Clamp
- c - Gimbal Housing Access Hole

5. Install exhaust bellows onto gimbal housing. Position hose clamp as shown. Tighten hose clamp screw using a screw driver thru access holes in gimbal housing.

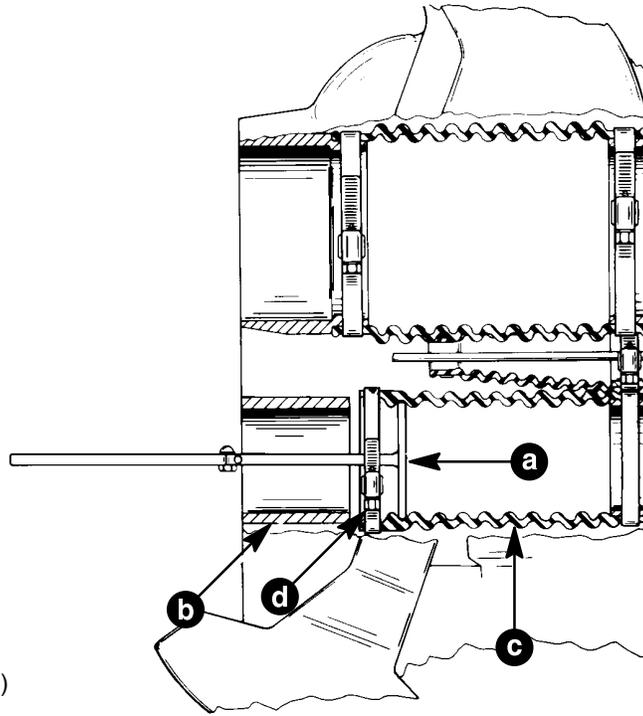
23154

- a - Expander Tool (91-45497A1)
- b - Bell Housing Flange
- c - Exhaust Bellows
- d - Hose Clamp

- d. Pull the tool until tool touches the flange on the bell housing (hose starts to slip onto the flange); then release the tool.

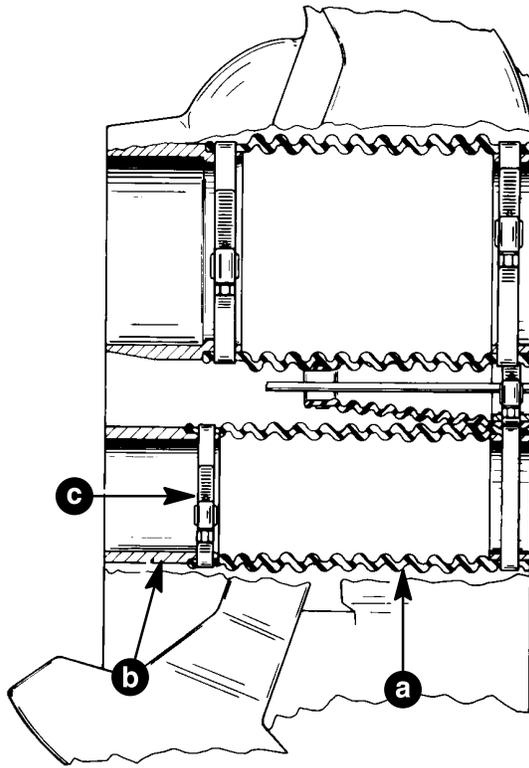
23158

- a - Exhaust Bellows
- b - Bell Housing Flange
- c - Hose Clamp

- e. Reposition the tool into the third bellows convolution.
- f. Pull the bellows the rest of the way onto the bell housing flange.
- g. Tighten hose clamp.
