**No. 94-7**

## A. STERN DRIVE – REAR ENGINE MOUNT BOLT TORQUE

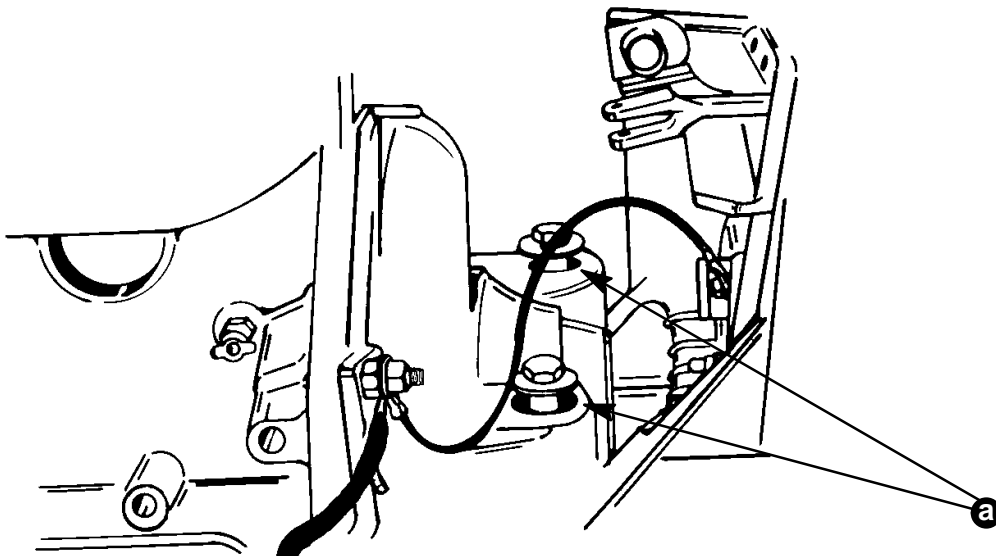
71651

A procedure from the pre-delivery checklist is being added to the 20 hour and 100 hour/annual checklist for all MerCruiser Stern Drive Products. Effective immediately, the torque on the rear engine mounts (a) must be checked and re-torqued to the proper torque value of 35-40 lb. ft. ( 47-54 N.m.).

Loosen each of the rear engine mounting bolts and re-torque. Check the torque again after 10 seconds. If the torque was not retained after a 10 second waiting period, remove the rear engine mount bolt(s) and check for stripped threads on the bolt and nut. If the bolt and nut are undamaged, check the inner transom plate for cracks or damage in the area near where the captive locknut for the rear engine mount(s) seats.

If the threads on either the bolt or nut are damaged, replace the bolt and nut. If the inner transom plate shows cracks or damage in the area where the captive locknut seats, replace the inner transom plate. Before replacing an inner transom plate, call your MerCruiser Technical Assistance Department for pre-approval.
