No. 97-21

## Required ECM Replacement

- 1998 MCM 350 Mag MPI Sterndrive Engines: S/N 0L010019-0L012709  
1998 MCM 7.4L MPI Sterndrive Engines: S/N 0L010003-0L014306  
1998 MIE 350 Mag MPI Inboard Engines: S/N 0L002008-0L002348  
1998 MIE 7.4L MPI Inboard Engines: S/N 0L002006-0L002826

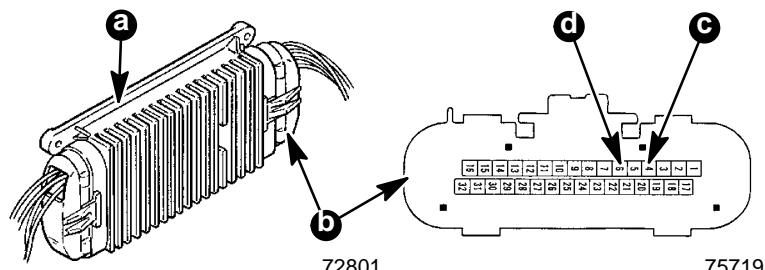
ECMs with check sum number '9371,' '9375' or '9361' for 350 MPI or 'A012' for 7.4L MPI are good. Inspect the electrical harness J1 connector to make sure that the BRN wire is in the J1-6 pin location instead of the J1-4 location. Refer to drawing on page 4 for J1-6 location. Follow instructions outlined under 'Changing Pin Location' to change wire/pin location if BRN wire/pin is in the J1-4 location.

- a - Check Sum Number on White Tag.  
b - J1 Harness Connector to ECM.  
c - J1-4 Pin Location-Incorrect.  
d - J1-6 Pin Location-Correct.

Change any ECMS that have a check sum number listed in 'a' or 'b', preceding. Be sure the BRN wire/pin in the J1-6 location.

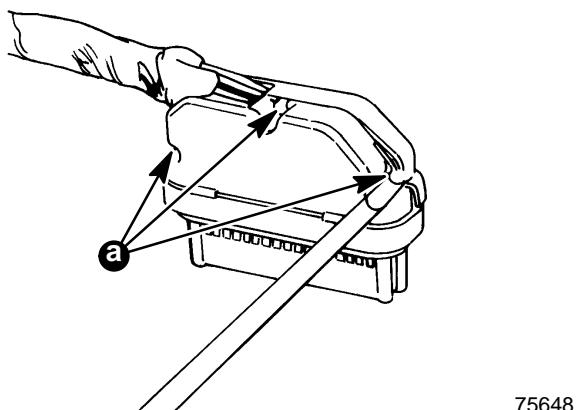
75648

a - Housing Locking Tabs.

1. Remove the J1 connector from the ECM.
2. Open the connector housing by lifting the locking tabs.

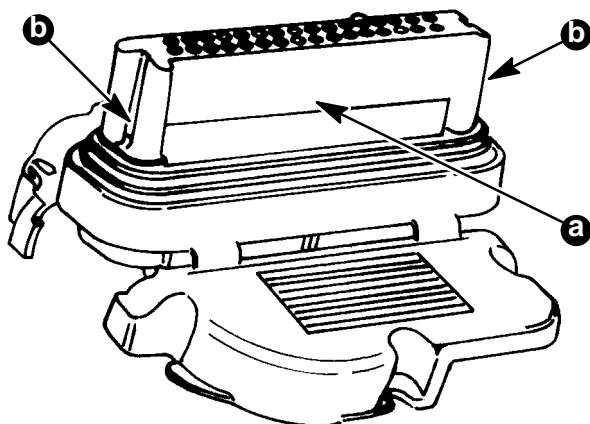
75649

a - Pin Protector.

b - Protector Locking Tabs.

3. Remove the pin protector by pressing in on locking tabs on both ends of the protector.

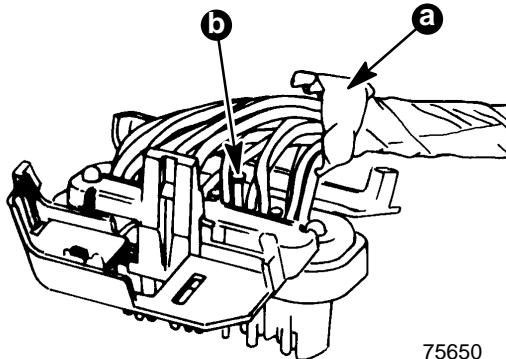
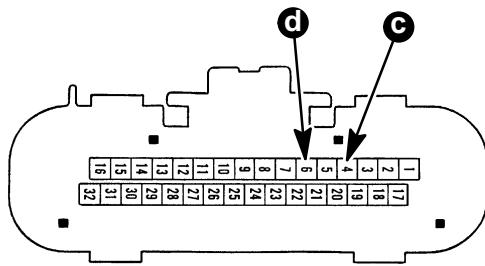
- a - Rolled Back Electrical Tape.  
 b - Plastic Plug in J1-6 Pin Location.  
 c - J1-4 Pin Location.  
 d - J1-6 Pin Location.

4. Roll the electrical tape back far enough so that you can work with the wires.
5. Remove the plastic plug from the J1-6 pin location.
6. Move the harness wires so they are aligned straight with the connector holes. This will make it easier to push the BRN wire/pin up and out of its hole.

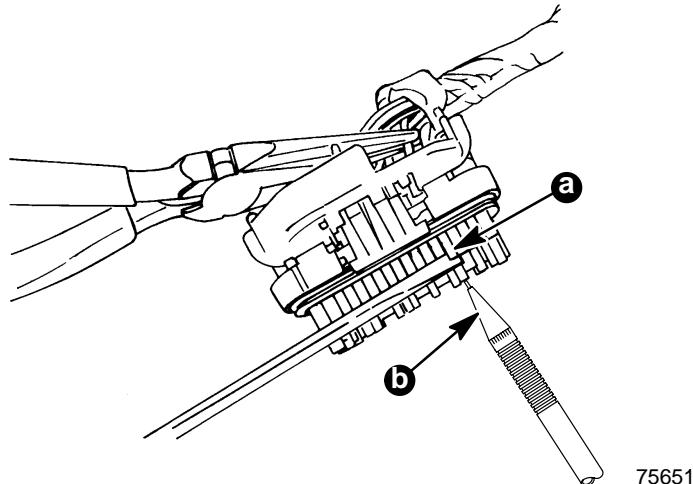
75651

- a - Pin Locking Tab.  
 b - Metal Tip of Mechanical Pencil.

7. While lifting 'up' on the pin's locking tab, use the metal tip of a mechanical pencil to push the pin up and out of the J1-4 pin location. When first starting to push on the BRN wire/pin, lift the pin slightly toward you and push up.

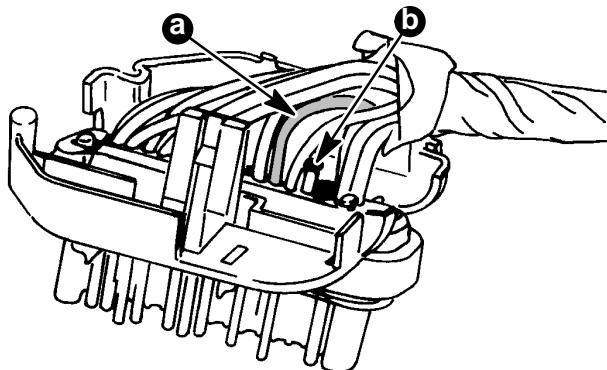
75653

a - BRN Wire/Pin Inserted In J1-6 Pin Location.  
b - J1-4 Pin Hole.

8. Move the BRN wire/pin to the J1-6 pin location. Push down on the BRN wire/pin until it locks in place.
9. Insert the plastic plug into the J1-4 pin hole location.
