No. 98-16

Revised January, 1999. This bulletin supersedes all of the following bulletins 94-1, 94-16, 96-1 and 97-7.

Bravo Drive Shaft Housing Replacement

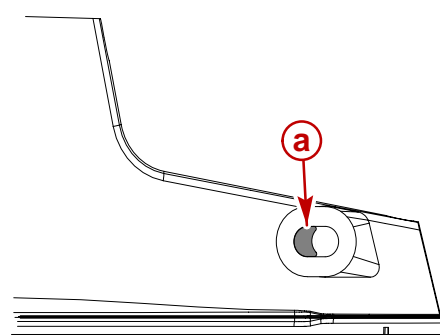
75157

- a** - Bravo One / Two Standard Insert Location
- b** - Bravo One / Two Optional Insert Location

For the Bravo One and Two, the insert is placed in the **FORWARD most position** in the aft anchor pin hole. This placement will give the normal minus 5 degrees of trim under. The insert may be placed in the **AFT most position** of the slotted hole to limit the amount of trim under for boat hulls requiring less trim under.

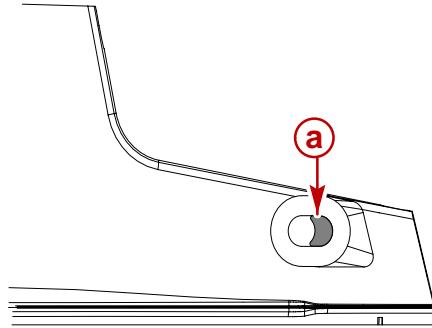
75158

a - Trim-In Limit Spacer Location

For the Bravo Three drive unit, the insert **MUST BE** placed in the **AFT most position** in the slotted hole to limit the Trim Under.

When the 1589-8868G21 housing is used on a Bravo Three drive unit, the Trim-In Limit Blocks (806692A2) will no longer be required. **DO NOT** reinstall them on the drive unit. If the blocks are already installed, they **MUST BE REMOVED**.

After placing the insert in the AFT most position of the slotted hole, install a Tilt Limit Spacer Kit (15768A3). Use 1 spacer per cylinder as shown below to prevent the bell housing and drive shaft housing from contacting the gimbal ring U-Bolt.
