SERVICE INFORMATION

## Proper Shift Set-up For The Commander 3000 Classic Control When Used With Alpha One Product

ALL Alpha One Product with Shift Assist

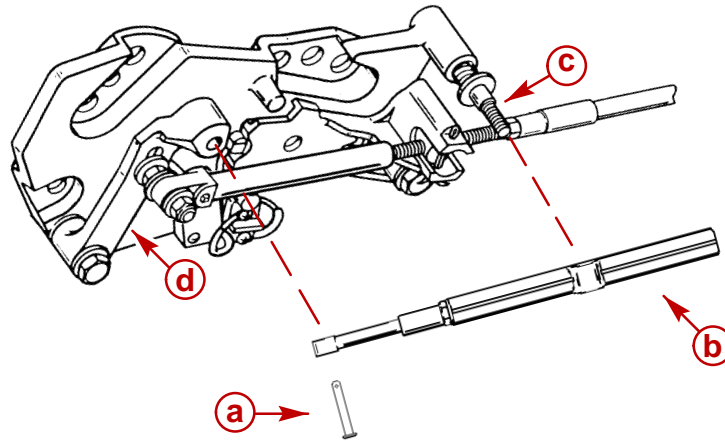
- a** - Clevis Pin
- b** - Shift Assist Assembly
- c** - Shift Plate Anchor Stud
- d** - Shift Lever

There should be no pressure on either side of the shift assist assembly attaching point. Failure to adjust properly could apply excessive load to the cable and cause the throttle only portion of the control to hang up and malfunction.

Now the Shift Assist Assembly must just slip over the stud on the shift plate assembly and the clevis pin must insert into the shift lever and the control cable with no effort. (The shift assembly should not require compression or extension to fit onto the shift plate with the control handle placed in neutral position.)

If the shift assist assembly requires effort to fit over the anchor stud and clevis pin, the shift cable from the control box is adjusted incorrectly. Remove the shift cable and reposition the adjustment barrel as required to allow the shift assist assembly to be attached with no effort.

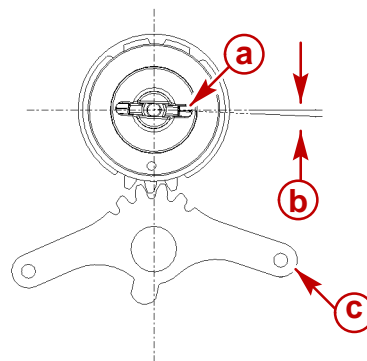
Excessive cable preload causes misalignment of the throttle only drive pin (a) in the center hub assembly so that it is not in the true neutral position. This does not allow the button to pop out because of interference with the shift gear when the slots are not in alignment. If the button is not all of the way popped out and the handle is forced, the lock ring is carried along with the shift gear. This will damage the housing notches or break the lock ring. When everything is in true neutral (no tension / compression) with the slots lined up, the throttle only button should pop out just fine.

- a** - Throttle Only Drive Pin
- b** - Excessive Cable Preload
- c** - Shift Cable Force (Tension or Compression)
