Official Recall Notification U.S. Federal Boat Safety Act—Possible Chafing of Orange Alternator Wire on 5.0L/5.7L/6.2L MPI Engines

Models Affected

Models Covered	Engine Serial Number
5.0 MPI	Alpha Drive 0M300000 to 0W387854
350 MAG MPI	
350 MAG MPI Horizon	
MX6.2 MPI	
MX6.2 MPI Horizon	
5.0 MPI	Bravo Drive 0M300000 to 0W386609
350 MAG MPI	
350 MAG MPI Horizon	
MX6.2 MPI	
MX6.2 MPI Horizon

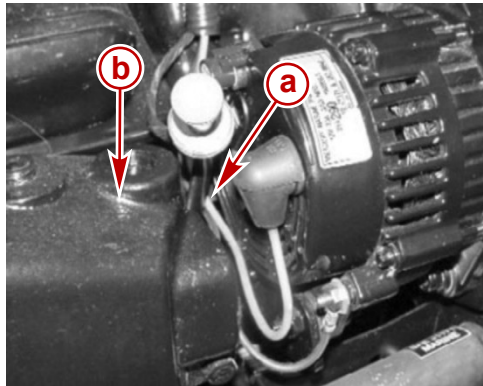
21326

The incorrect routing places the orange alternator wire between the oil dipstick tube and the alternator. With that incorrect routing, it is possible that the insulating material will be chafed by the dipstick tube or the alternator, which could cause the wire to fail. If the wire fails, it could become an ignition source. See the "incorrect routing" photographs below.

On engine—Incorrect routing

a - Wire pinched by dipstick tube

2. a. If the orange alternator wire is found to be free of evidence of damage caused by denting, rubbing, or chafing, route the wire under the alternator as shown below. No further action is required.

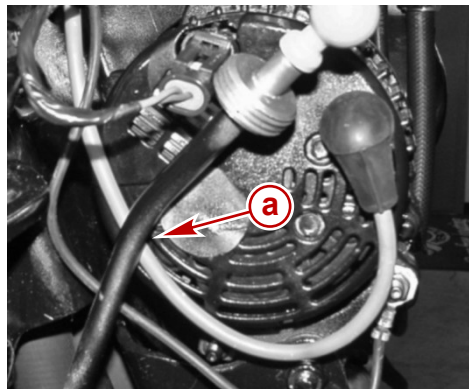
21333

On engine—Incorrect routing (exhaust manifold removed for clarity)

a - Wire pinched by dipstick tube

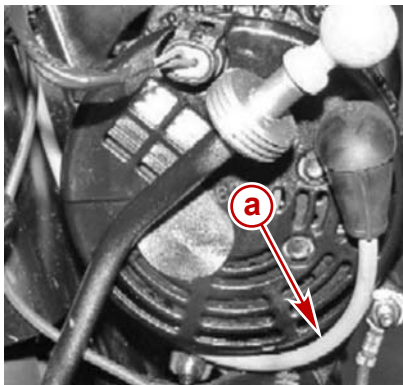
21336

The correct routing passes the orange alternator wire beneath the alternator, not in contact with the dipstick tube, which eliminates the opportunity for chafing and failure identified above. See the "correct routing" photograph following.

On engine—Correct routing (exhaust manifold removed for clarity)

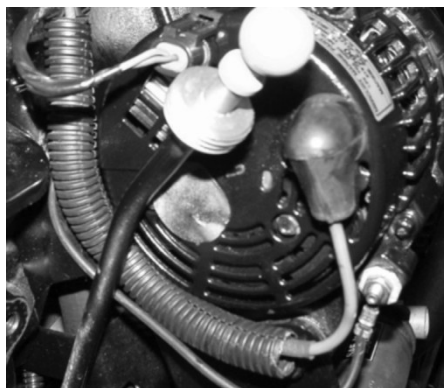
21346

Wire Routed Under Alternator (exhaust manifold removed for clarity)

16. Ensure that the wire is routed below the alternator and not pinched by the dipstick tube.
